## **Phase II Report: Investigation of the Wind Resistance of Asphalt Shingle Roof Coverings**

**SERRI Project:  
Investigation of the Wind Resistance of  
Asphalt Shingle Roof Coverings**

Date Published:  
June 16, 2013

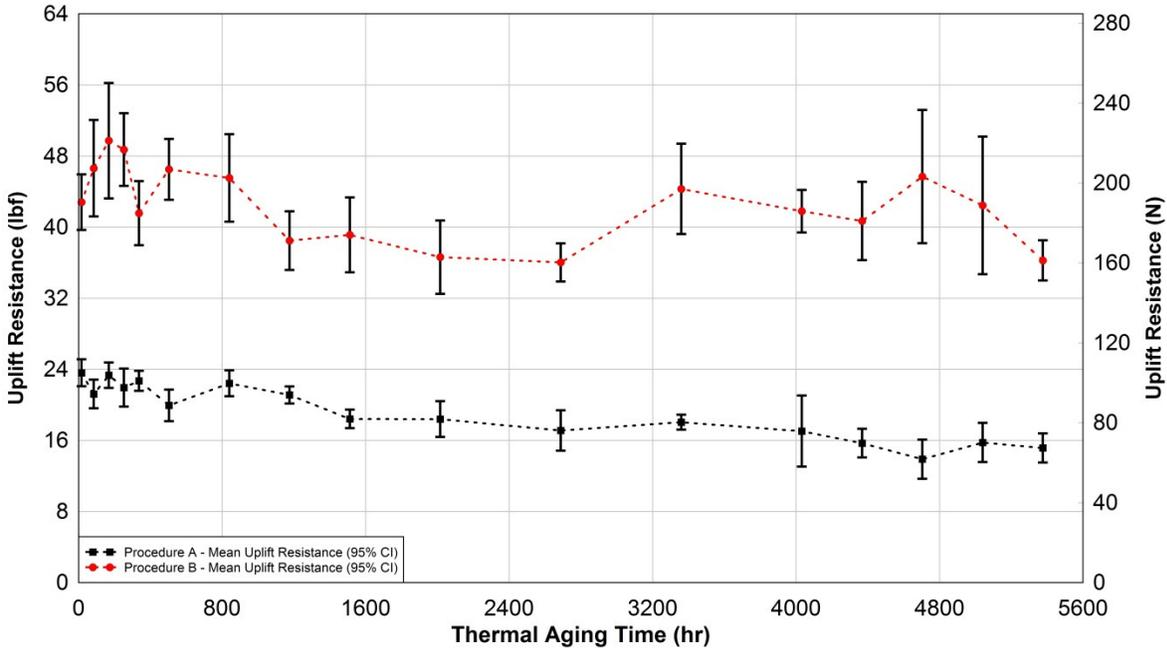
Fig. 3. TT-101 mean ( $\pm$  95% confidence interval) ASTM D6381 mechanical uplift resistance versus thermal aging time.

The long-term reduction in uplift capacity of ASTM D6381 Procedure B specimens (Figure 3 and Table 4) was less dramatic than Procedure A's, but statistically significant reductions in mean uplift resistance were observed on 3 out of the 16 (19%) time intervals. The first significant reduction occurred after 2016 h, producing a 27.5 N (6.2 lbf) reduction in mean uplift capacity. However, as the aging progressed past 2688 h, mean uplift resistance regained its similarity to the 16 h mean capacity. By the final uplift time interval (5376 h) the mean uplift resistance of the aged specimens was statistically lower than the new shingle specimens, resulting in a 29.3 N (6.6 lbf) loss of uplift capacity (15% reduction).

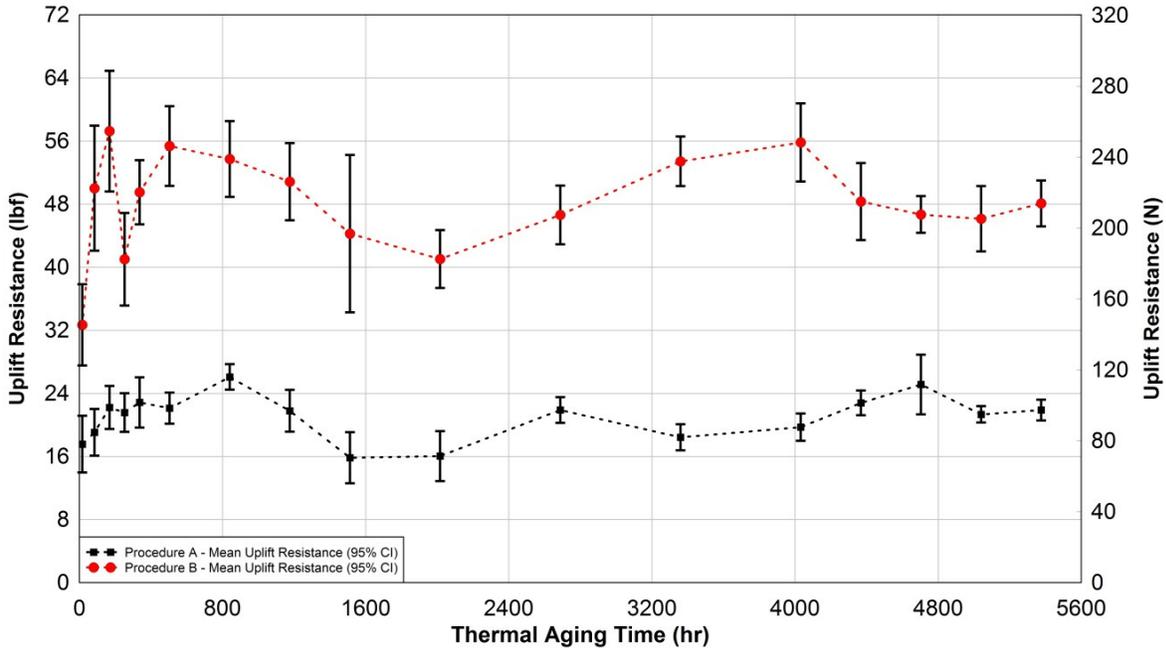
Fig. 4. TT-102 mean ( $\pm$  95% confidence interval) ASTM D6381 mechanical uplift resistance versus thermal aging time.

Procedure B specimens exhibited greater strengthening through the aging process than Procedure A's. The first two time intervals (84 h and 168 h) saw significant increase in mean uplift capacity with a high confidence ( $p$ -values = 0.003 and 0.000, respectively). Only 2 out of the following 14 time intervals did not show significant increases in mean uplift capacity. The specimen's resistance to Procedure B uplift increased 47% between the initial and final time intervals ( $p$ -value = 0.000).

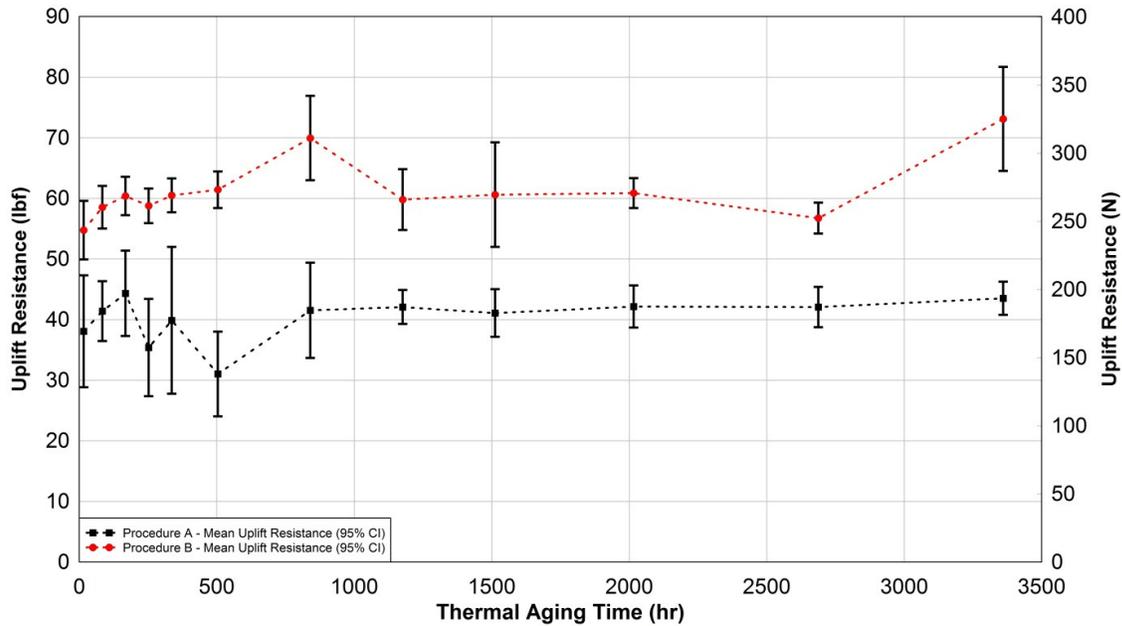
Fig. 5. TT-103 mean ( $\pm$  95% confidence interval) ASTM D6381 mechanical uplift resistance versus thermal aging time.

10.8 N (2.4 lbf) of one another. Procedure B's initial (16 h) test produced less variable data than Procedure A's (Figure 5) and the first statistically significant increase in mean uplift resistance was observed after 504 h of thermal exposure. The final time interval produced a mean uplift capacity of 325.2 N (73 lbf), compared to the initial mean uplift capacity of 243 N (54.6 lbf). This 34% increase in mean uplift resistance between the new and aged was statistically significant (p-value = 0.003).

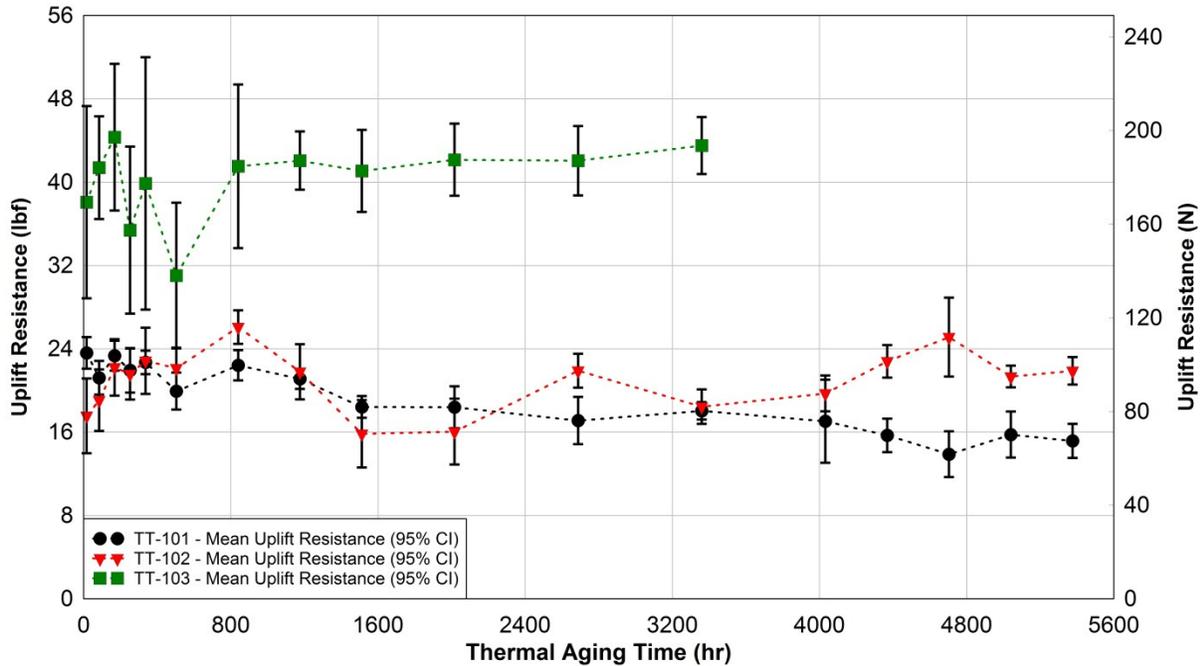
Fig. 6. Comparison of TT-101, -102, and -103 mean ( $\pm$  95% confidence intervals) ASTM D6381 Procedure A mechanical uplift resistance versus thermal aging time.

1. The sealant used on TT-103's sealant strip has the highest adhesive strength per unit surface area.
2. TT-103 has the shortest distance between the shingle's leading edge and its sealant strip.
3. The mean sealant strip contact surface area of TT-103 is the highest of the three manufacturers.

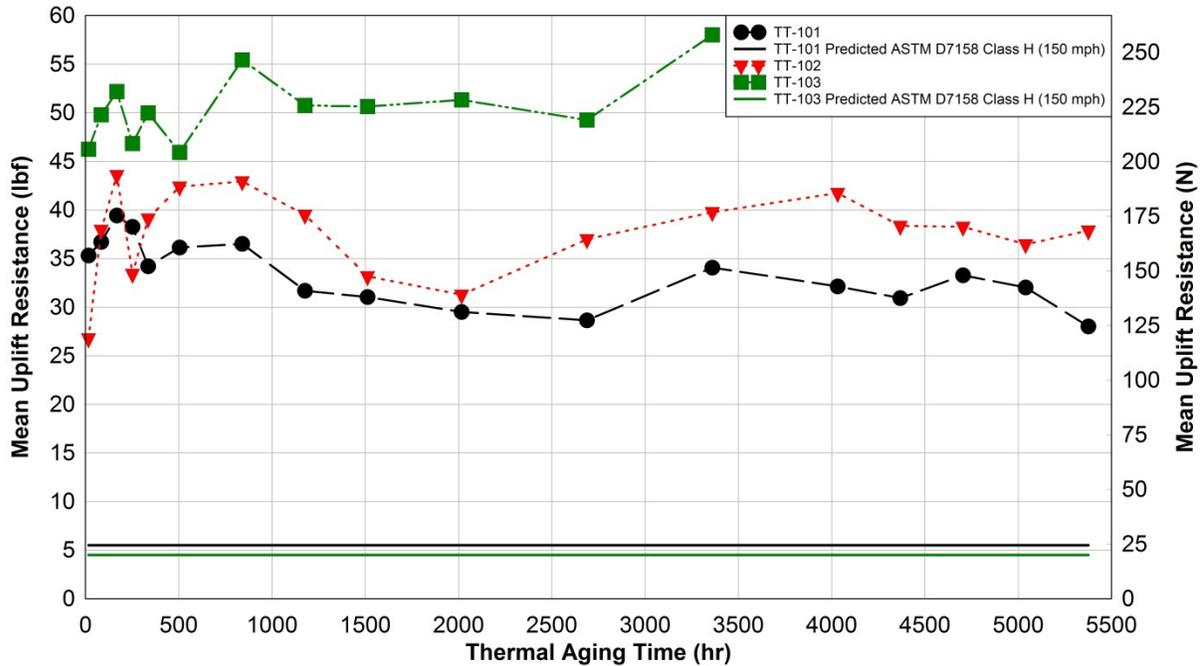
Fig. 10. Mean ASTM D7158 total uplift resistance versus thermal aging time. Note: TT-102’s manufacturer did not provide its product’s ASTM D7158 uplift coefficients, therefore, TT-101’s ASTM D7158 uplift coefficients were used to develop the total load equation for TT-102.

The ASTM D7158 mean total uplift resistance of the thermally aged asphalt shingles is given in Figure 10 along with the required total uplift resistance to meet ASTM D7158 Class H wind resistance based on data from TT-101 (24.5 N [5.52 lbf]) and TT-103 (20.0 N [4.5 lbf]). All three manufacturers exceed the ASTM D7158 Class H wind resistance requirements across all time intervals. A statistically significant reduction in TT-101's uplift resistance was observed during ASTM D6381 Procedures A and B testing, but the mean total uplift resistance was still roughly five times the ASTM D7158 Class H minimum requirement. Note that these values represent the mean values of the sampled population and the method outlined in ASTM D7158 and performed on the data presented herein does not account for outliers – beyond their inclusion within the mean data calculation.

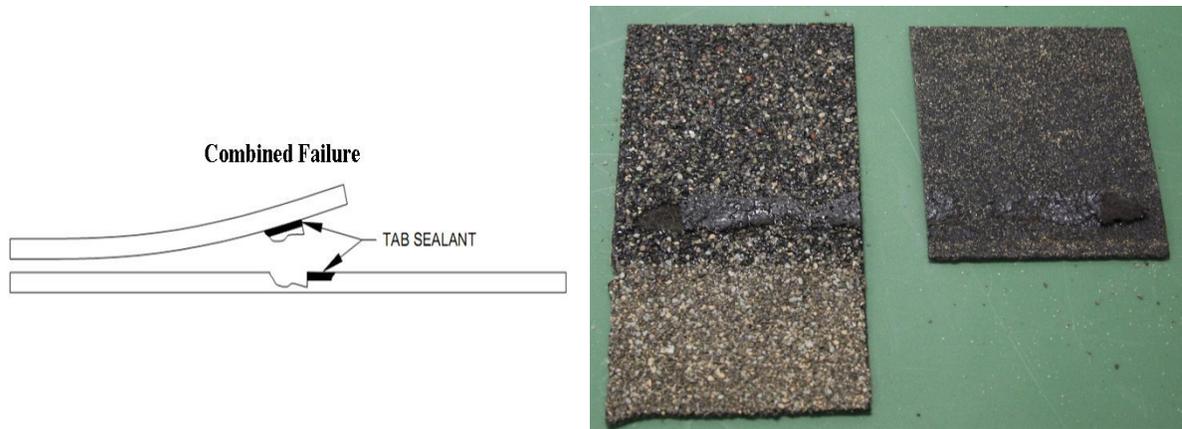
**Fig. 13. Combined (mixed-modal).**

3. Combined: This is a mixed-mode failure whereby partial cohesive failure in the adherend and partial adhesive failure are observed on the mechanically uplifted specimen. No attempt to quantify the relative contribution of each failure mode has been made for this report.

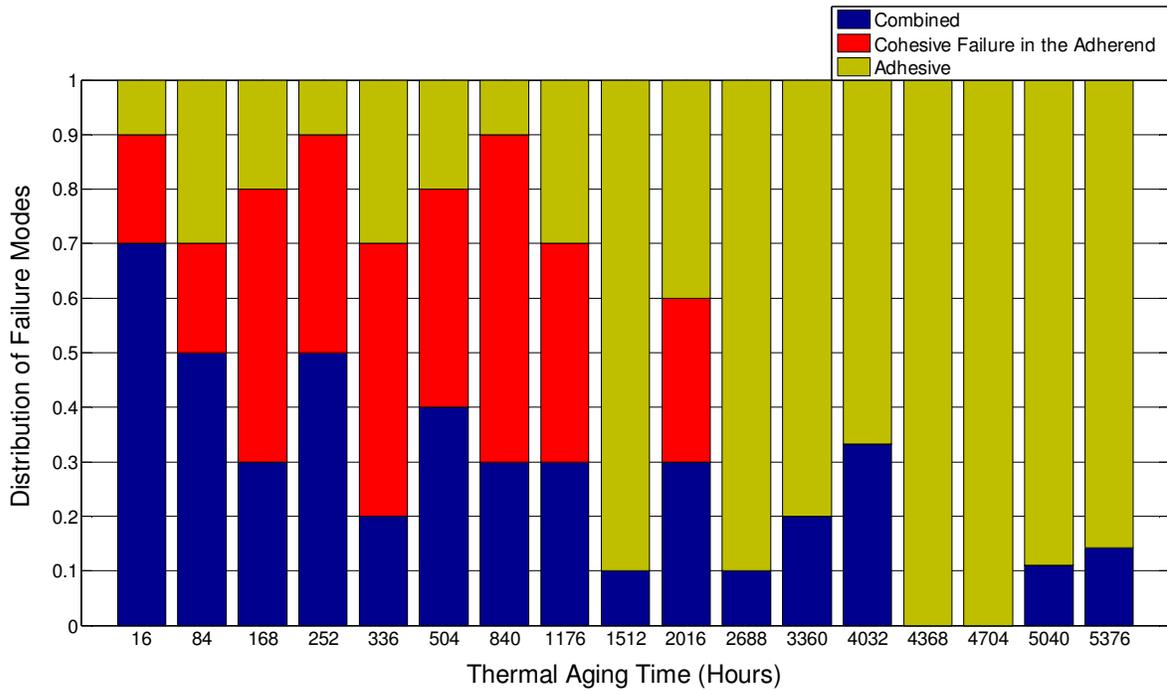
Fig. 14. Distribution of failure modes versus thermal aging time for TT-101 - Procedure A.

3. For all manufacturers, the dominant failure modes observed in Procedure A do not match the dominant failure modes observed in Procedure B. An example of this conclusion is given by examining the failure modes reported for TT-101 specimens. Cohesive failures in the adherend dominate Procedure B test specimens across all aging time intervals (Figure 15). However, for Procedure A specimens, cohesive failures in the adherend occurred less often. Furthermore, the failure mode trends are not visible in the corresponding Procedure B failure mode data. Recall that the two test methods in the ASTM D6381 test procedure were developed with the intent of simulating the partial peel-type and partial direct tension loading that exists during actual wind uplift. With the two test methods producing different failure limit states (i.e., loss of adhesion in the sealant strip bond or loss of adhesion within the shingle matrix); it is possible that the true in-service limit state may not be defined with the current ASTM D6381 test procedure.

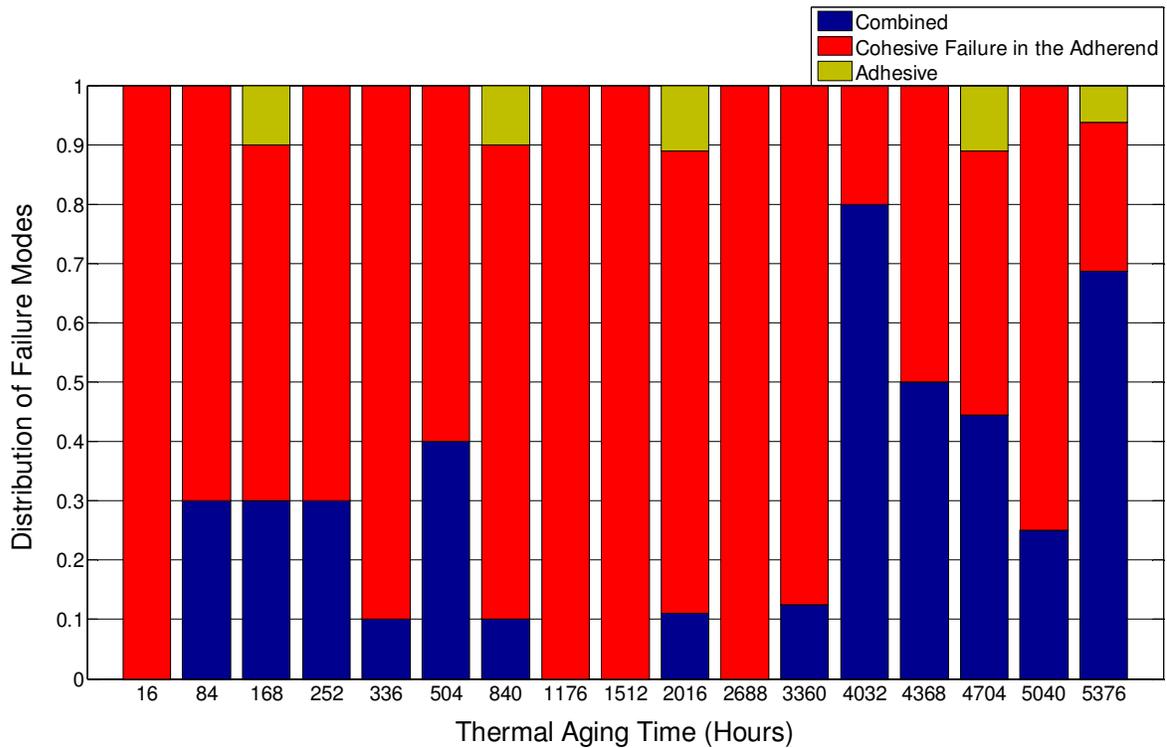
Fig. 15. Distribution of failure modes versus thermal aging time for TT-101 - Procedure B.

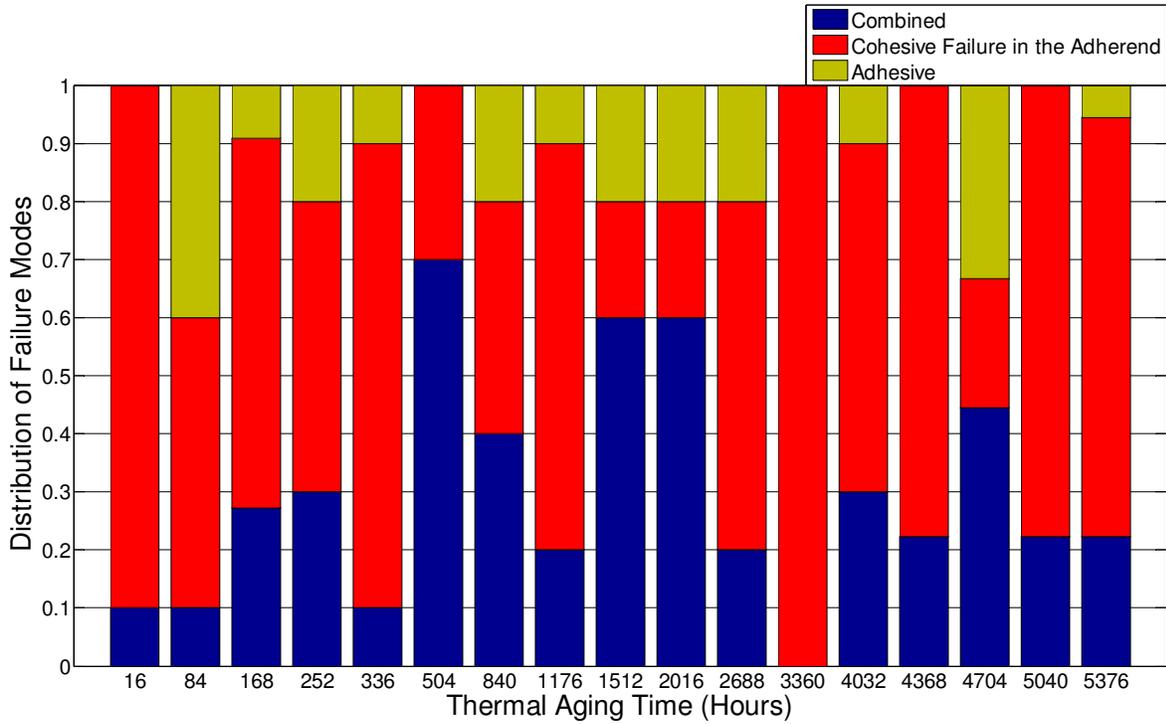
Fig. 16. Distribution of failure modes versus thermal aging time for TT-102 - Procedure A.

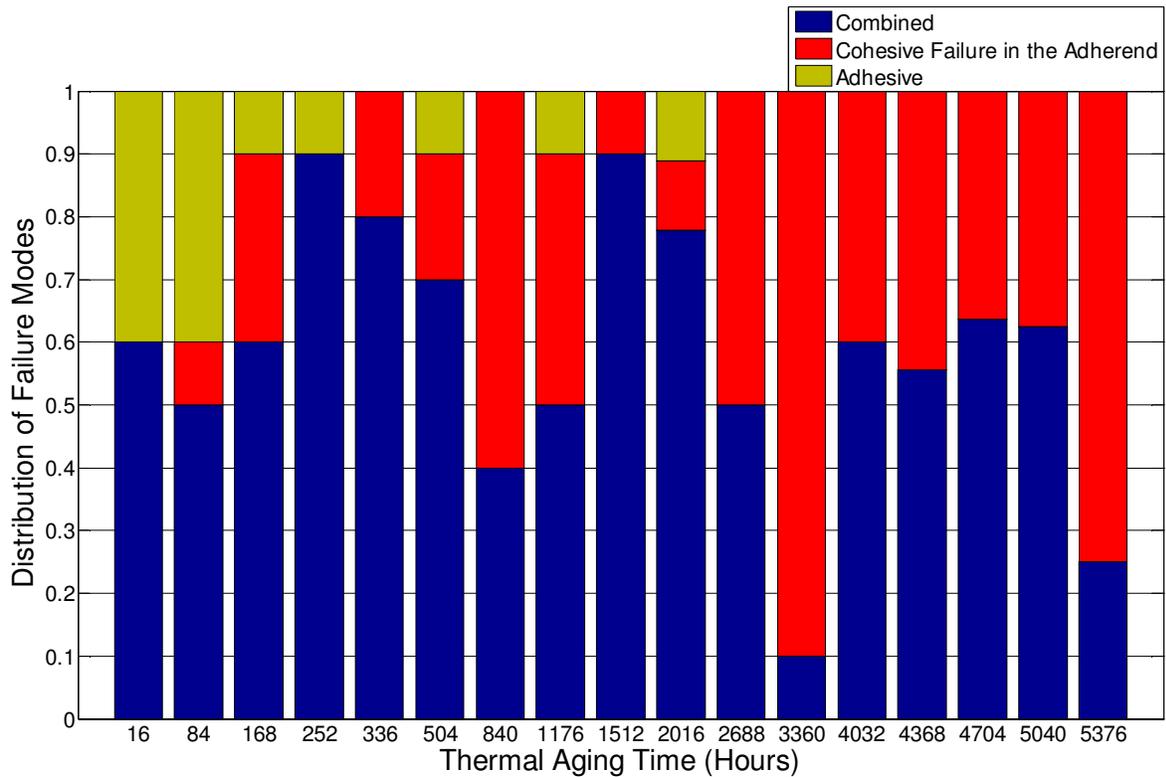
Fig. 17. Distribution of failure modes versus thermal aging time for TT-102 - Procedure B.

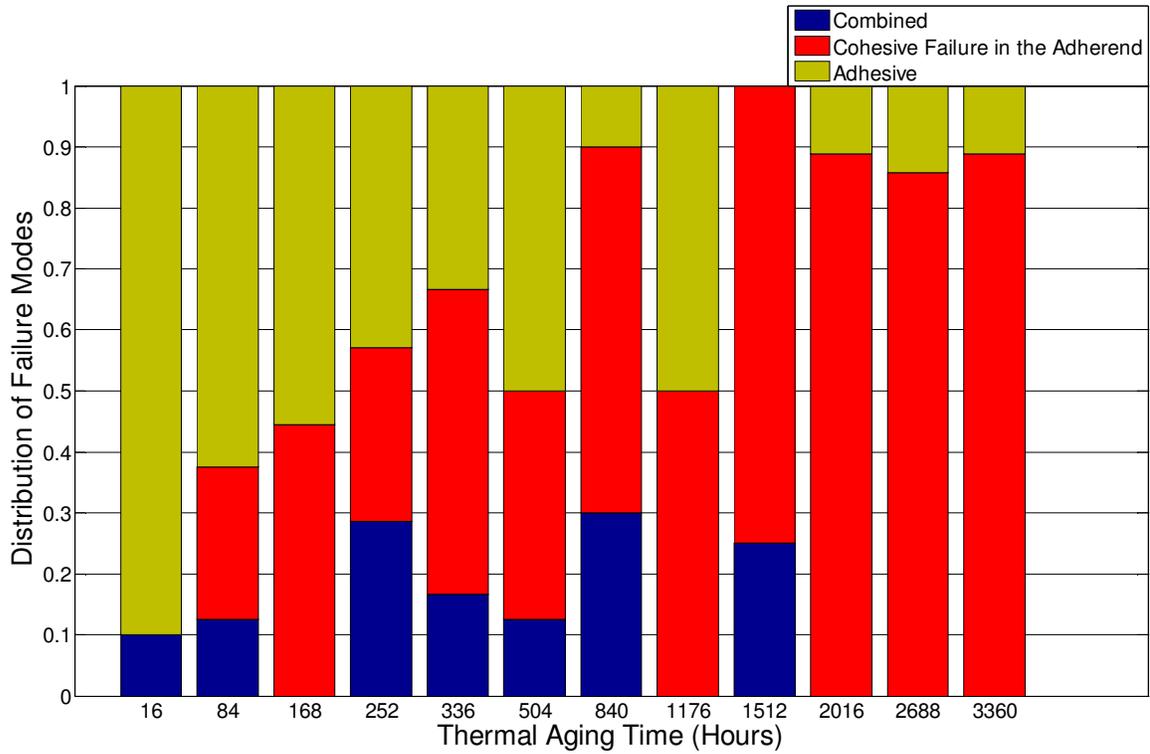
Fig. 18. Distribution of failure modes versus thermal aging time for TT-103 - Procedure A.

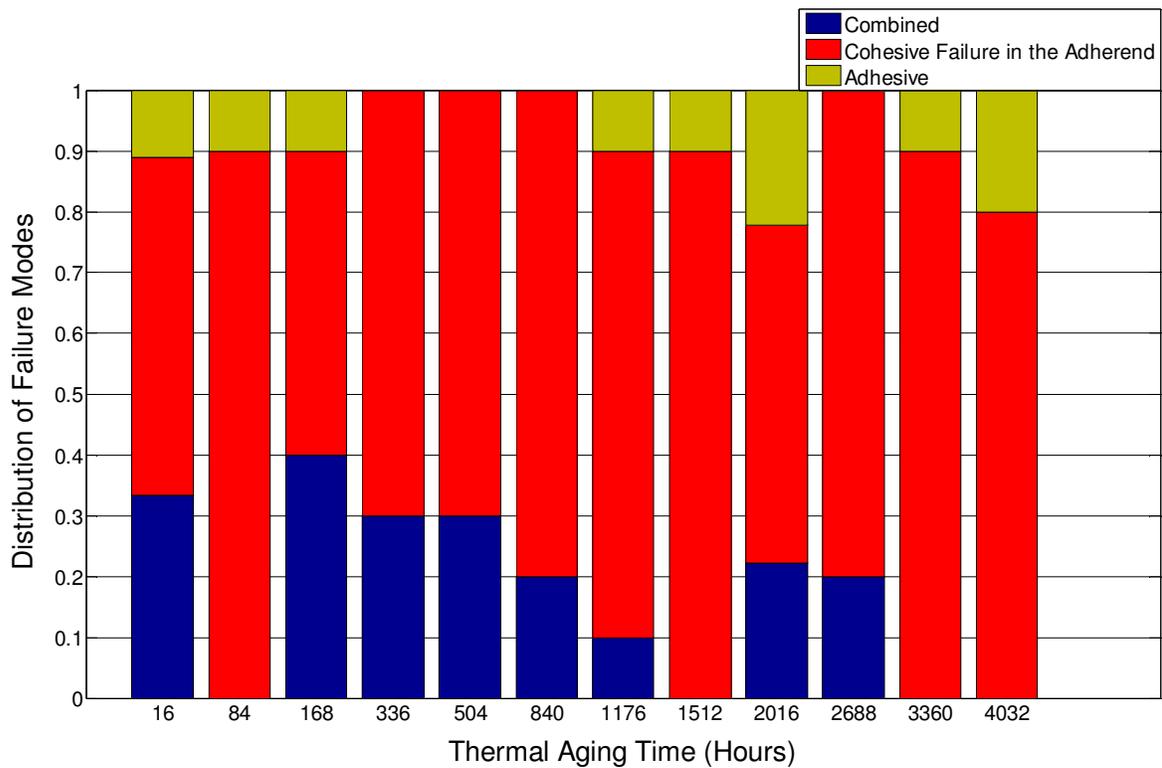
Fig. 19. Distribution of failure modes versus thermal aging time for TT-103 - Procedure B.

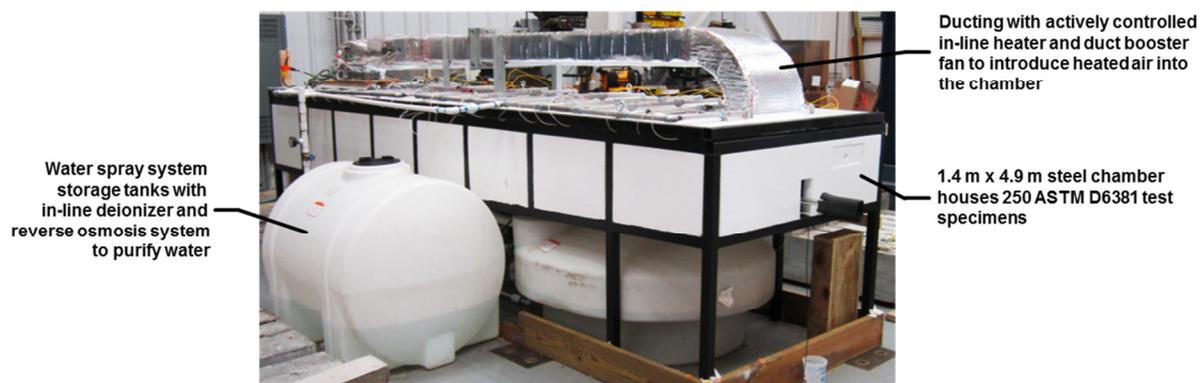
Fig. 21. Exterior view of the accelerated aging chamber.

Most accelerated weathering chambers (e.g., the QUV system manufactured by Q-Lab) are significantly smaller than the capacity required for this experiment. Therefore, a larger accelerated weathering chamber was designed and built to conform to the requirements for accelerated weathering of bituminous materials set forth in ASTM D4799-08, ASTM G151-10, and ASTM G154-06 (Figure 21). The chamber had plan dimensions of 1.4 m by 4.9 m (4 ft 6 in by 16 ft) and a water spray retention basin with a chamber height that slopes from 0.30 m to 0.48 m (1 ft to 1 ft 6 in).

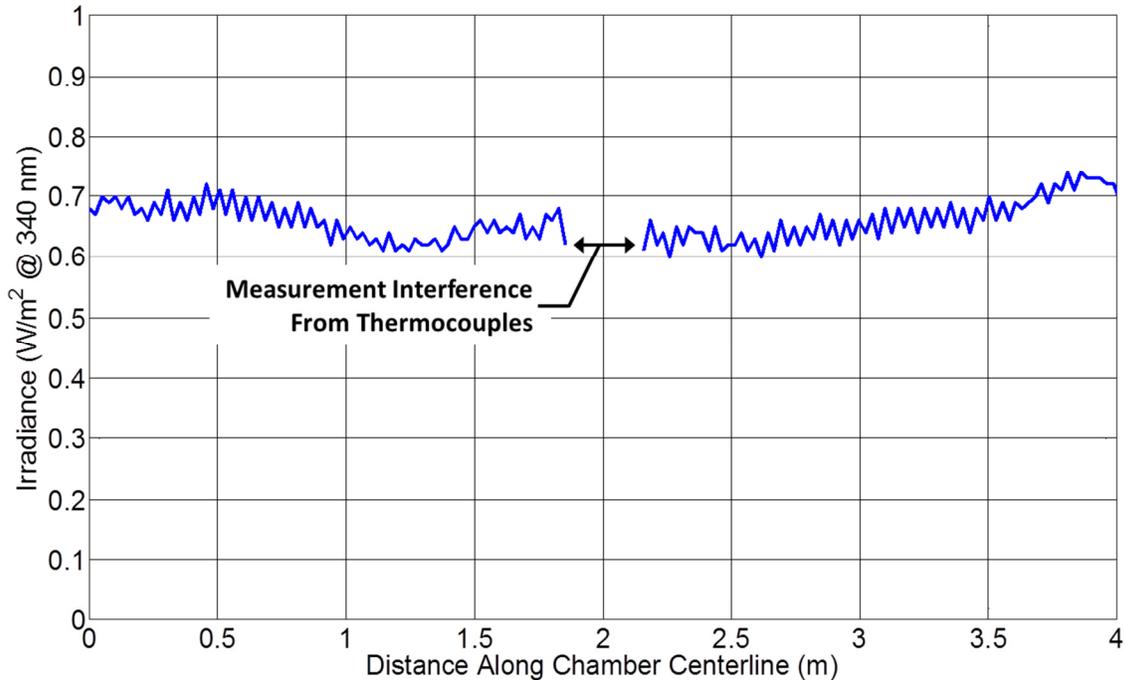
**Fig. 23. Distribution of irradiance output from UVA 340 lamps along the centerline of the accelerated aging chamber.**

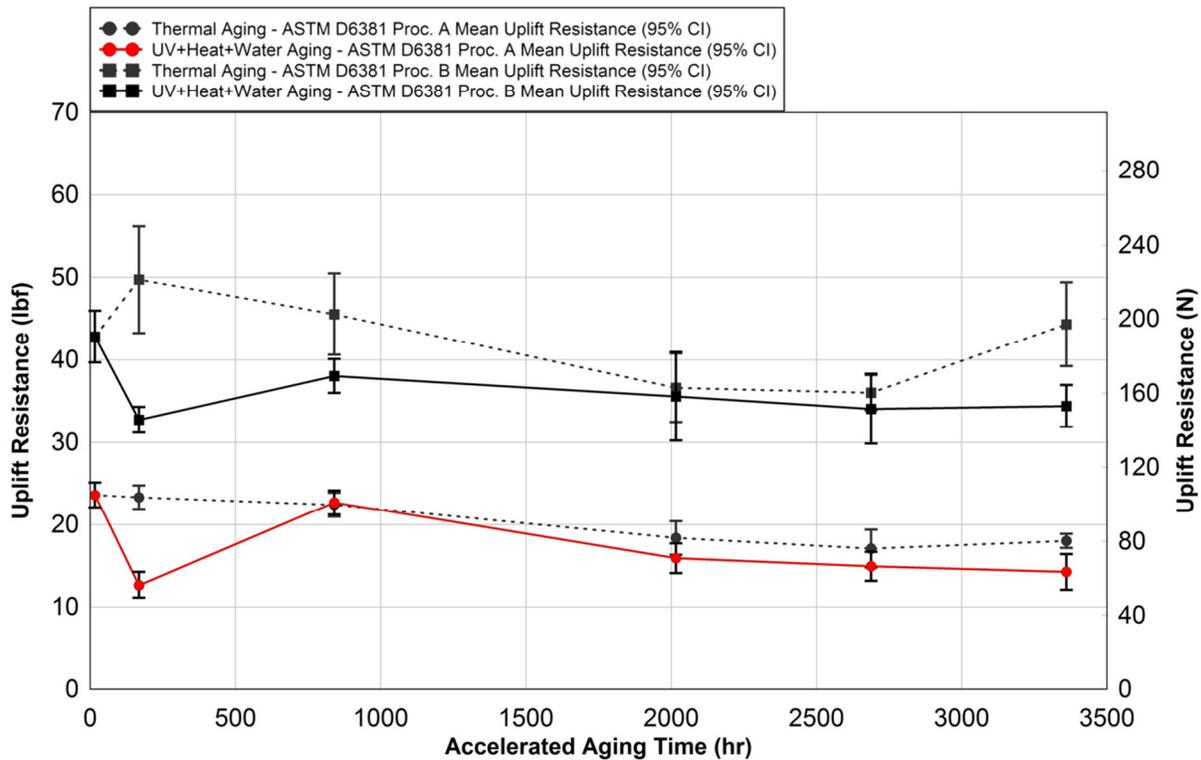
Fig. 25. TT-101 mean ( $\pm$  95% confidence interval) ASTM D6381 mechanical uplift resistance for UV+Heat+Water and thermal aging versus accelerated aging time.

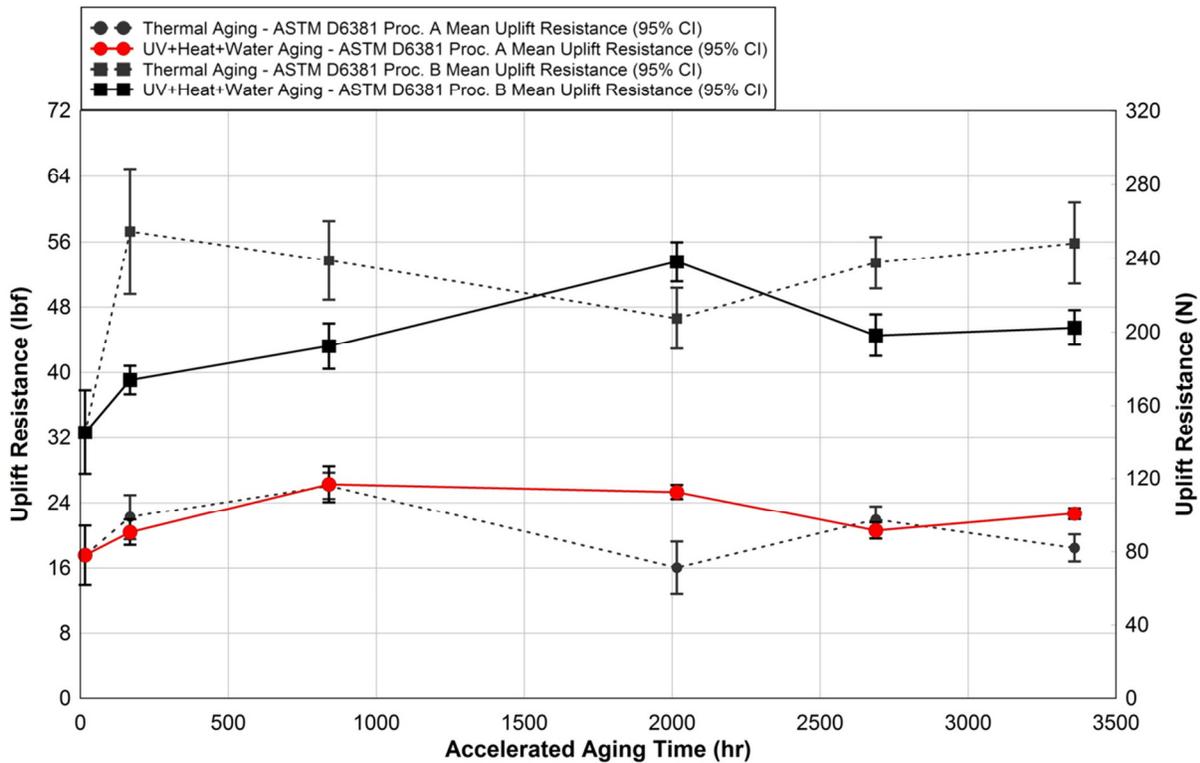
Fig. 26. TT-102 mean ( $\pm$  95% confidence interval) ASTM D6381 mechanical uplift resistance for UV+Heat+Water and thermal aging versus accelerated aging time.

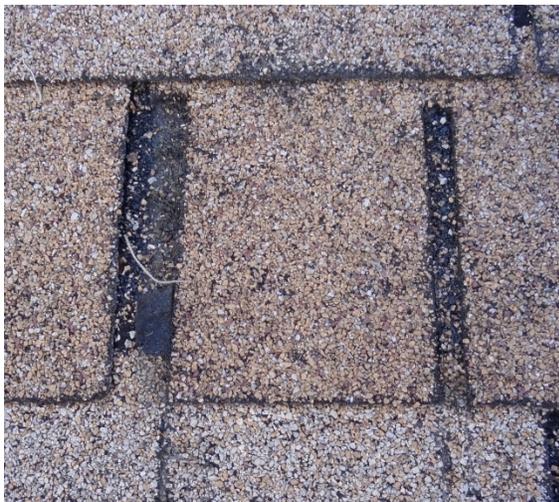
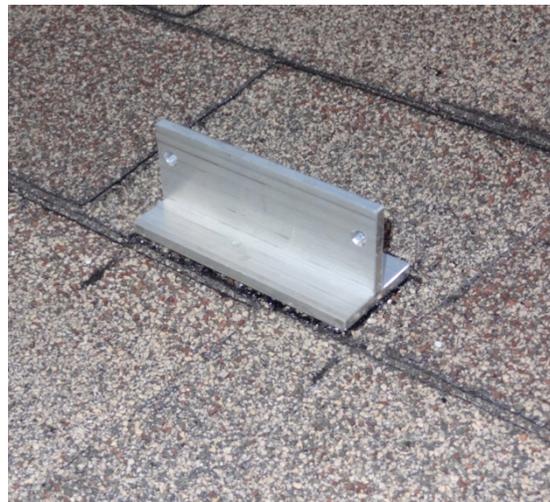
**Fig. 29. Test specimens prepared for in-situ ASTM D6381 mechanical uplift testing (a) Procedure A specimen and (b) Procedure B specimen.**

starting from the leading edge of the shingle's strip (Figure 29a). Care was taken not to disturb the sealed specimen. Additional vertical cuts were made in the adjacent shingles to prevent interference during uplift testing.

- b. Procedure B specimens were made using a hook blade knife to cut two 38 mm (1.5 in) vertical lines (upslope) into the upper shingle strip starting from the leading edge of the shingle's strip. The two vertical lines were 95 mm (3.75 in) apart. The top portion of the shingle specimen was then isolated from the surrounding shingle by 95 mm (3.75 in) horizontal cut along the top of the vertical cut lines. Once the 38 mm (1.5 in) by 95 mm (1.5 in) sealed specimen was isolated, an ASTM D6381 specified aluminum tee was epoxied to the specimen and allowed to cure overnight prior to uplift testing (Figure 29b).

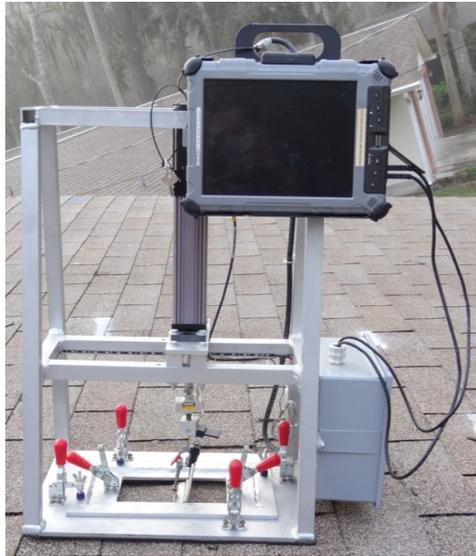
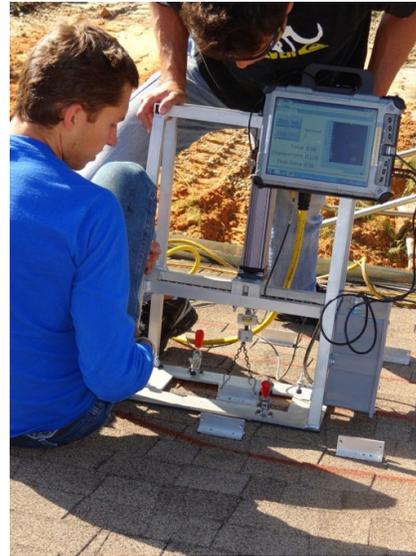
Fig. 30. The Portable Test Apparatus performing in-situ ASTM D6381 mechanical uplift tests: (a) Procedure A and (b) Procedure B.

2. ASTM D6381 Procedure A tests were conducted by first placing the PMUA over the specimen such that only the specimen was exposed through the bottom plate of the apparatus. The ASTM D6381 Procedure A specified test clamp, attached to the actuator's arm, was then secured to the leading edge of the specimen for mechanical uplift testing (Figures 30a and 31). Using the test program, the actuator's arm was raised until the slack in the chain connecting the clamp to the actuator was removed. The load cell reading was zeroed in the test program, followed by the initiation of the mechanical uplift test. Once a test was complete, the investigator visually inspected and recorded the failure mode of the test specimen.

- Similar to Procedure A tests, ASTM D6381 Procedure B tests were conducted by first placing the PMUA over the specimen such that only the specimen was exposed through the bottom plate of the apparatus. The aluminum tee was then connected to the actuator via two chains hooked into either side of the tee. Using the test program, the actuator's arm was raised until the slack in the chains was removed (Figure 30b). The load cell reading was zeroed in the test program, followed by the initiation of the mechanical uplift test. Once a test was complete, the operator visually inspected and recorded the failure mode of the test specimen.

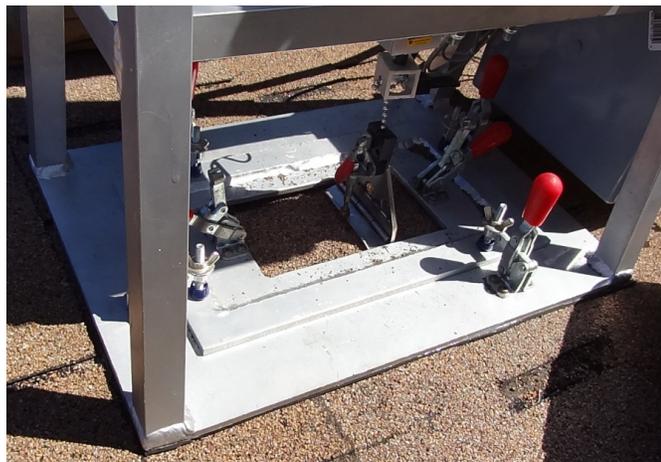
Fig. 31. The Portable Test Apparatus performing in-situ ASTM D6381 Procedure A mechanical uplift tests.

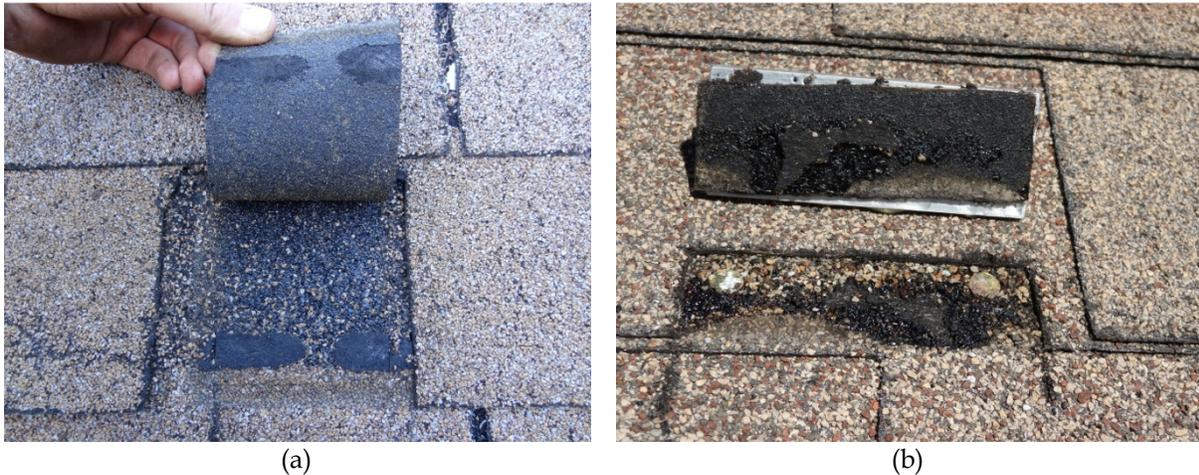
**Fig. 32. Example of failure modes for mechanically uplifted shingles: (a) cohesive failure in the adherend (ORM-01) and (b) combined cohesive failures in the sealant and adherend (ORG-01).**

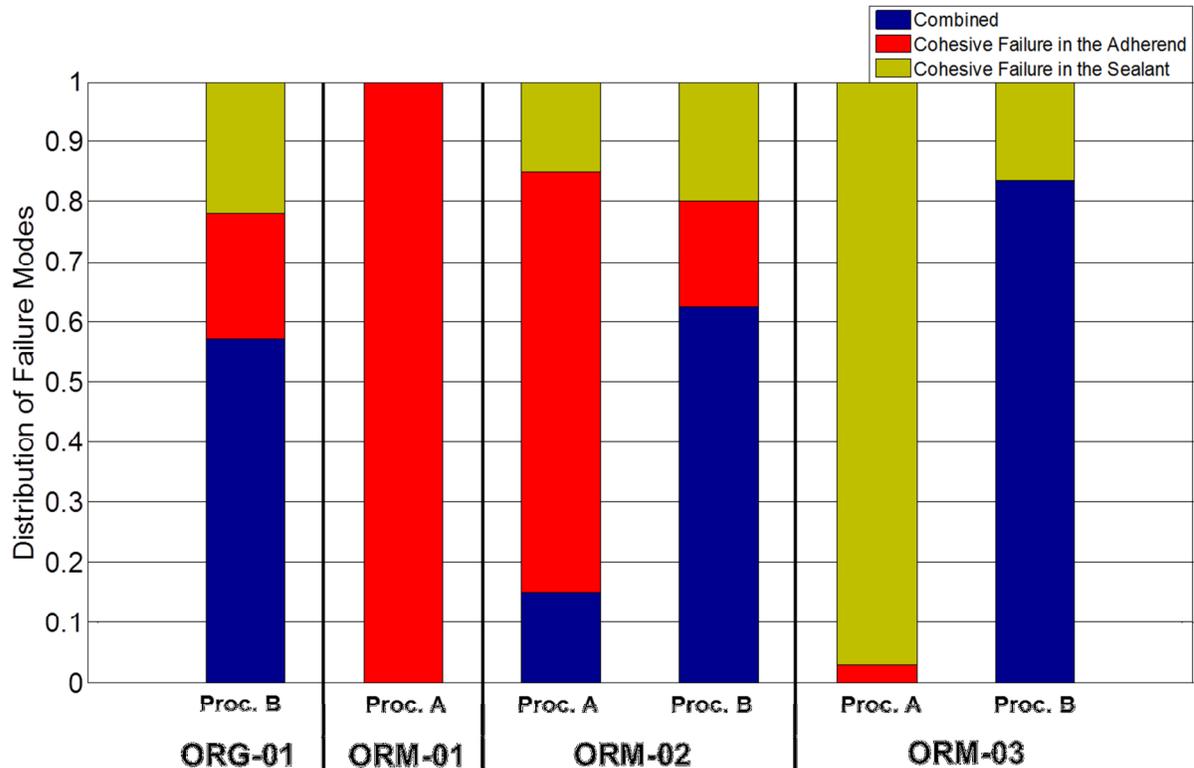
Fig. 33. Distribution of failure modes for in-situ ASTM D6381 mechanical uplift tests.

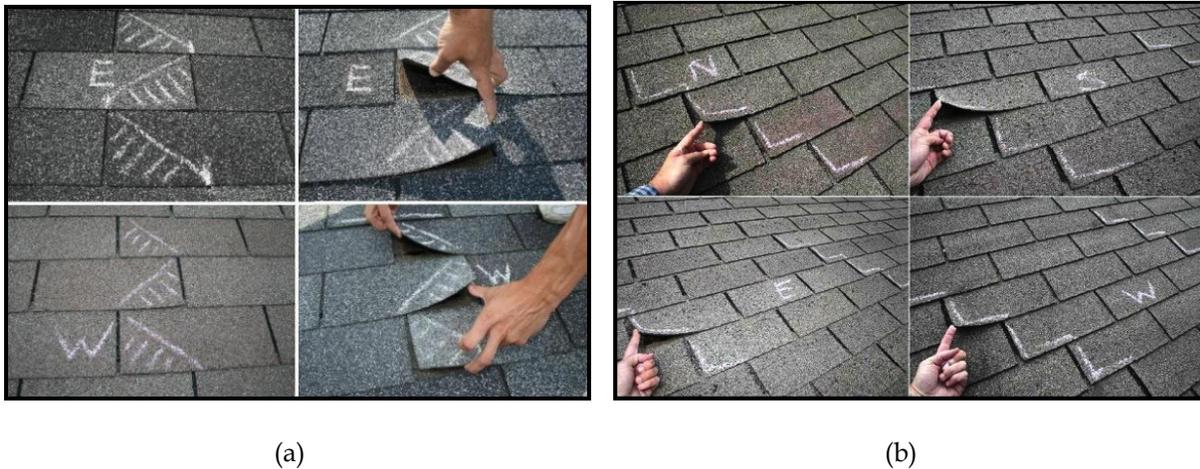
**Fig. 34. Patterns of partially unsealed asphalt shingles reported in Marshall et al. (2010). (© American Meteorological Society. Used with permission).**

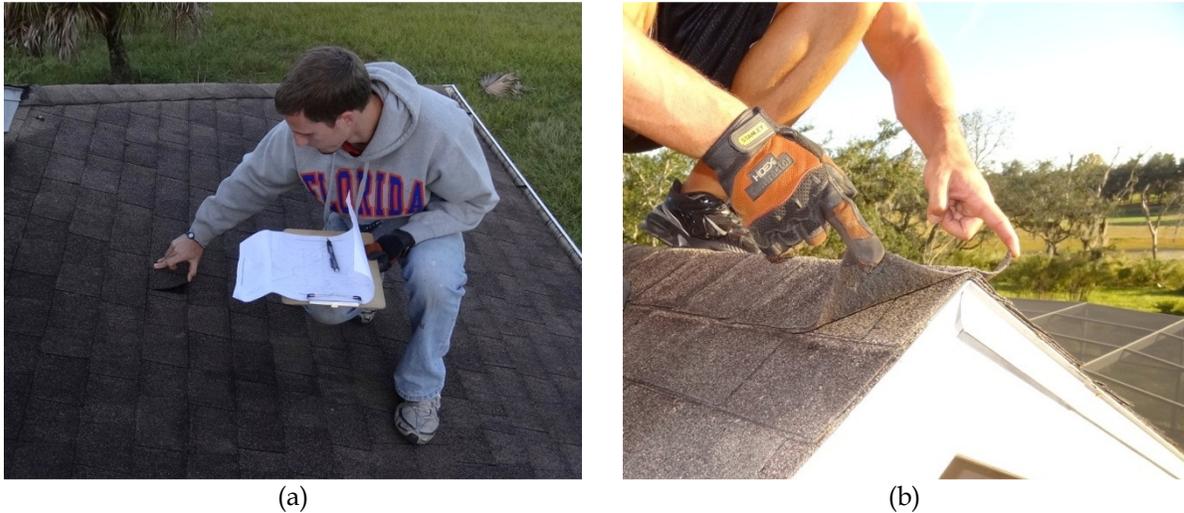
**Fig. 36. UF investigators conducting an unsealed shingle survey: (a) unsealed field shingle and (b) unsealed ridge shingle.**

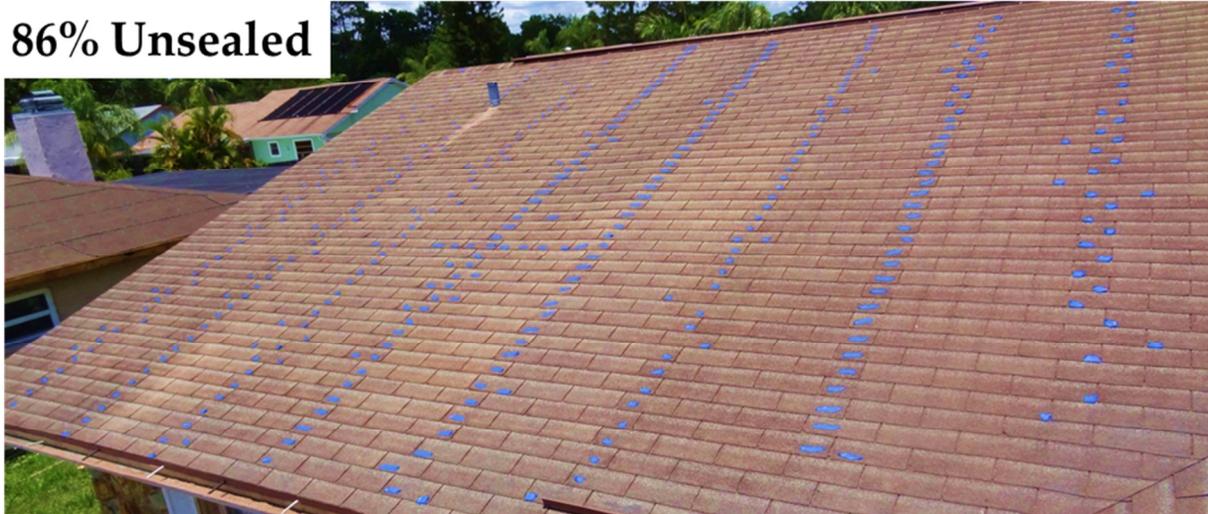
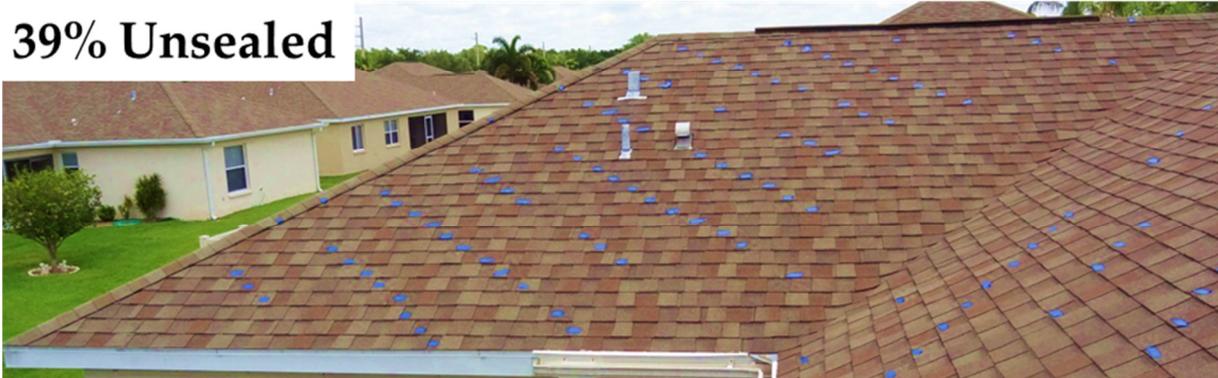
**86% Unsealed**

**39% Unsealed**

**Fig. 37. Example of unsealing patterns for (a) raked three-tab system with 86% unsealing and (b) diagonally installed laminate system with 39% unsealing.**

Figures 37 and 38 depict typical patterns and amount of unsealing that was observed with blue tape marking the location of unsealed shingle strips. The patterns are not random in nature and were observed on both three-tab and laminate systems with the pattern conforming to the shingle's installation method (i.e., racked or diagonally installed).

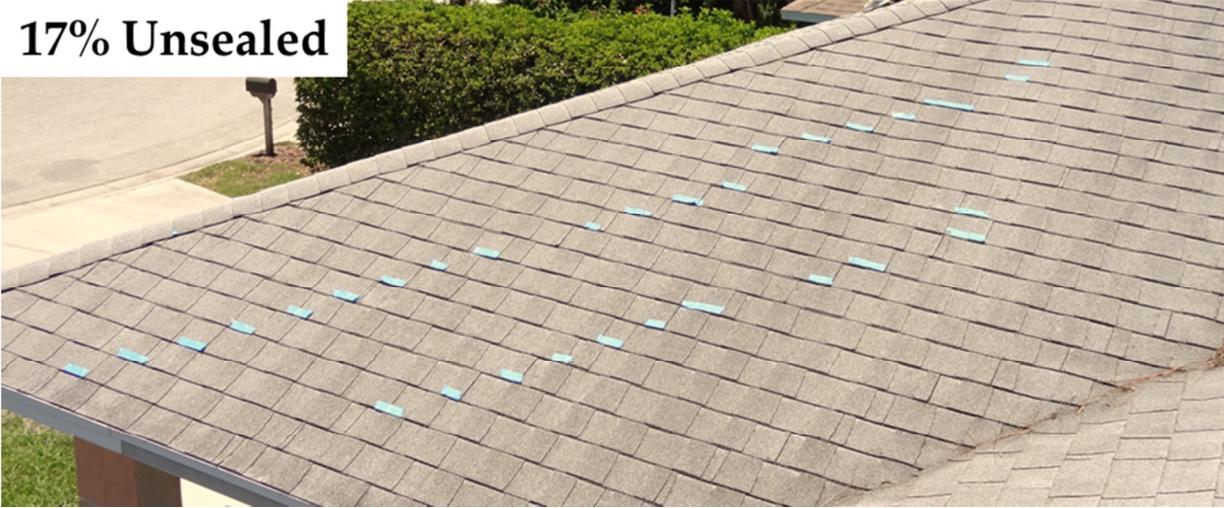
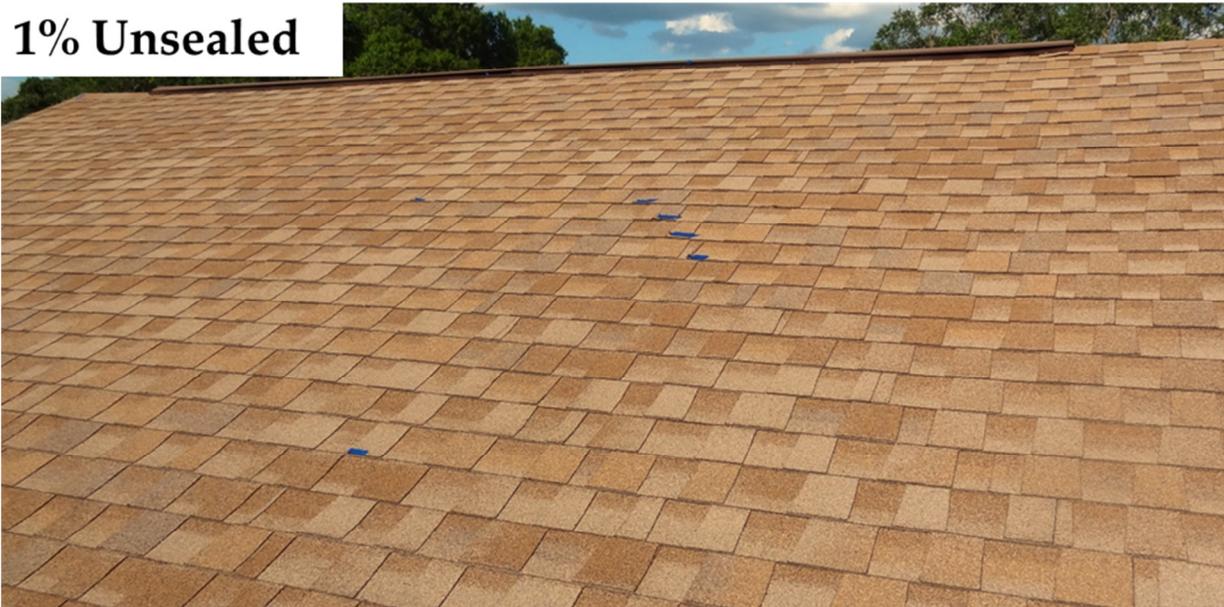
**17% Unsealed**

**1% Unsealed**

**Fig. 38. Example of unsealing patterns for (a) diagonally installed laminate system with 17% unsealing and (b) diagonally installed laminate system with 1% unsealing.**

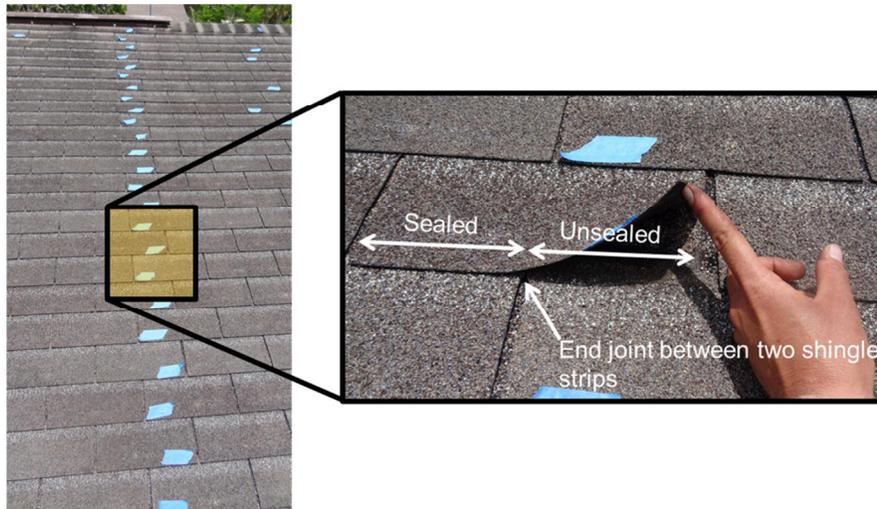
**Fig. 39. Typical unsealing pattern of three-tab shingles that are vertically installed.**

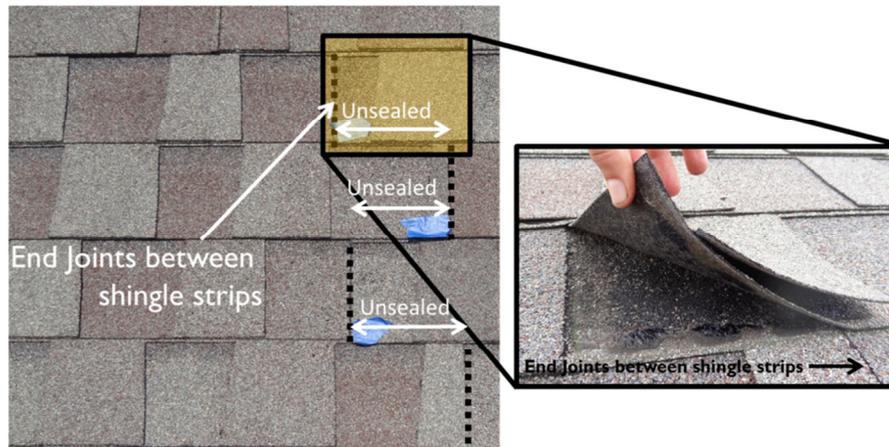
**Fig. 40. Typical unsealing pattern of laminate shingles showing a transition between diagonal directions.**
