## **Phase II Report: Investigation of the Wind Resistance of Asphalt Shingle Roof Coverings**

**SERRI Project:  
Investigation of the Wind Resistance of  
Asphalt Shingle Roof Coverings**

Date Published:  
June 16, 2013

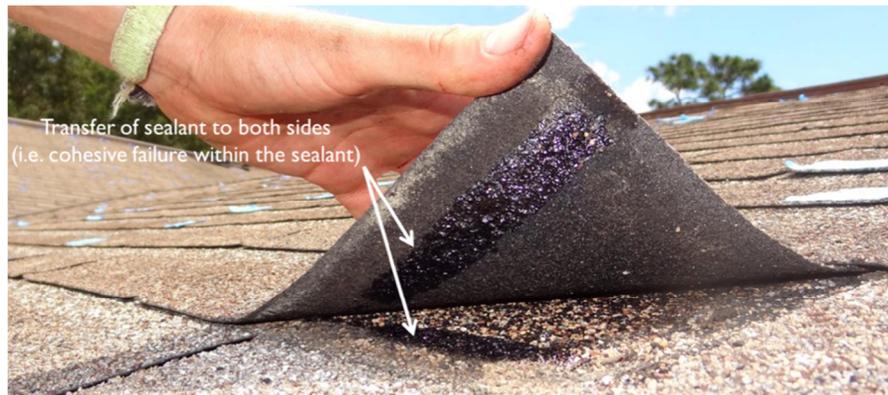
**Fig. 41. All unsealed shingles near the end joint failed cohesively within the sealant strip, suggesting that shingles were previously adhered.**

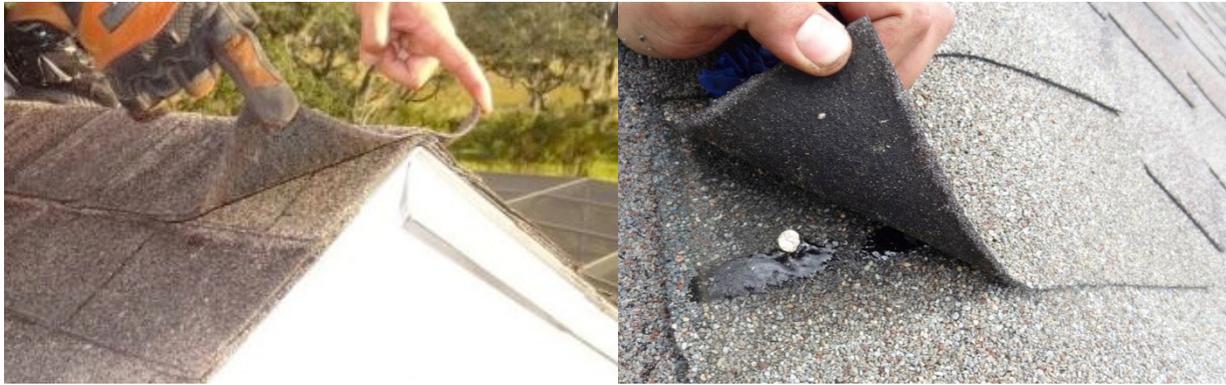
**Fig. 44. Typical partially unsealed ridge and hip shingle conditions: (a) fully unsealed ridge shingle due to lack of sealant strip below cap and (b) poor adhesion on edges of shingle.**

1. Completely unsealed hip and ridge shingles due to a lack of sealant strips below the leading edge (Figure 44a). This error occurred when the installer used shingles that did not contain sealant strips. This unsealing condition was observed on three of the 27 homes investigated.
2. Adhesive failure between the shingle's sealant strip and the shingle above. Partial unseal was observed on one or both sides of the roof slope, starting from the edge of the shingle and extending towards the hip/ridge line (Figure 44b). The adhesion along the ridge/hip line was significantly better than the edges of the shingle.

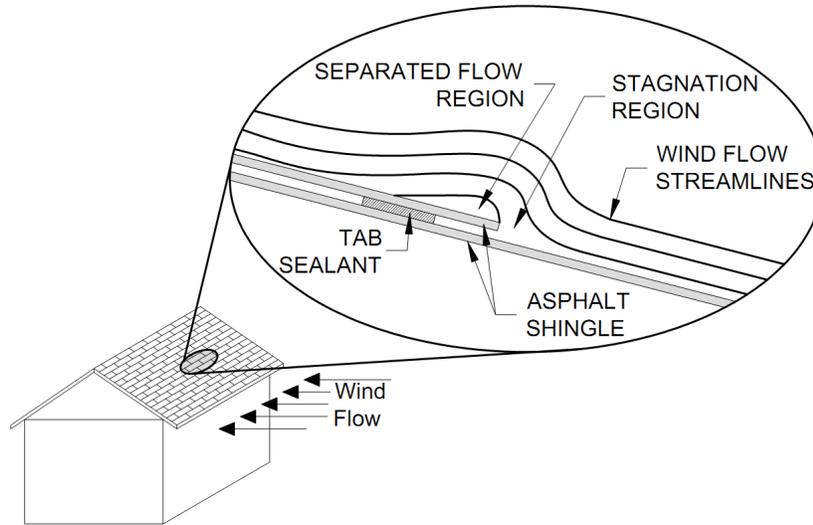
**Fig. 46. Wind uplift forces on asphalt shingles are generated from the separation of wind over the shingle's leading edge.**

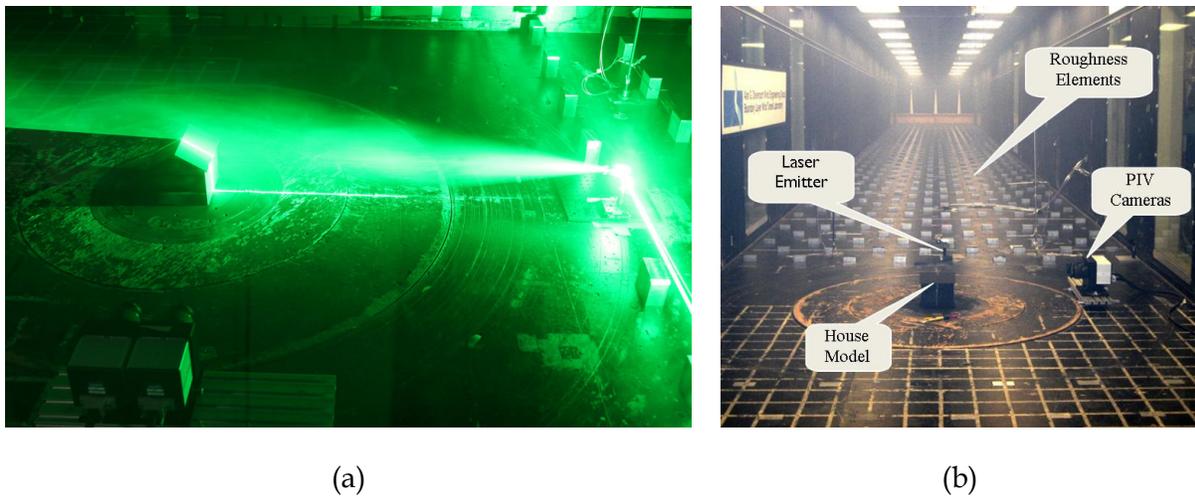
Fig. 48. (a) Particle Image Velocimetry test setup and (b) downwind view of Particle Image Velocimetry test setup components.

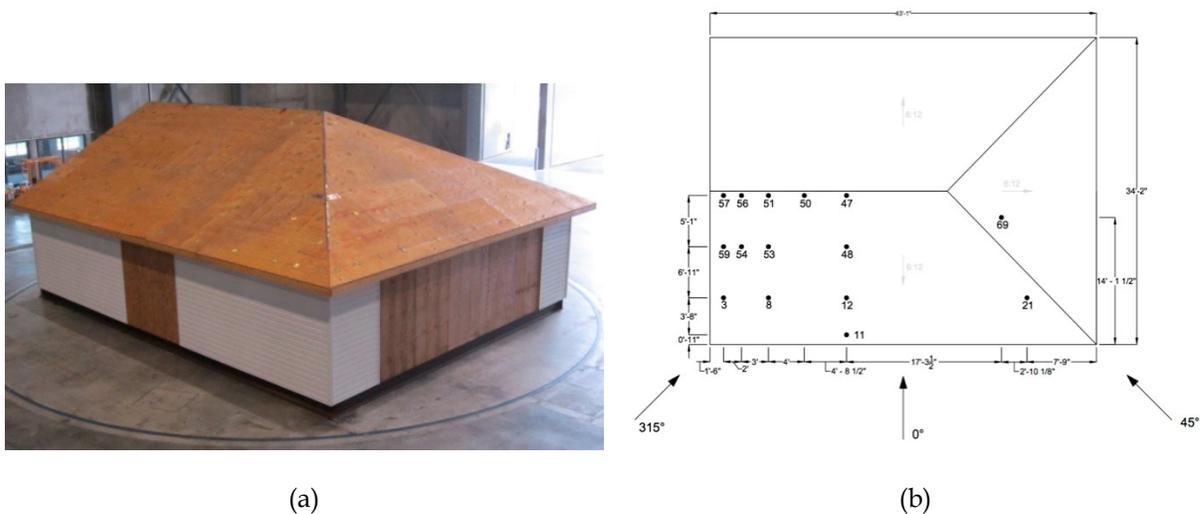
Fig. 49. (a) Aerial view of the test building and (b) roof plan with near roof surface wind measurement locations and experiments wind directions shown.

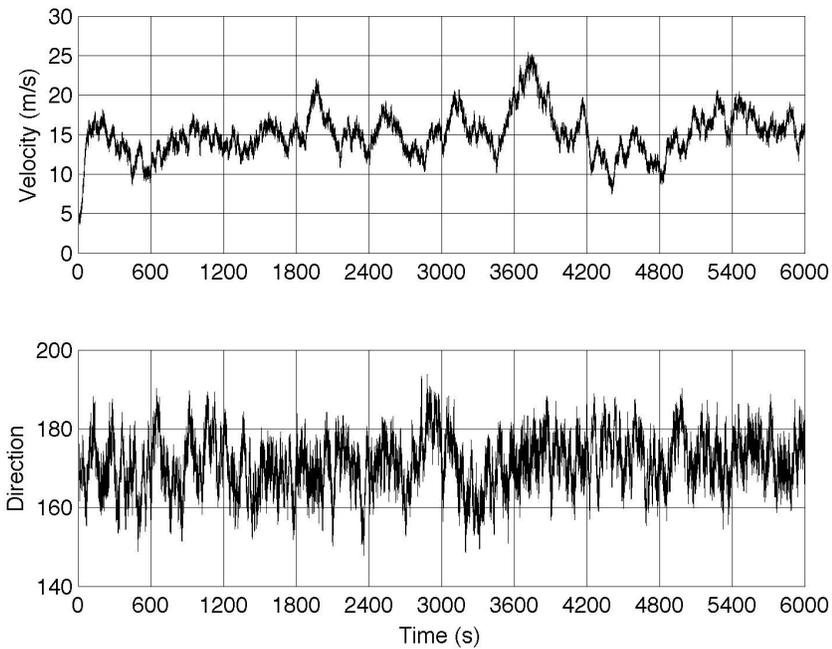
**Fig. 50. Wind velocity and direction measured at the eave height of the subject home.**

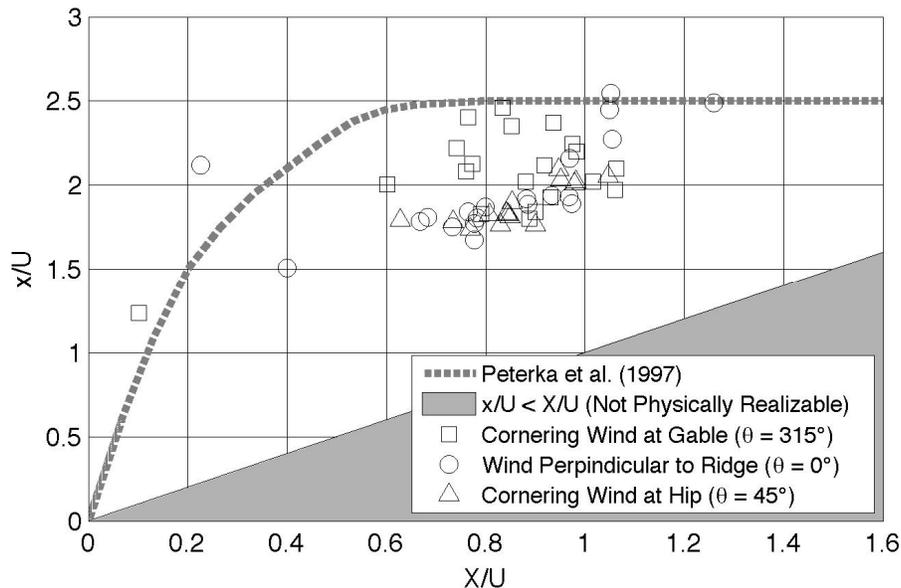
Fig. 52. Comparison of peak speed-up ( $x/U$ ) versus mean speed-up ( $X/U$ ) over the full-scale building roof tested in the IBHS Research Center and wind tunnel modeling results performed by Peterka et al. (1997).

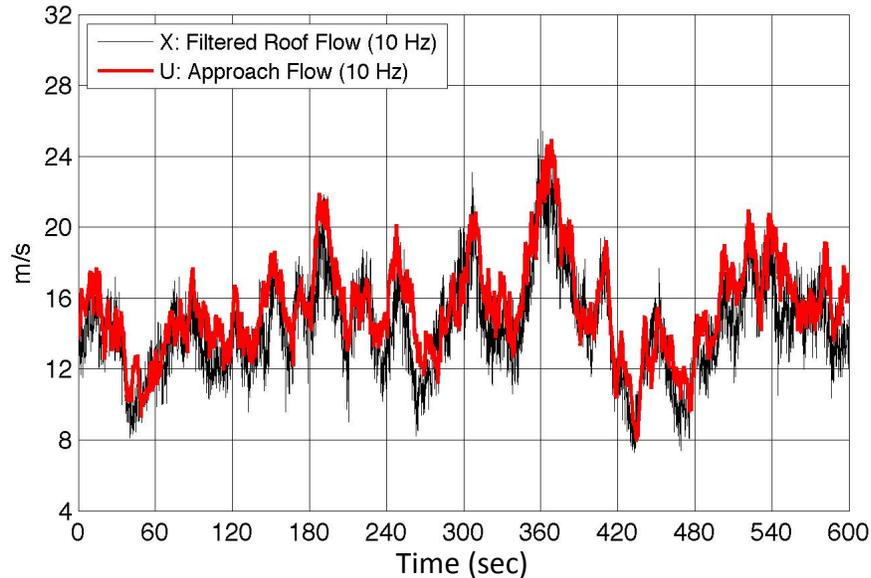
**Fig. 54. Low-pass filtered (10 Hz) velocity record of Location 57 compared to approach flow measured at eave height.**

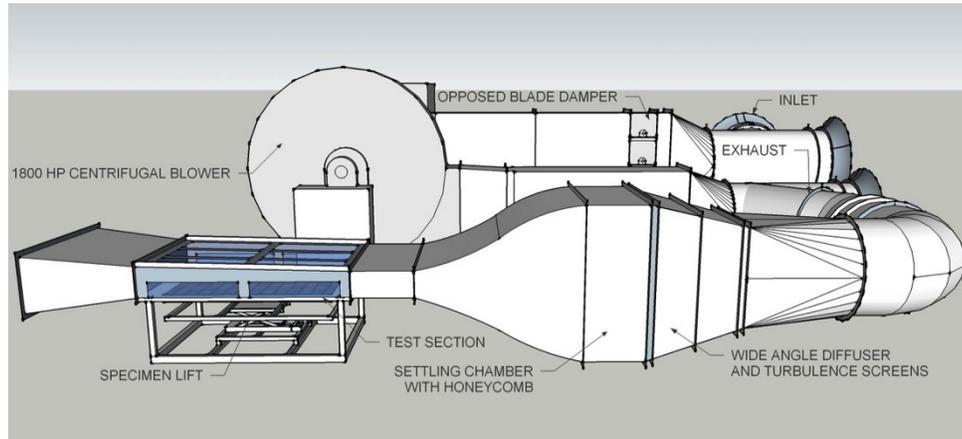
Fig. 55. Rendering of the Dynamic Flow Simulator componentry.

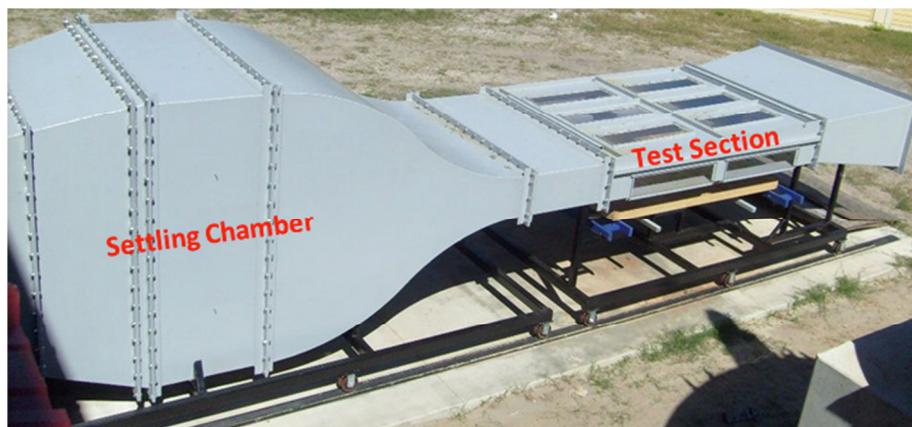
Fig. 56. Dynamic Flow Simulator, as constructed.

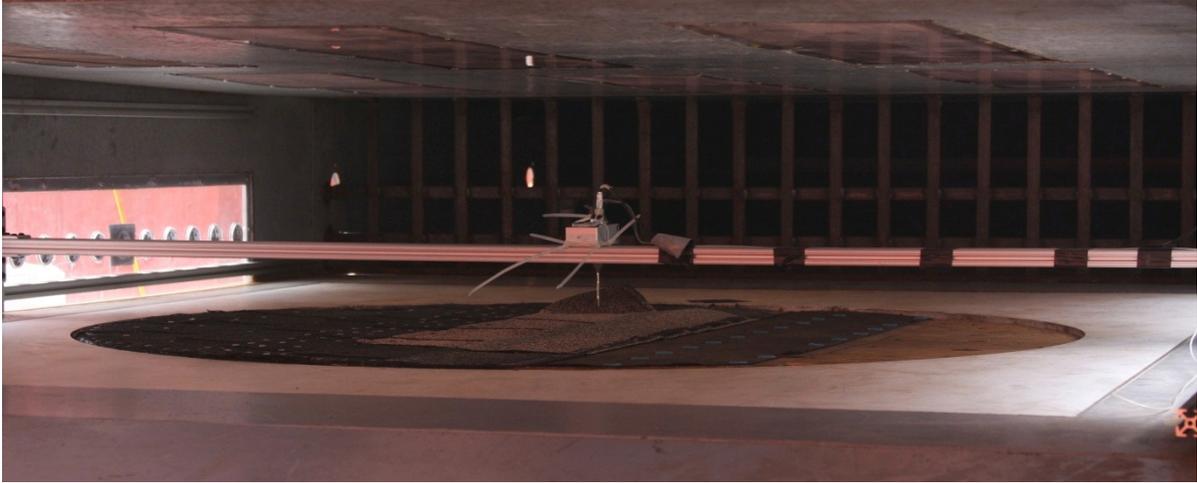
**Fig. 57. Test specimen in the Dynamic Flow Simulator test section with upstream turbulence grid shown.**

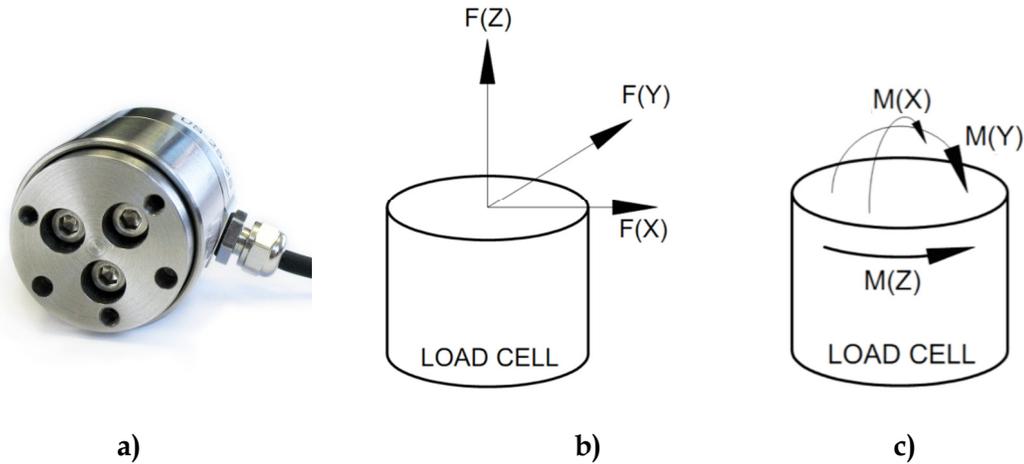
Fig. 58. a) Six-axis load cell measured: b) three forces and c) three moments.

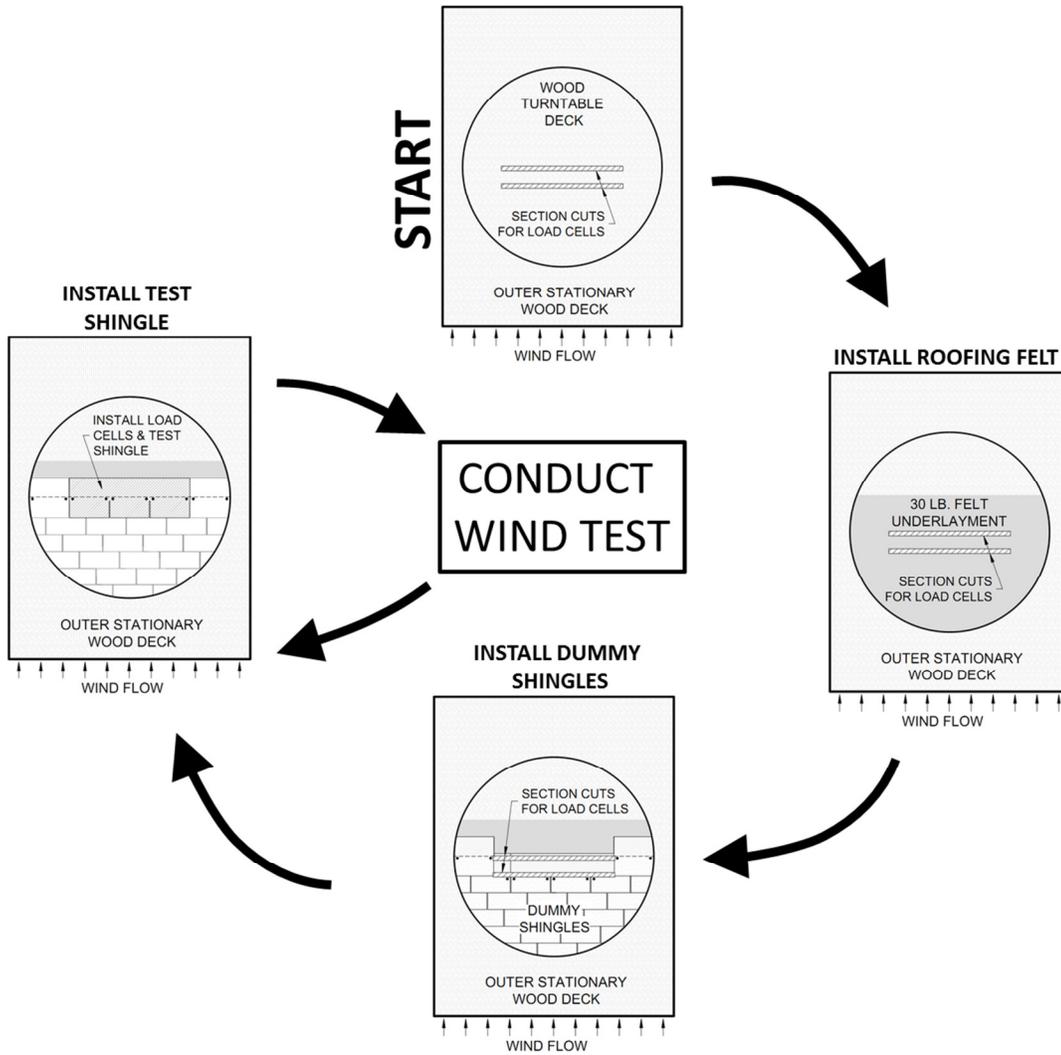
Fig. 64. Installation and wind test procedure. (Note: Three-tab shingle system shown. Laminate shingle system follows same procedure)

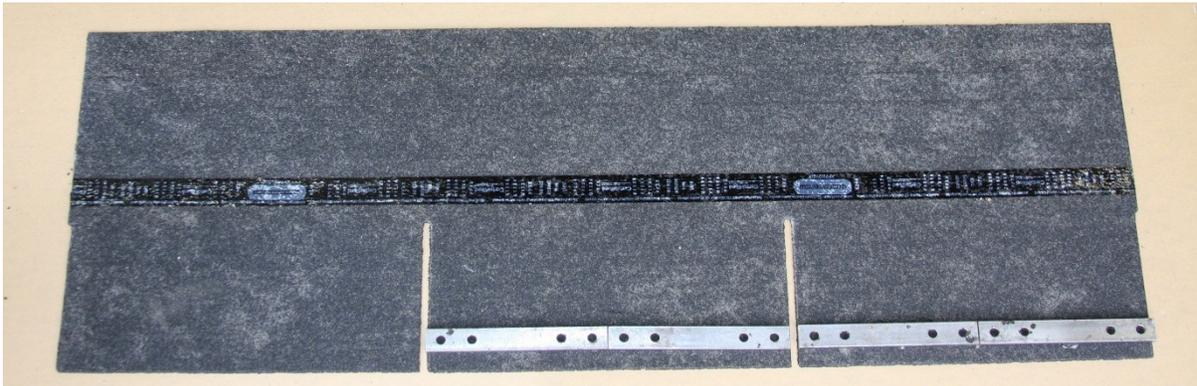
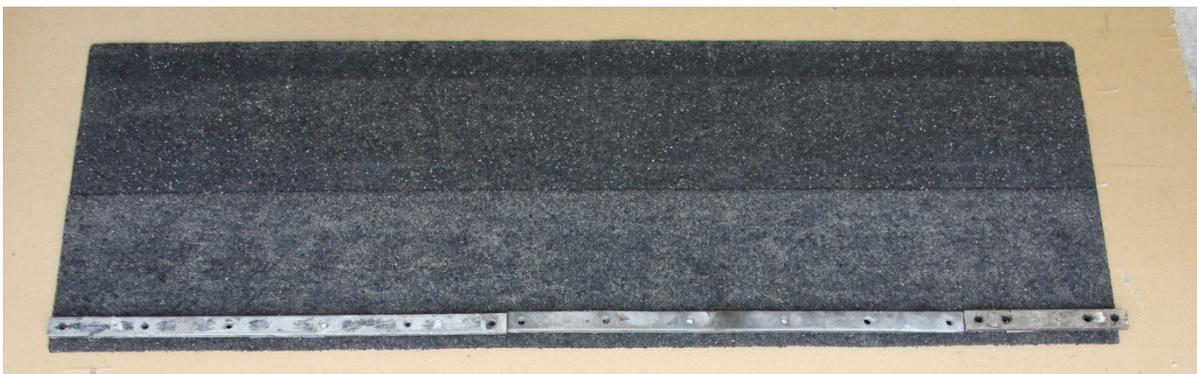
**Fig. 68.** Epoxied steel flat bars on (a) underside of three-tab test shingle and (b) underside of laminate test shingle.

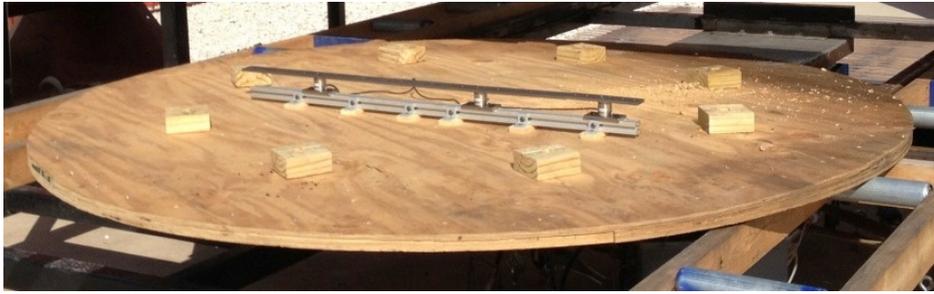
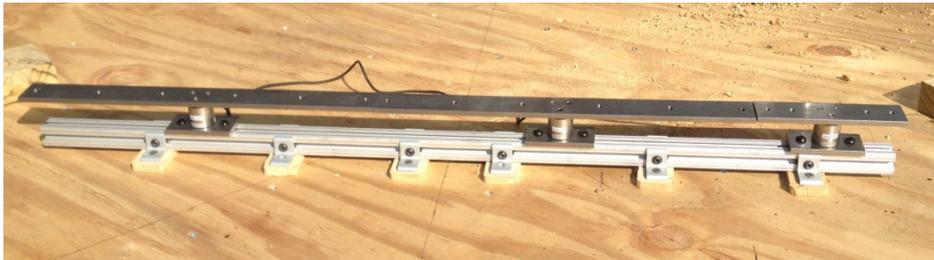
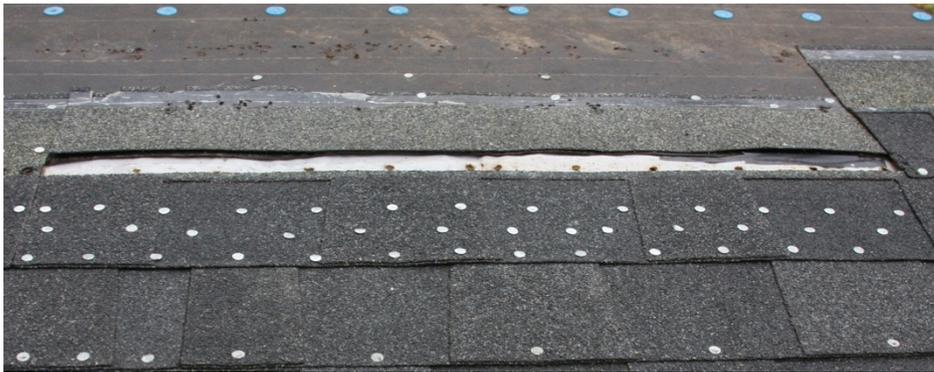
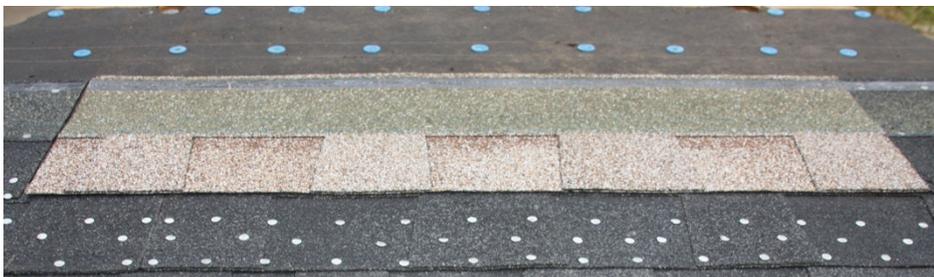
**Fig. 69. Laminate test specimen deck and test shingle installation procedure: (a) lower deck with load cells, (b) closer view of load cell arrangement, (c) top deck with cutout for load cells shown and (d) test shingle placed over the cutout to produce a complete test specimen.**

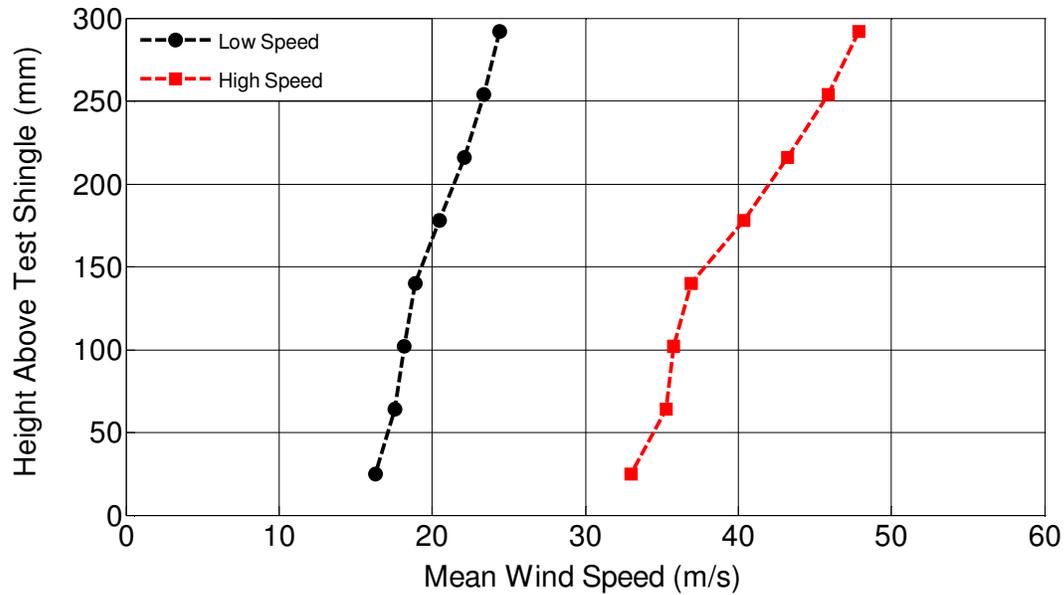
**Fig. 73. Vertical profile of mean longitudinal wind speeds. Note: wind speeds were adjusted during testing to match target wind speeds measured at 25 mm (1 in) above the shingle surface.**

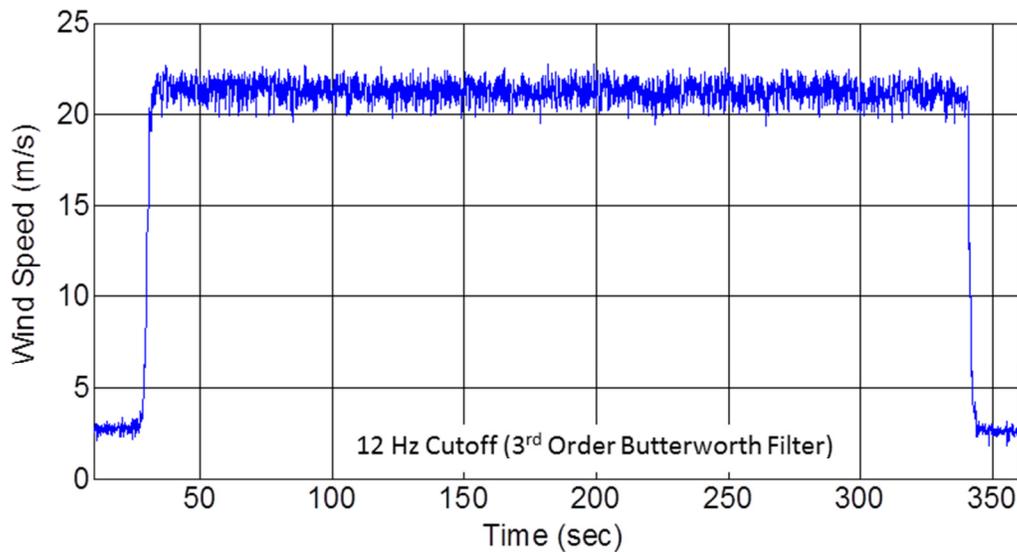
Fig. 76. Example wind speed time-history for Low Wind Level test.

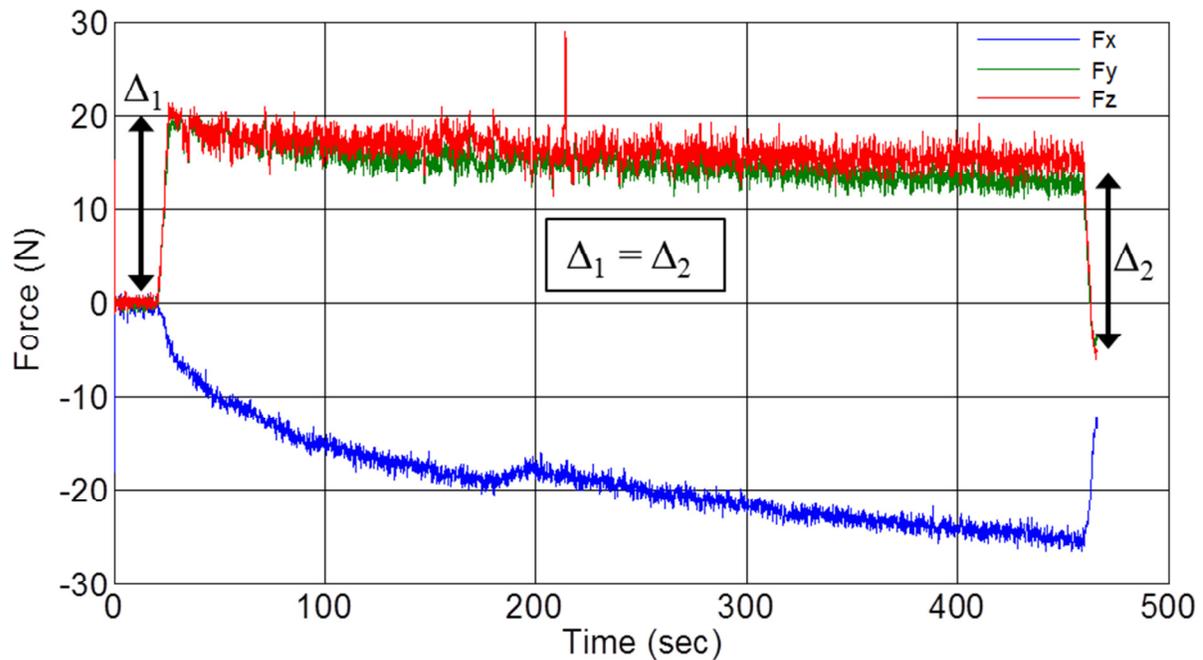
Fig. 79. Example of temperature effects on load cell output – force time-history record for Measurement Location C2 on fully sealed three-tab Test Shingle Specimen 3 - 45° wind azimuth - High Wind Level.

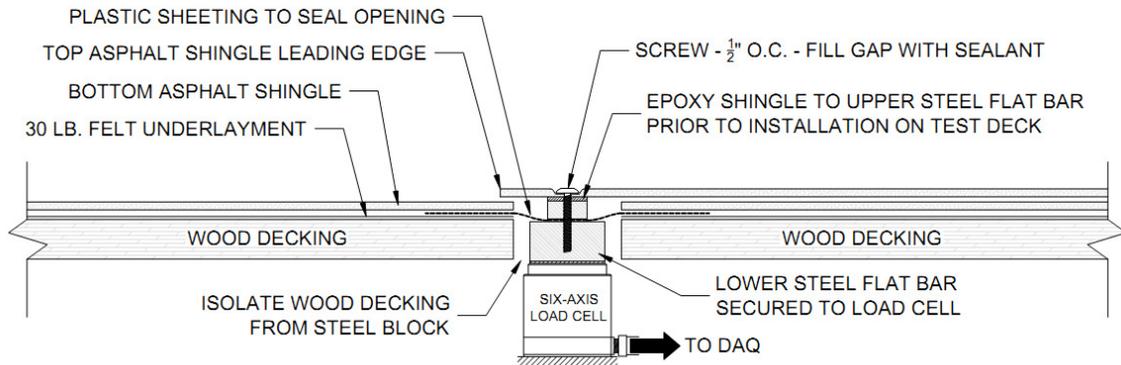
**Fig. 81. Connection detail for specimen's sealant strip to six-axis load cell.**

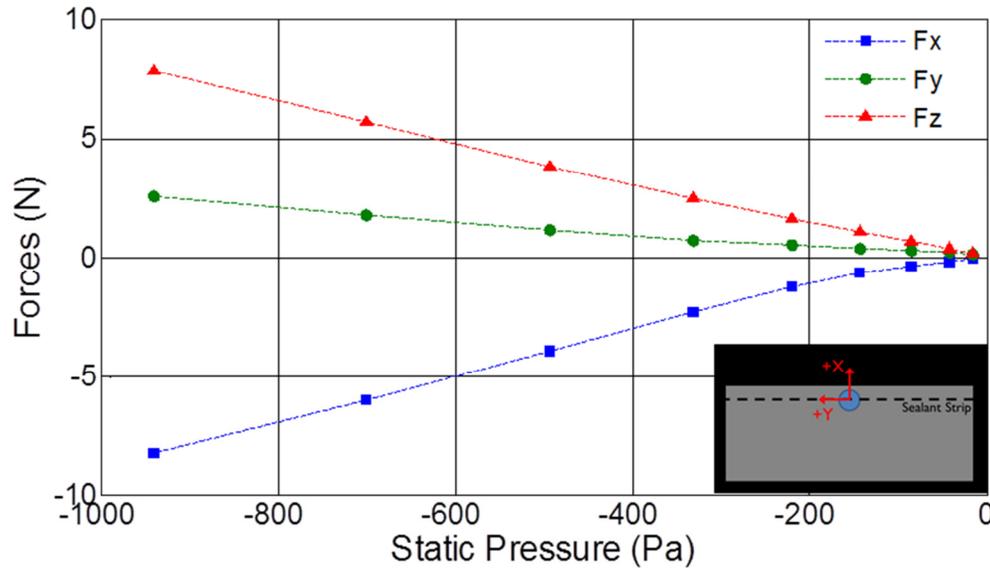
Fig. 84. Force measurements of six-axis load cell attached to laminate shingle specimen in response to static pressure.

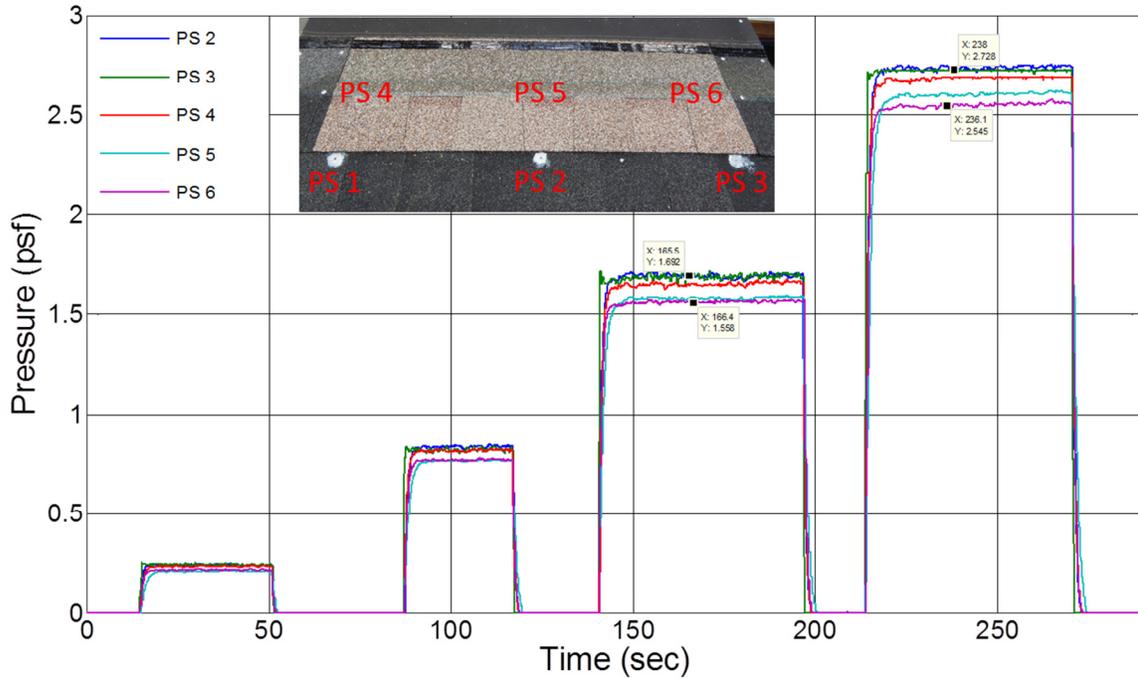
Fig. 86. Measured static pressures on top and bottom surface of laminate shingle. (1 psf = 47.8 Pa)

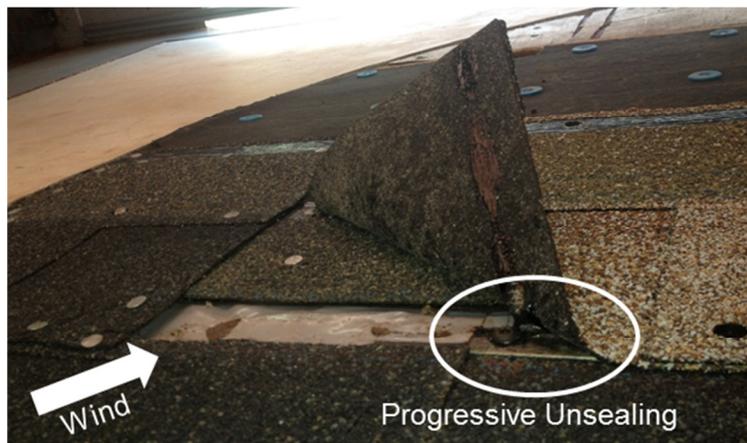
Fig. 88. Progressive unsealing observed on partially unsealed laminate shingle specimen.

The combined uplift and total force coefficient results of Tables 32 and 33, respectively, suggest that a 152 mm (6 in) unsealing does not cause an increase in measured total load along the sealant strip. However, progressive unsealing was observed in one laminate specimen at the interface of shingle's lower surface and the left side of the steel flat bar connecting the shingle to the load cell, as shown in Figure 88. The specimen began unsealing during tests at the 22.5° wind azimuth and continued unsealing throughout the test sequence. It appears that an unsealing of this type exposes the adjacent sealed portion of the sealant strip to a concentration of peel-type stresses. Further discussion of the implications of this finding is provided in the Significant Findings and Conclusions Section 3.3.4 below.

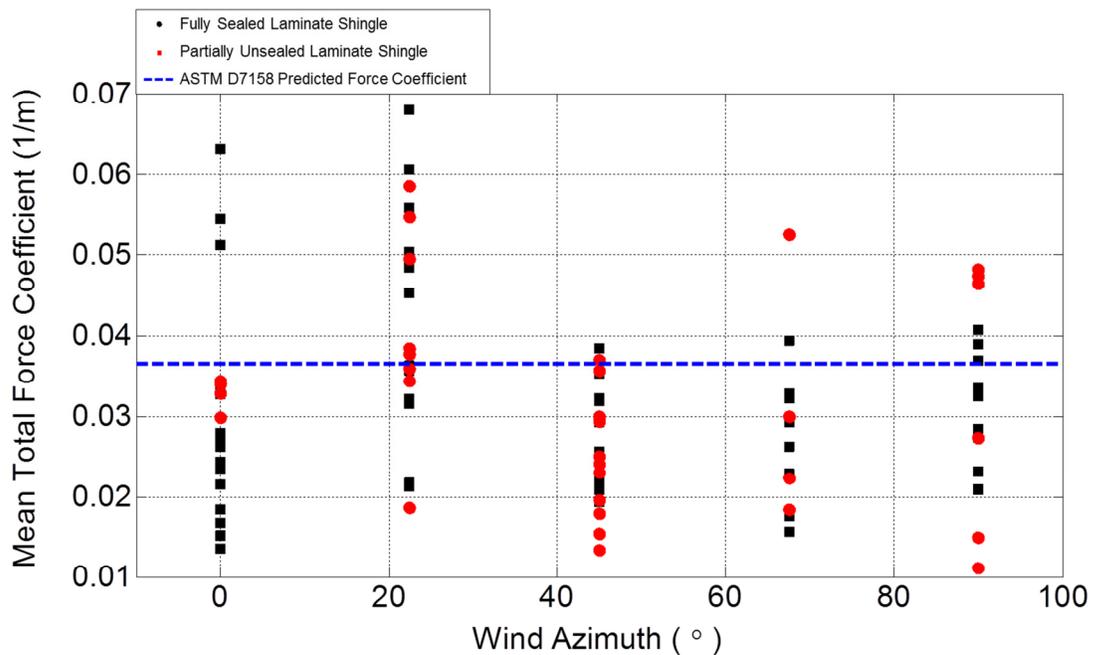
Fig. 89. Mean total force coefficient for laminate shingle specimens versus wind azimuth.

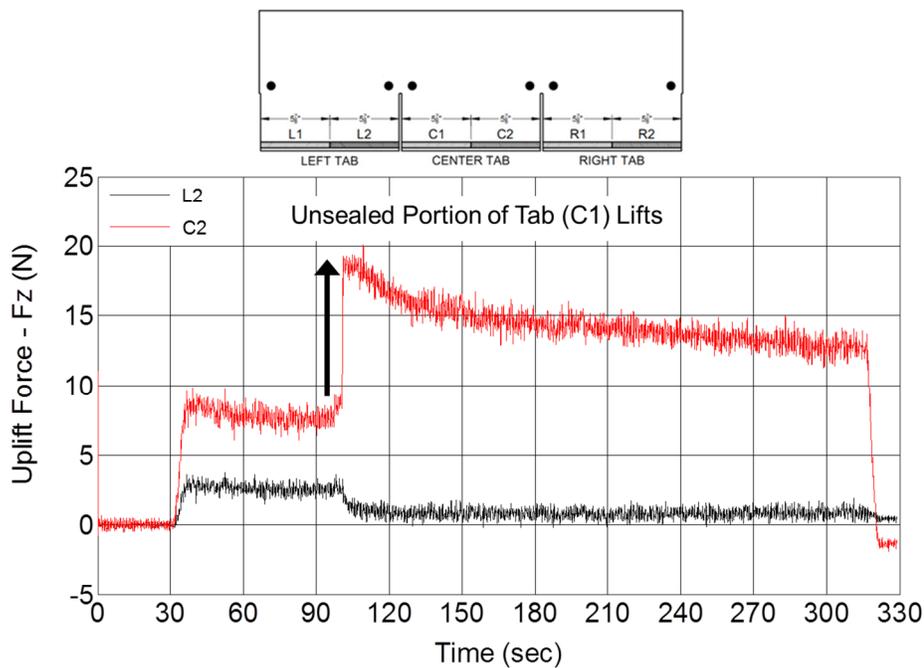
**Fig. 91. Lifting of the unsealed portion of a three-tab specimen increased the uplift force on the sealed portion of the tab.**

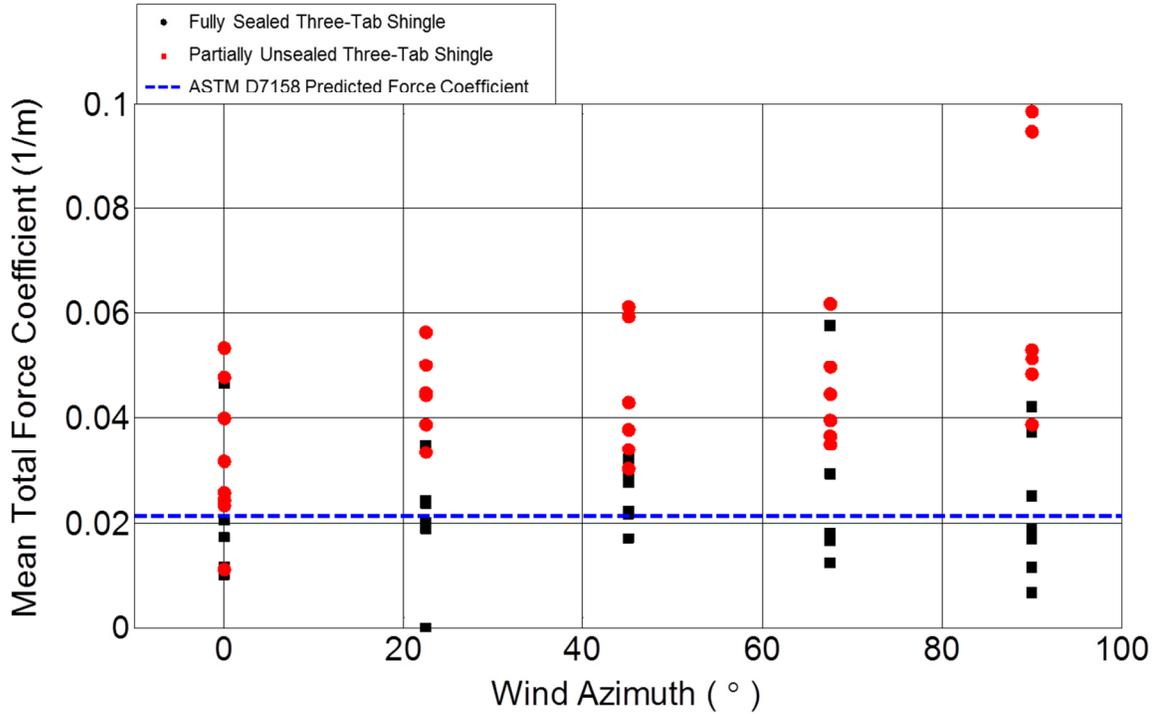
Fig. 92. Mean total force coefficient for three-tab specimens versus wind azimuth.

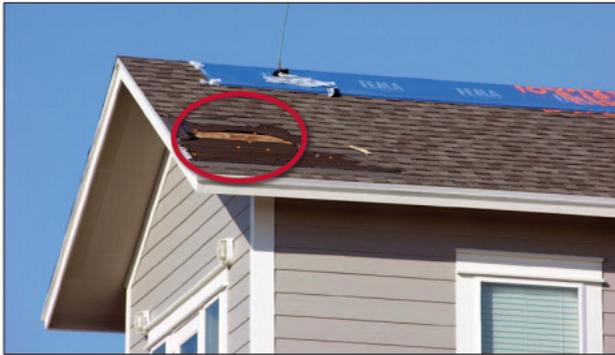
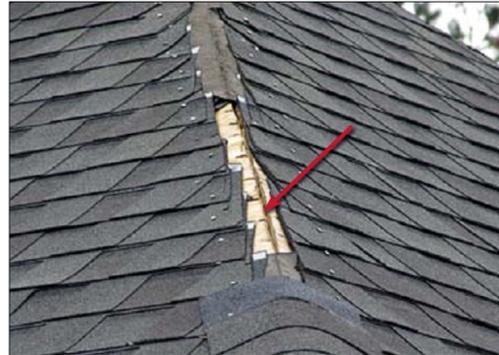
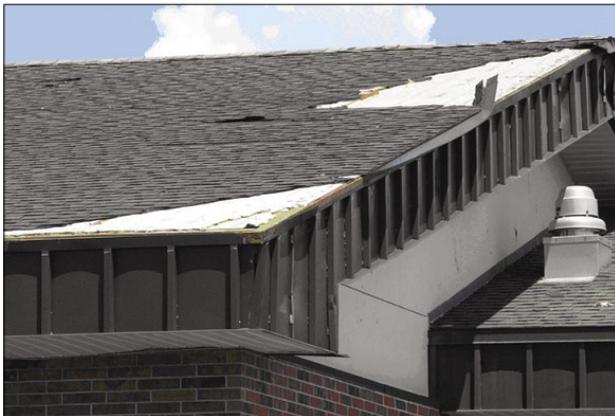
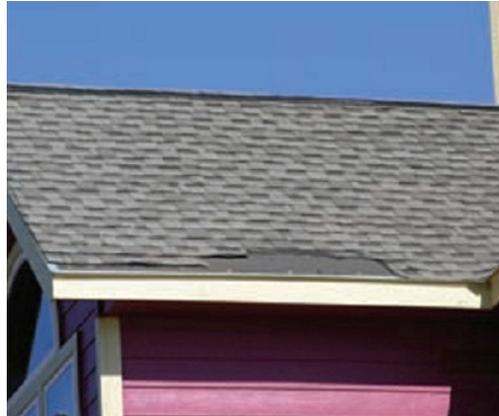
**Fig. 93. Post-storm observations of shingle roof systems: (a) rake edge shingle blow off [Photo from FEMA (2011)], (b) hip shingle blow off [Photo from FEMA (2011)], (c) rake shingle and underlayment blow off [Photo from FEMA (2005a)], and (d) eave shingle blow off [Photo from FEMA (2009)]**

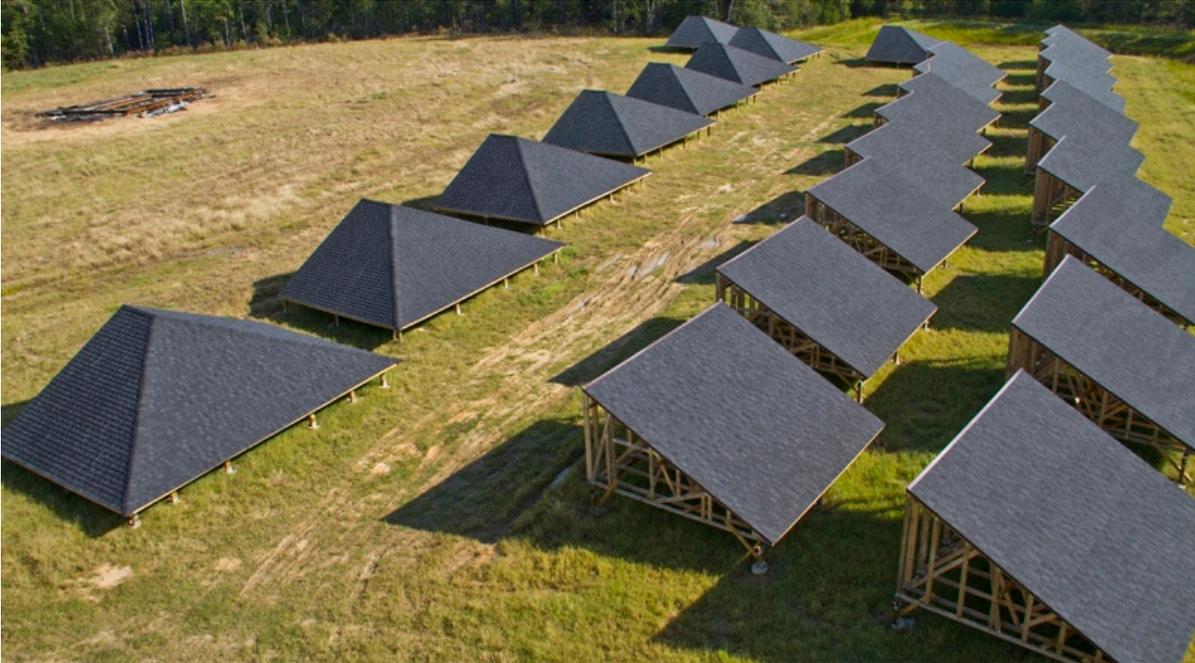
**Fig. 98. Aerial view of the completed asphalt shingle roof sections at the IBHS Research Center. The roofs were located at this field site throughout their 11 month conditioning phase.**

The asphalt shingle roof specimens were constructed at the IBHS Research Center from July 2011 to mid-August 2011. UF constructed the roof specimen's wood support structures, erected the roof trusses, and installed the wood roof sheathing. A professional roofing contractor installed the asphalt shingle roof coverings and roof accessories (e.g., drip edge flashings). The roof slopes on all mono-slope and front faces of the hip roof sections were oriented south to maximize the amount of sun exposure on the shingle systems (Figure 98). The roof specimens were conditioned on this site for an 11 month period prior to wind testing to allow the self-sealing adhesive on the shingle to fully adhere and to subject the roofs to four seasons.

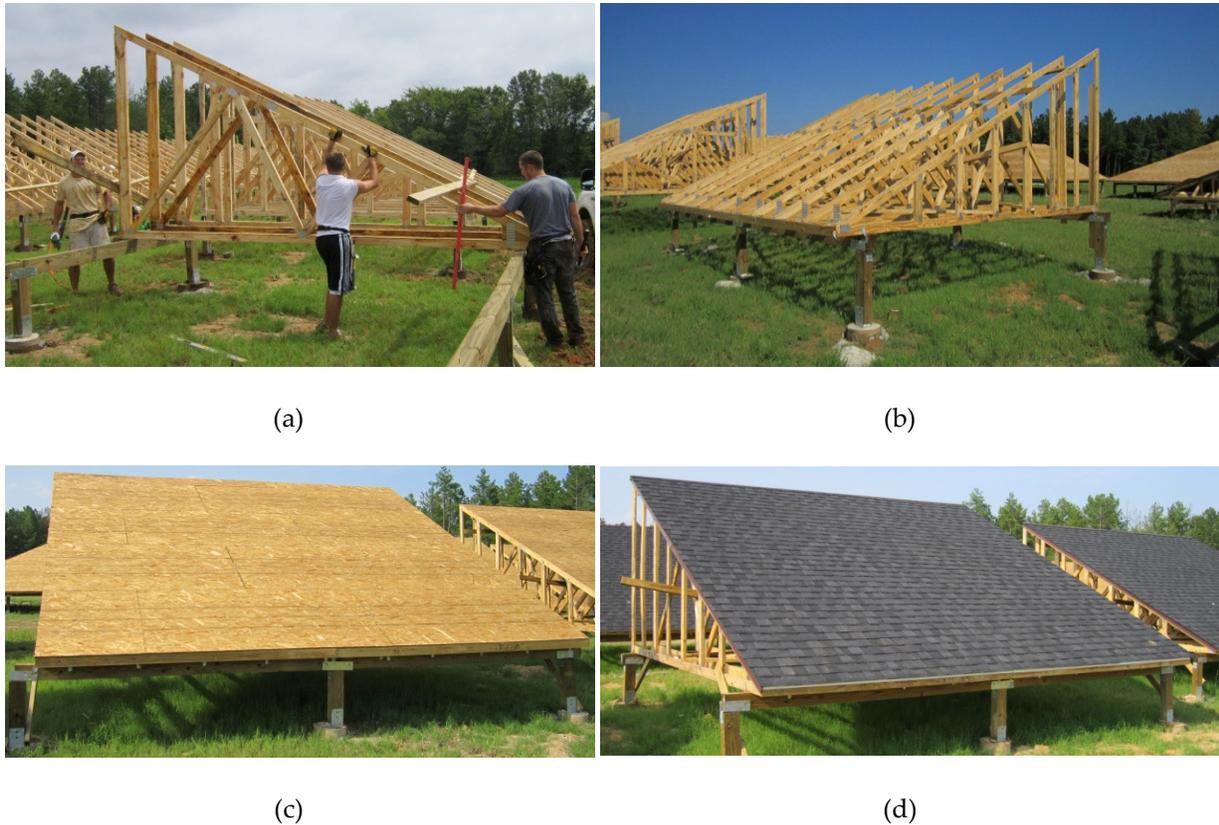
**Fig. 99. (a) - (c) Construction of the mono-slope gable roof sections. (d) Completed mono-slope gable roof section.**

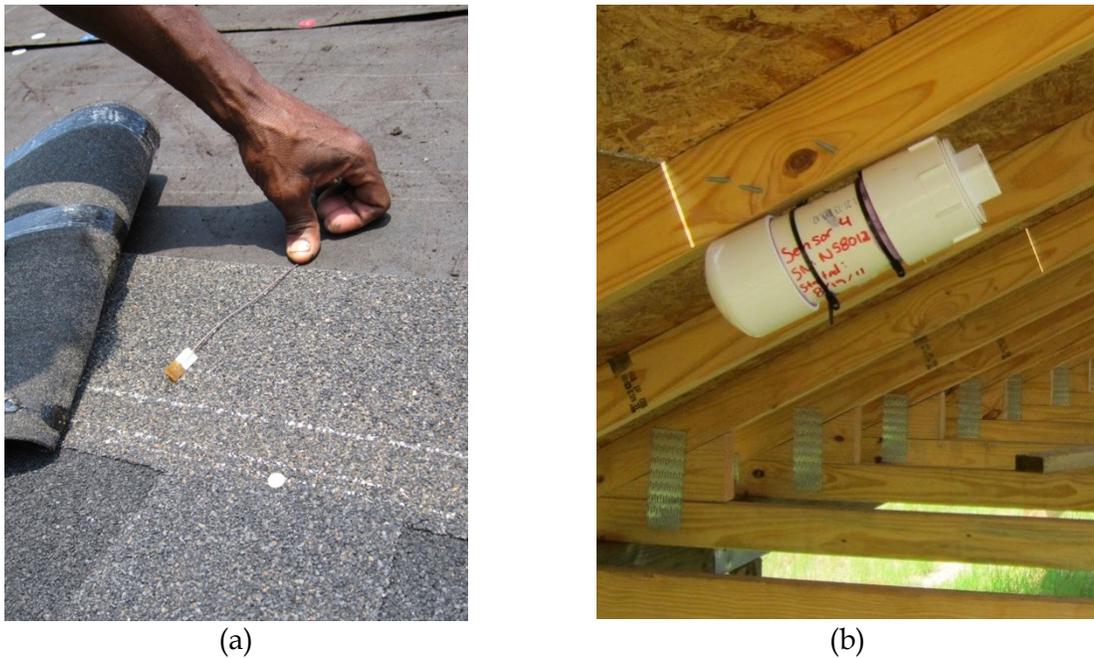
**Fig. 101. (a) Omega copper-constantan thermocouple was sandwiched between two shingles and recorded thermal loads encountered during conditioning period. (b) Thermocouple data loggers were installed in PVC housing and secured to roof trusses for weather protection.**

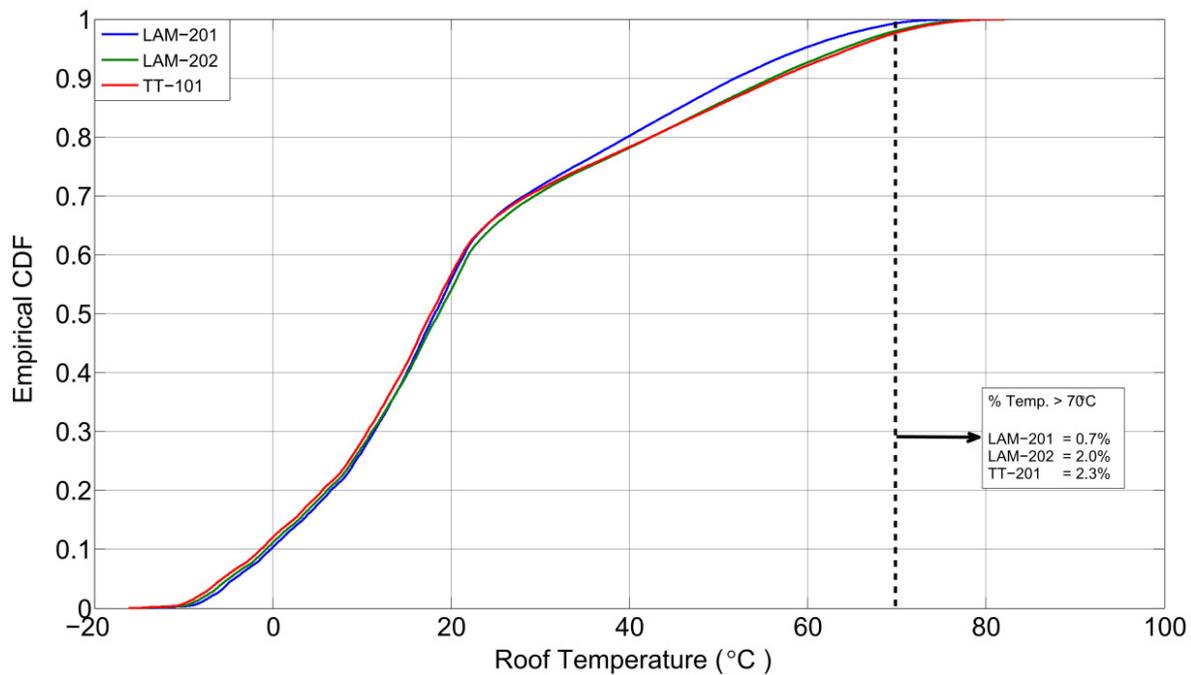
**Fig. 102. Empirical cumulative distribution function (CDF) for measured roof temperatures during the condition phase.**

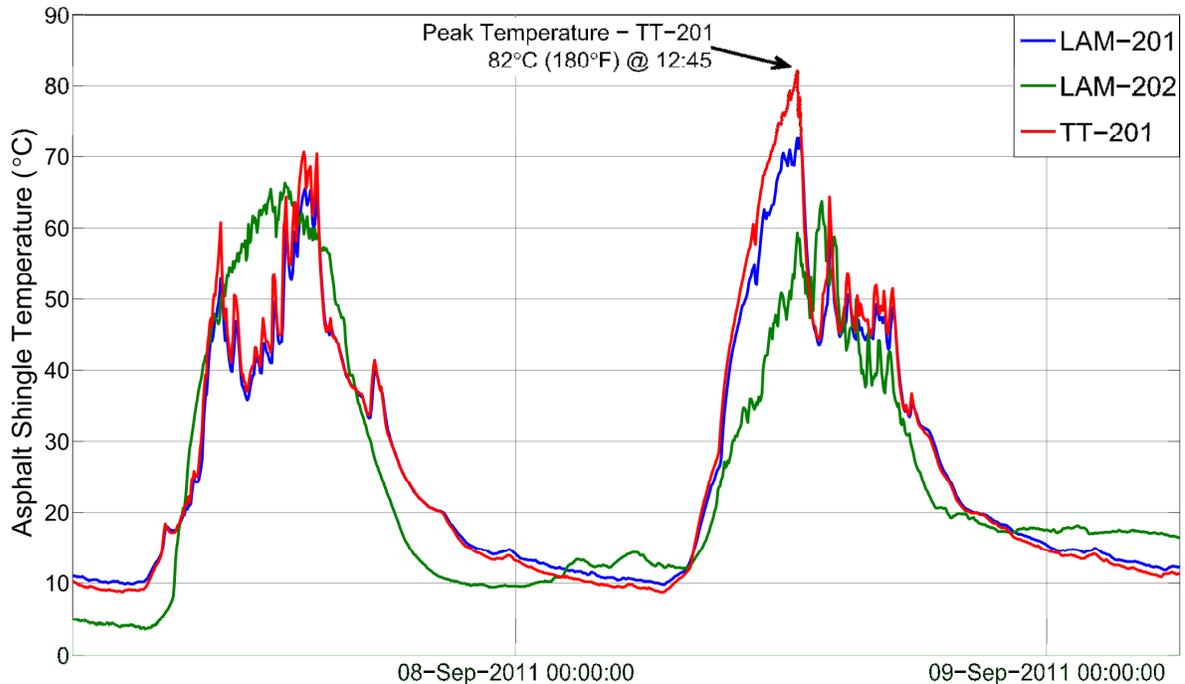
Fig. 103. Example temperature time history generated from thermocouples embedded between shingles during the conditioning phase. The peak observed temperature during the conditioning phase is shown.

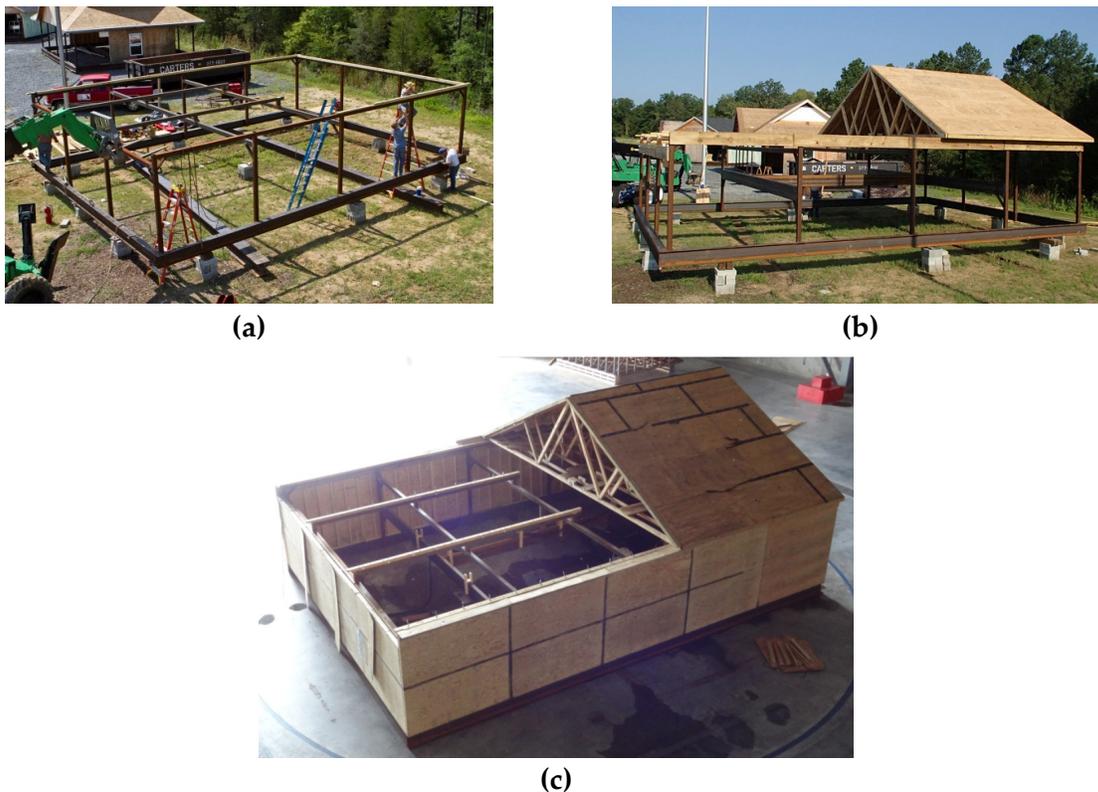
**Fig. 104.** The base structure construction consisted of (a) modifications to the existing steel structural framing, (b) installation of a permanent gable end 6:12 roof and (c) installation of wood-framed exterior walls secured to the steel frame.
