## **Phase II Report: Investigation of the Wind Resistance of Asphalt Shingle Roof Coverings**

**SERRI Project:  
Investigation of the Wind Resistance of  
Asphalt Shingle Roof Coverings**

Date Published:  
June 16, 2013

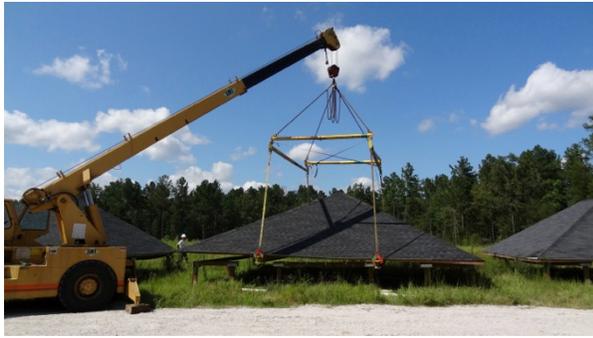
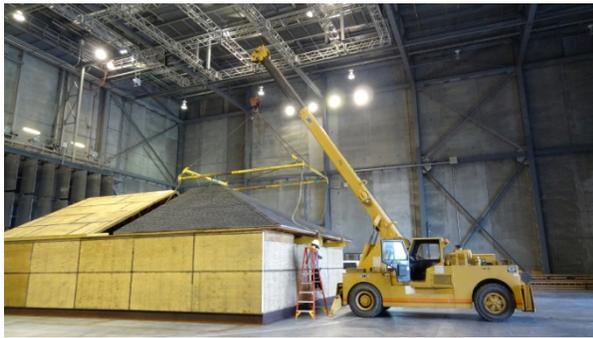
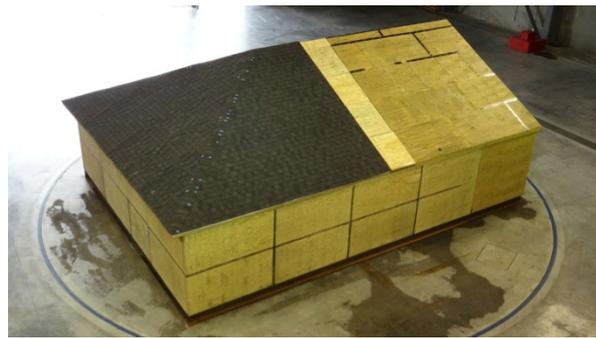
**Fig. 105. Hip roof installation procedure: the roof was (a) carried from the conditioning site with crane and rigging, then (b) driven inside the test chamber and (c) hoisted onto the base structure. A survey for the presence of unsealed shingles (following ERP #6) was conducted before testing (d) and blue painter's tape was used to mark the location of unsealed shingles.**

4. The rigging and beam clamps were then removed from the lifting beams and the beams were pushed into the base structure. Next, the 0.9 m (3 ft) exposed gap between the permanent and specimen's interior gable ends was covered with 11.9 mm (0.47 in) thick structural grade plywood fastened to the 4x4 dimensional lumber using 38 mm (1.5 in) screws at an approximate spacing of 102 mm (4 in) on center.

5. The roof specimen was secured to the base structure's wall top plates using a single Simpson Strong-Tie H2.5Z hurricane strap at each truss along the three wall lines. A completed hip roof test building is shown in Figure 105d.

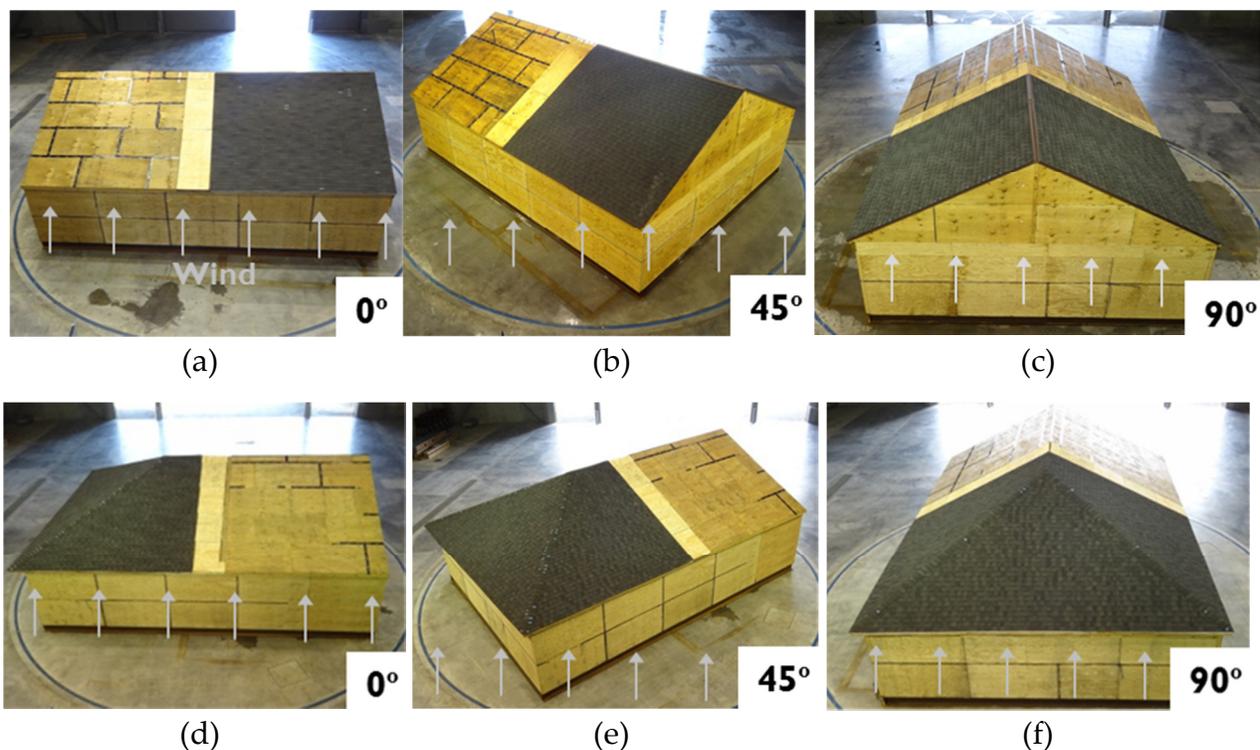
Fig. 107. Wind directions for (a) - (c) gable roof sections and (d) through (f) hip roof sections.

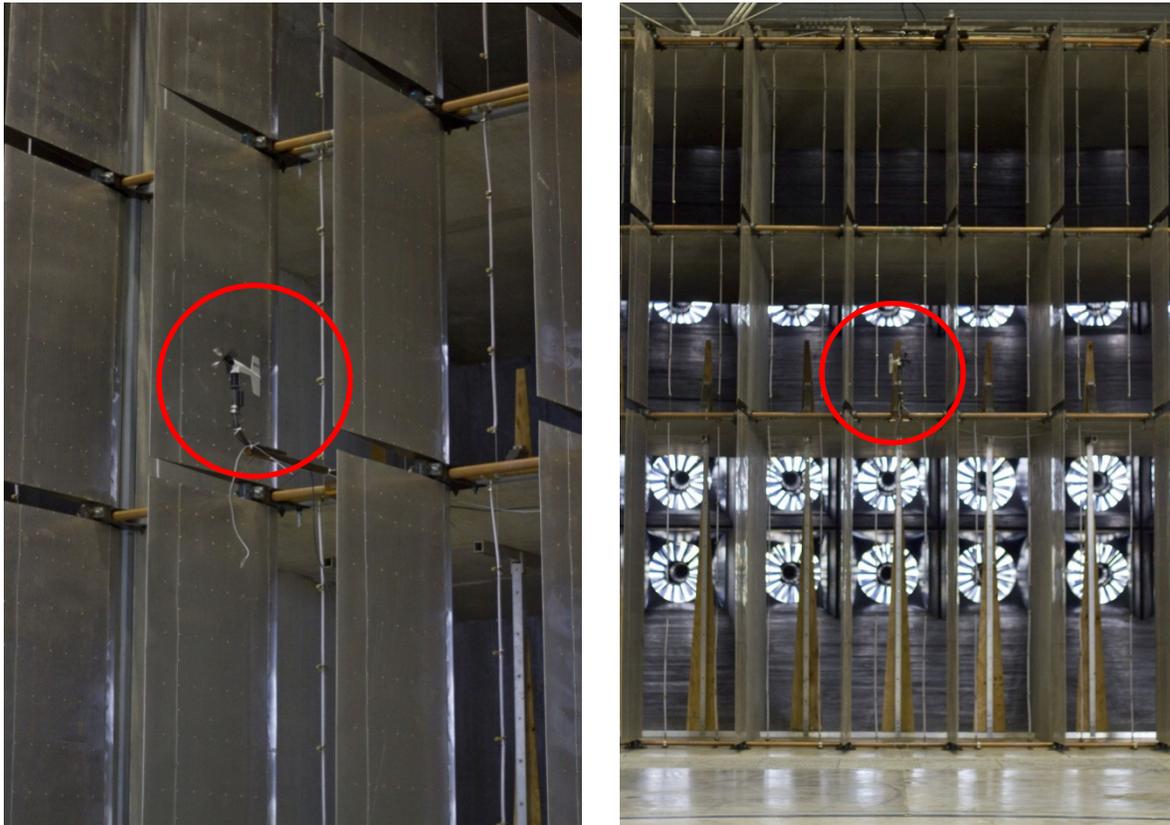
Fig. 109. Wind monitor (shown in red circle).

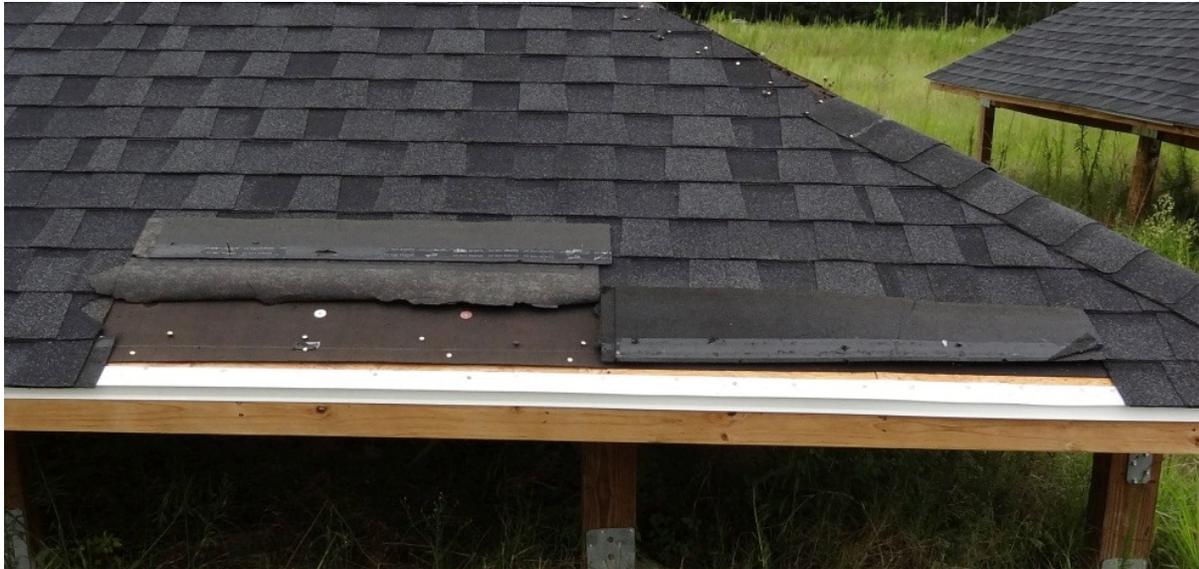
**Fig. 113. Pull-through of the starter strip around fasteners on LAM-201 – Roof 6. The fasteners were placed approximately 102 mm (4 in) from the butt edge of the starter strip.**

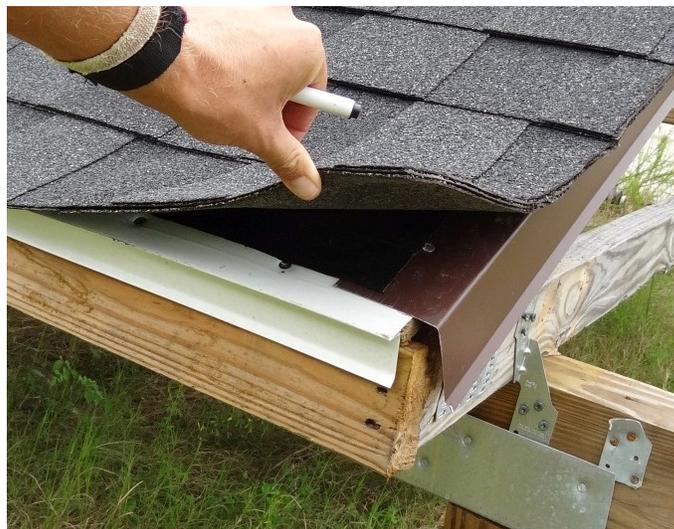
**Fig. 114. Pull-through of the starter strip around fasteners on LAM-201 – Roof 2. The fasteners were placed approximately 127 mm (5 in) from the butt edge of the starter strip.**

Conversely, the eave edge performance of LAM-201 was variable. Windward eaves on five out of the six roofs had pull-through of starter strip shingles at their fasteners. In general, this pull-through at the eave caused isolated surface cracking to the starter strip, first, and second shingle courses. Pull-through of leeward eave shingles was not observed. Post-test assessment of the eaves which sustained pull-through indicated that the location of the starter strip fasteners from the eave edge played a significant role in the wind performance of the eave. For all eaves with pull-through, starter strip fasteners were located 102 – 127 mm (4 – 5 in) from the eave edge (Figure 113 and 114). This was a contractor error. ARMA's Asphalt Roofing Residential Manual (2006) specifies that the starter strip fasteners should be located 38 – 76 mm (1.5 – 3 in) from the eave edge. Whereas, FEMA 499 FS 7.3 recommends 25 mm (1 in) to 64 mm (2.5 in) with 25 mm (1 in) preferred if framing conditions permit. As will be noted for the other manufacturers' shingle systems, placing fasteners within ARMA's nailing tolerance may have prevented the pull-through in eave shingles. Inspection of several eave shingles that did not sustain pull-through revealed nail placements within ARMA's specifications.

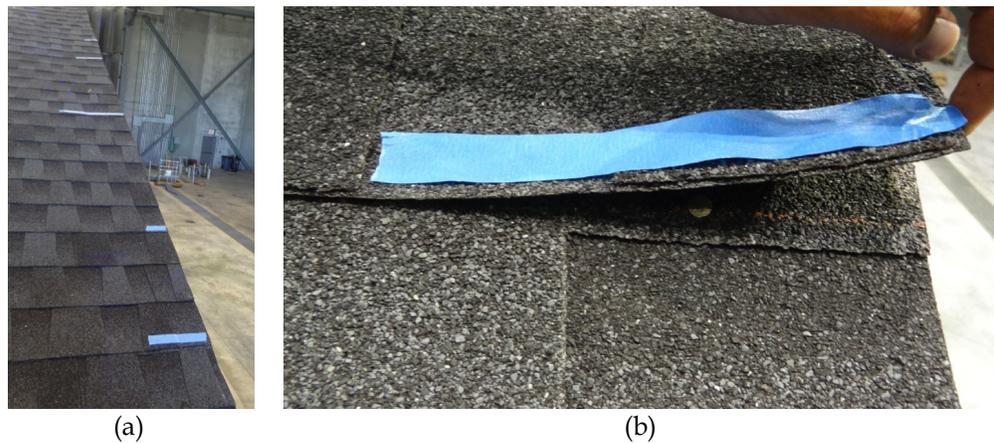
**Fig. 115. Pre-test roof survey of LAM-202 - Roof 2 found five partially unsealed shingles along the windward rake. The blue tape was placed on the leading edge where shingles were found unsealed prior to the wind testing. The cause of the partial unseal is unknown.**

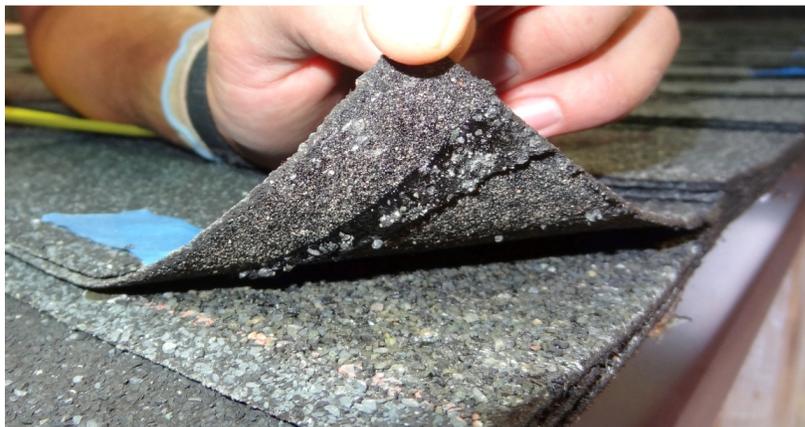
**Fig. 119. Pre-wind test unsealed rake shingle with an adhesive failure mode – LAM-202 – Roof 3.**

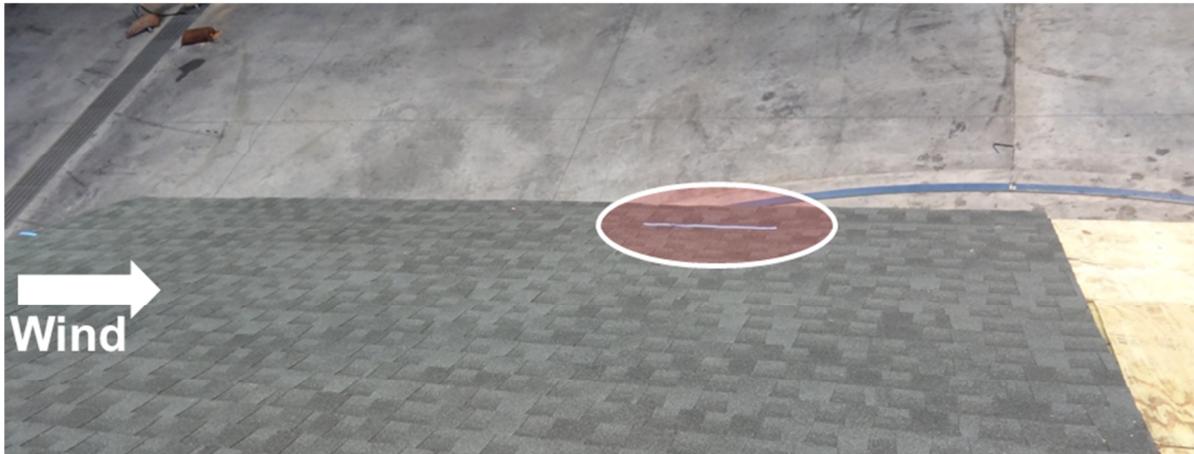
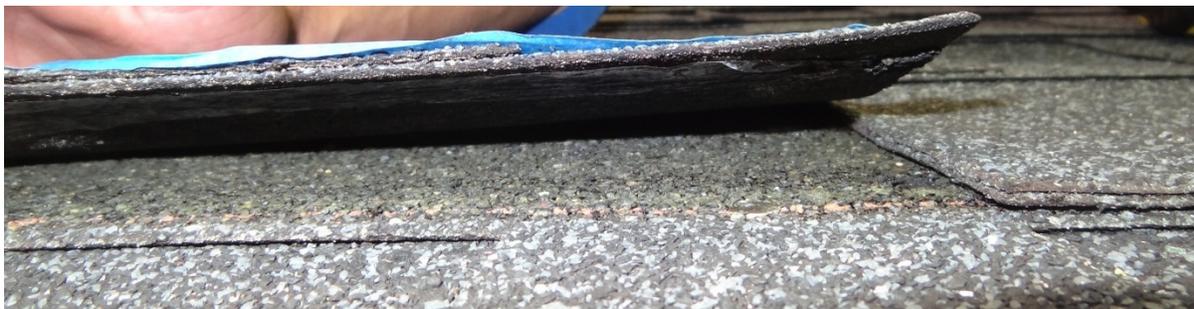
**Fig. 120. Shingle with 711 mm (28 in) of unsealed length (a) located on the third course on the interior of the roof section. (b) The non-sealing was caused by a transfer of the release tape onto the sealant strip. This shingle remained on the roof during wind testing and no surface cracks were observed following the test.**

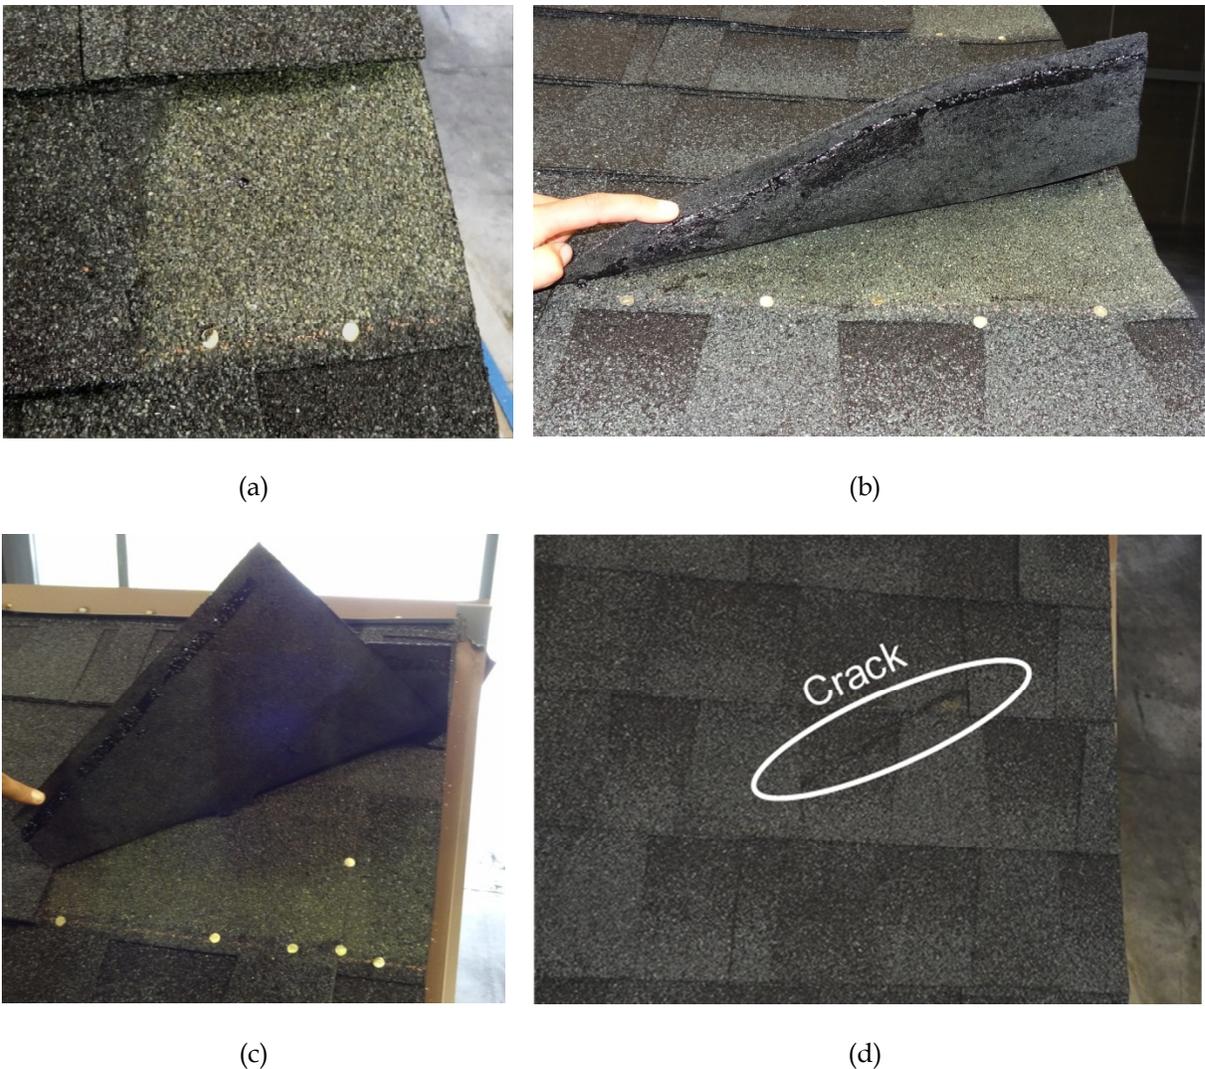
**Fig. 121. LAM-202 – Roof 3 pre-test unsealed shingles: (a) loss of shingle during wind tests, (b) and (c) pre-test unsealed shingles that lifted during wind testing, (d) crack formed on shingle surface due to pre-test unsealed shingle lifting during wind test.**

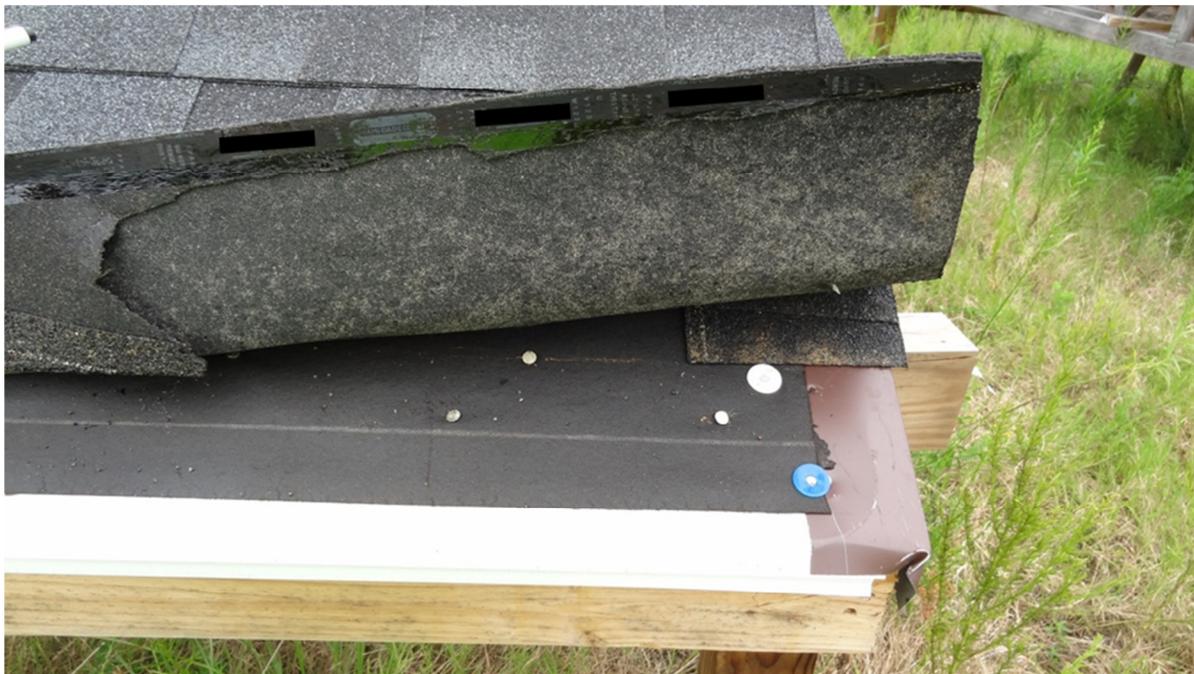
**Fig. 122.** Pull-through of the shingle system’s eave starter strips around the fasteners on LAM-202 – Roof 2. The fasteners were placed approximately 127 mm (5 in) from the butt edge of the starter strip.

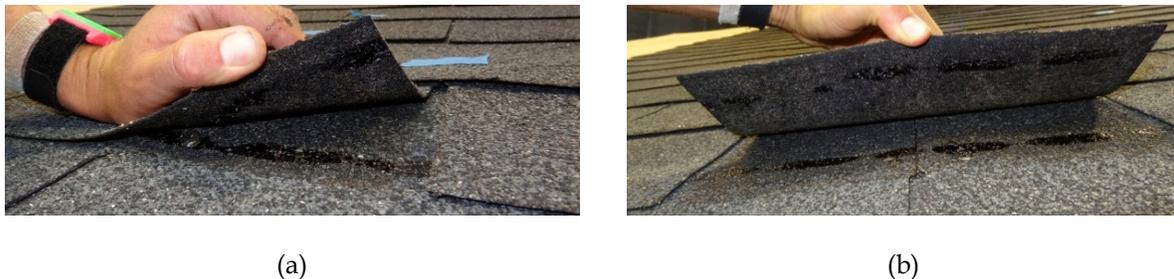
**Fig. 123. TT-201 – Roof 5 pre-test unsealing was caused by a cohesive failure in the tab sealant for both (a) partially and (b) fully unsealed shingles.**

The greatest amount of pre-test unsealing occurred on Roof 5 (45°) with 12% of the roof's shingles either partially or fully unsealed (Figure 124). In contrast to the adhesive mode of unsealing noted on the unsealed shingles of LAM-201 and LAM-202, a majority of TT-201's pre-test unsealed shingles failed cohesively within the sealant strip (Figure 123). This indicates that the shingles were, at one time, fully sealed and became unsealed either due to natural weathering or due to stresses caused by the transport of the roof specimen from the conditioning site to the test chamber. The progression lifted and blown off shingles caused by the unsealed shingles is presented in Figure 125. During Wind Level 1, several unsealed shingle tabs lifted and larger "sheeting" type lifting and blow off occurred near the ridge where several unsealed shingles were adjacent to one another. Additional shingle tabs lifted throughout Wind Levels 2-4, producing the final result shown in Figure 126. Post-test assessment of Roof 5 found that 9% of the field shingles were blown off or damaged to the point where repair or replacement would be required. The assessment also found that pre-test unsealed shingles with a minimum unsealed length of 152 mm (6 in) (i.e., one-half tab width) became unsealed during the wind test. This is a significant finding because this shows that partially unsealed shingles can become fully unsealed during wind storms. Recall that the roof surveys conducted on naturally-aged roofs in Section 2.5.4 found patterns of partially unsealed three-tab shingles containing an unsealed length of one-half tab width. Therefore, given the results of Roof 5, it appears that the partially unsealed three-tab shingles observed on the naturally-aged homes can become unsealed in below design-level wind events.

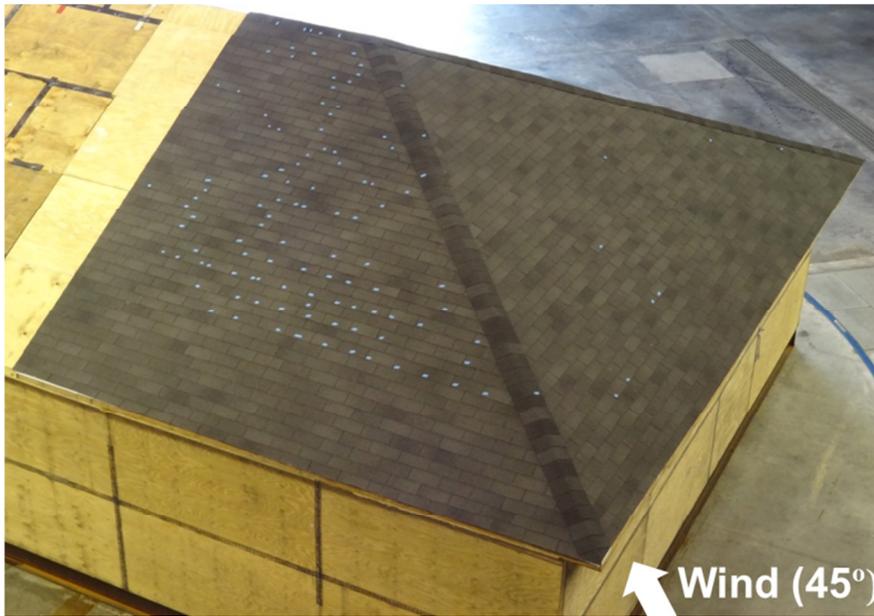
Fig. 124. Unsealed shingles found on TT-201 – Roof 5 prior to wind testing. Blue marks denote the location of full/partially unsealed shingle.

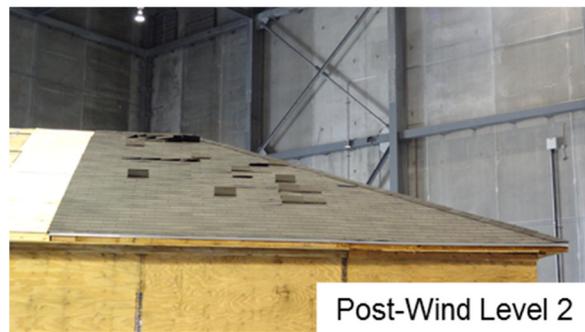
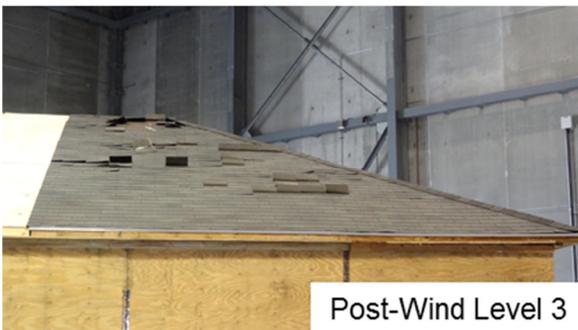
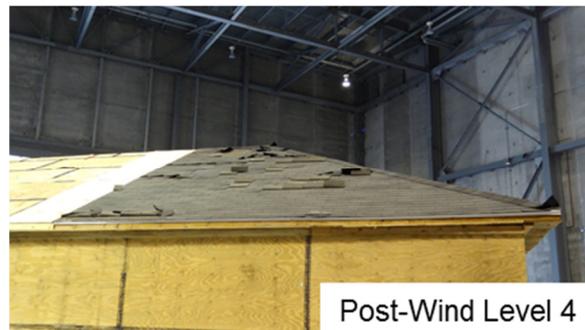
Fig. 125. Progression of shingles lifting, folding, and blowing off during wind testing of TT-201 – Roof 5.

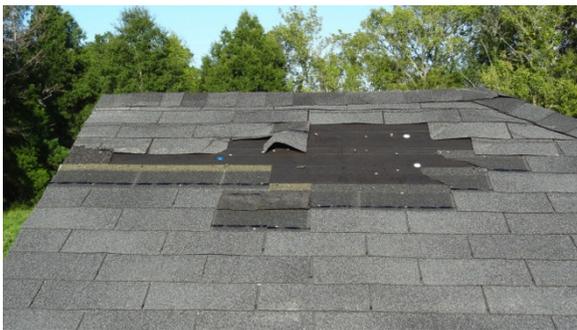
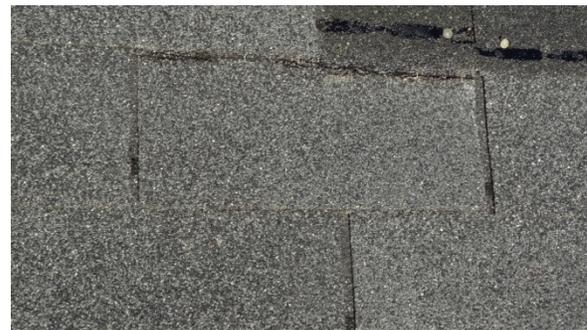
Fig. 127. TT-201 - Roof 5 (a) blow off of shingles caused by a group of pre-test unsealed shingles. (b) Horizontal crack formed by lifting of the unsealed tab during wind testing.

1. Pre-wind test fully and partially unsealed shingle tabs. The unsealed shingles lifted in the wind and either folded backwards, causing horizontal cracking near the top of their exposure, or blew off the roof due to fatigue from fluttering in the wind (Figure 127). More pre-wind test unsealing was evident on TT-201's three-tab shingles than the laminate shingles of LAM-201 and LAM-202.
2. Pull-through around rake edge fasteners or eave starter strip fasteners. Fasteners were placed outside of ARMA (2006) edge distance tolerance. Unlike the eave starter strip pull-through at fasteners on LAM-201 and LAM-202 roofs, the pull-through of TT-201's eave starter strips and rake shingles caused larger areas of surrounding field shingles to unseal, blow off, or sustain surface cracks.

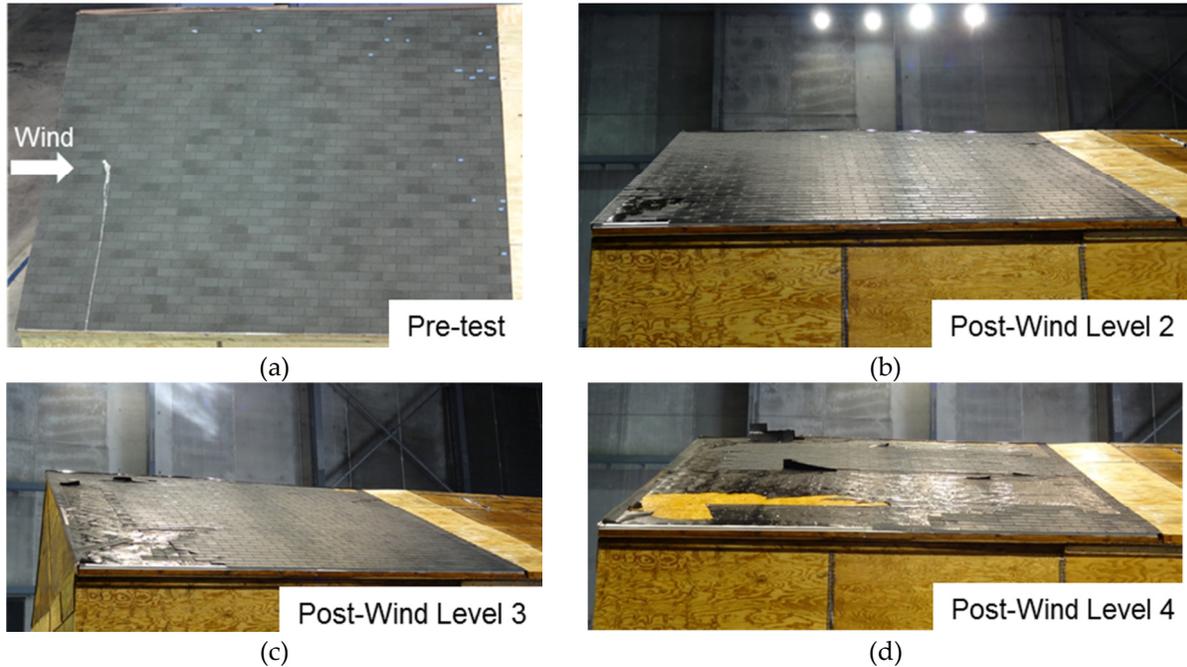
**Fig. 128. Progression of shingle blow off for TT-201 - Roof 3. Fasteners placed further from the roof's edges than recommended by ARMA (2006).**

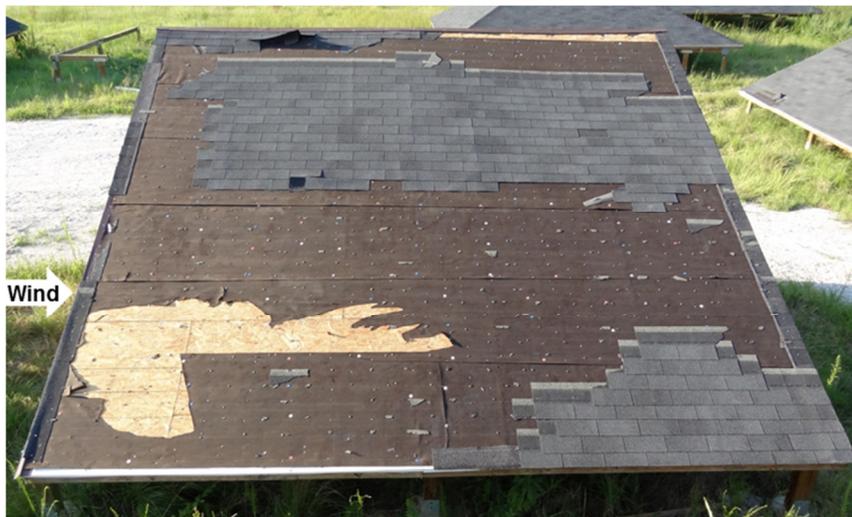
**Fig. 129. TT-201 - Roof 3 with blown off shingles caused by eave and rake shingles that pulled-through their edge fasteners. Note: The location of fasteners was not within ARMA (2006) specification.**

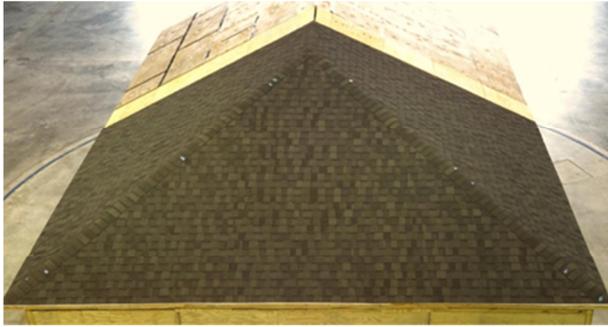
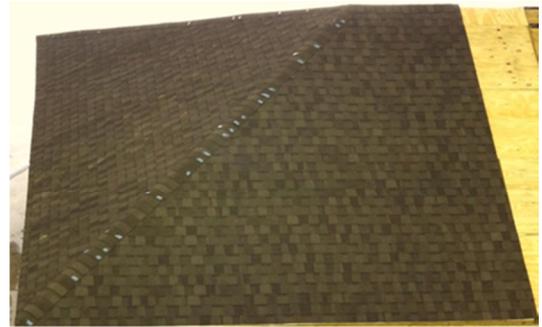
10% Unsealed Hip Shingles

31% Unsealed Hip Shingles

Fig. 130. Example of partially unsealed hip shingles (marked with blue tape): (a) LAM-201 – Roof 6 (10% unsealed) and (b) LAM-202 – Roof 4 (31 % unsealed)

Pre-test partially and fully unsealed hip and ridge shingles were found on all hip roof specimens and the rate of unsealing was higher in the pre-manufactured hip/ridge shingles than the cut three-tabs. A visual reference of the different levels of unsealed hip shingles is given in Figure 130. Hip shingles were typically sealed along the centerline of the hip line, but unsealed at the edges of the shingle, either on one or both sides of the hip line (Figure 130). Inspection of unsealed hip shingle's sealant strip showed adhesive failures between the sealant strip and the bottom of the shingle. This indicates that the hip shingles were likely not sealed from the time of installation to the time of inspection. Similar results of unsealed hip shingles were obtained on the roof surveys detailed in Section 2.5.4.2.

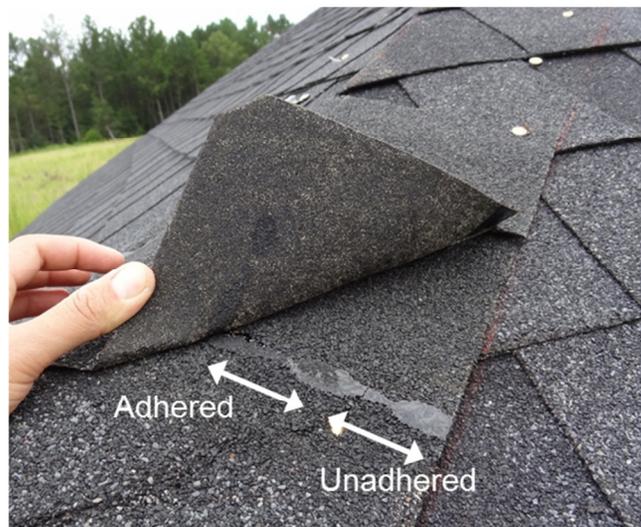
Fig. 131. Example of unsealed hip shingle on LAM-201 – Roof 5. The shingle was unadhered at the edge of the hip shingle and adhered closer to the center of the hip line. (Note: this photo was taken after wind testing.)

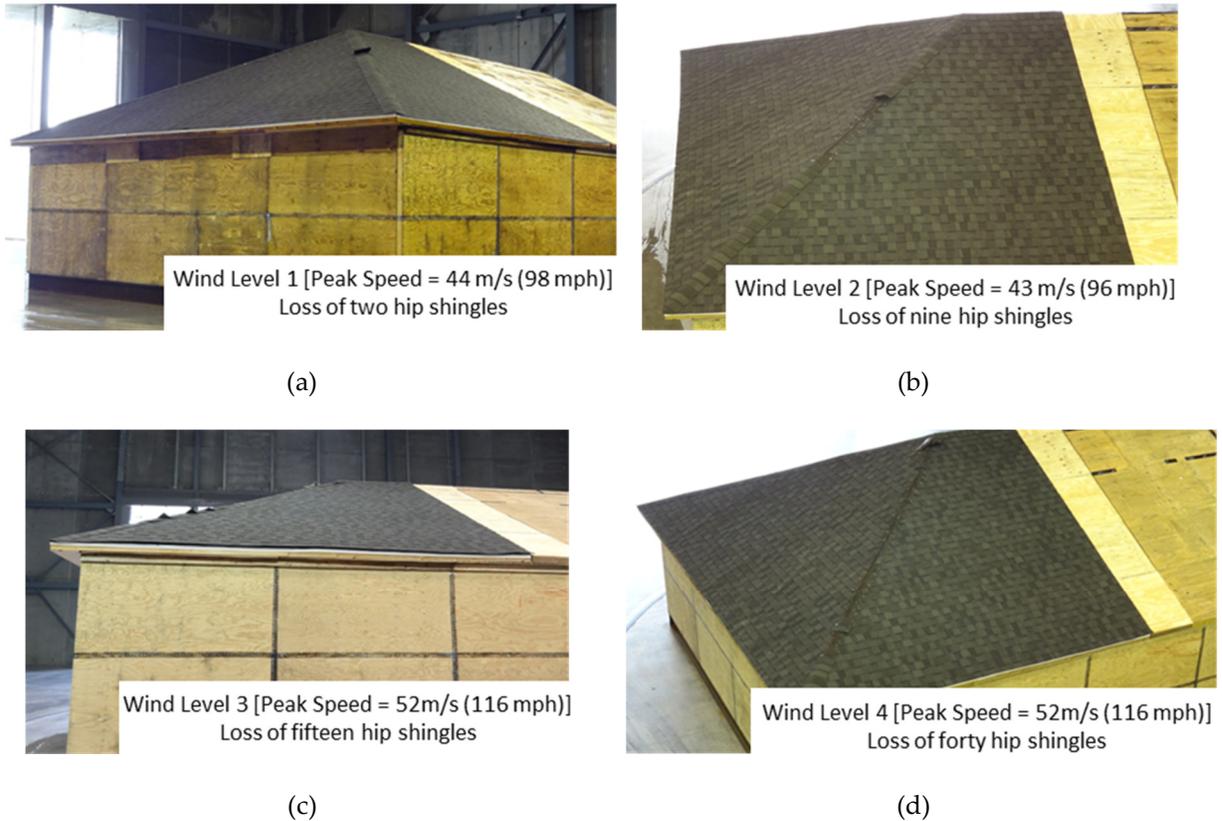
**Fig. 132. Progression of hip shingle blow off through the wind test sequence for specimen LAM-201 - Roof 4.**

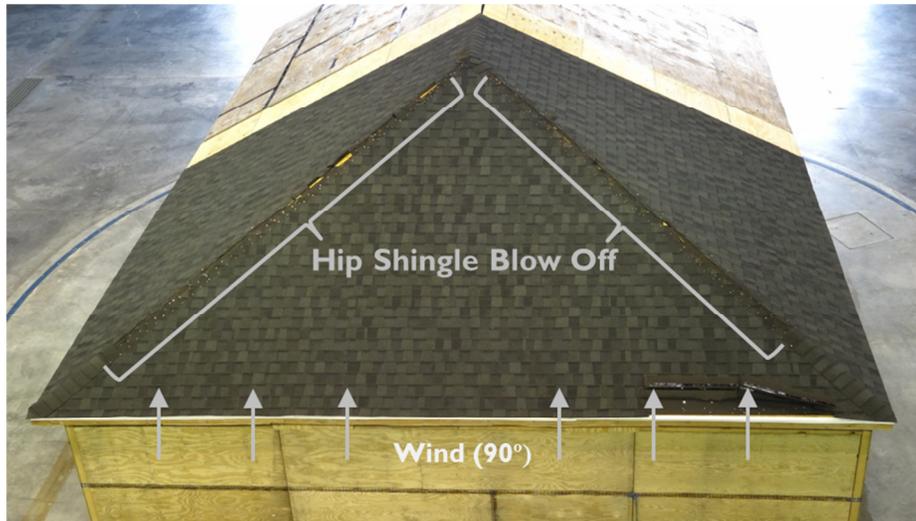
**Fig. 135. Typical hip shingle blow off for 90° wind azimuth (photo of LAM-201 – Roof 6 specimen).**

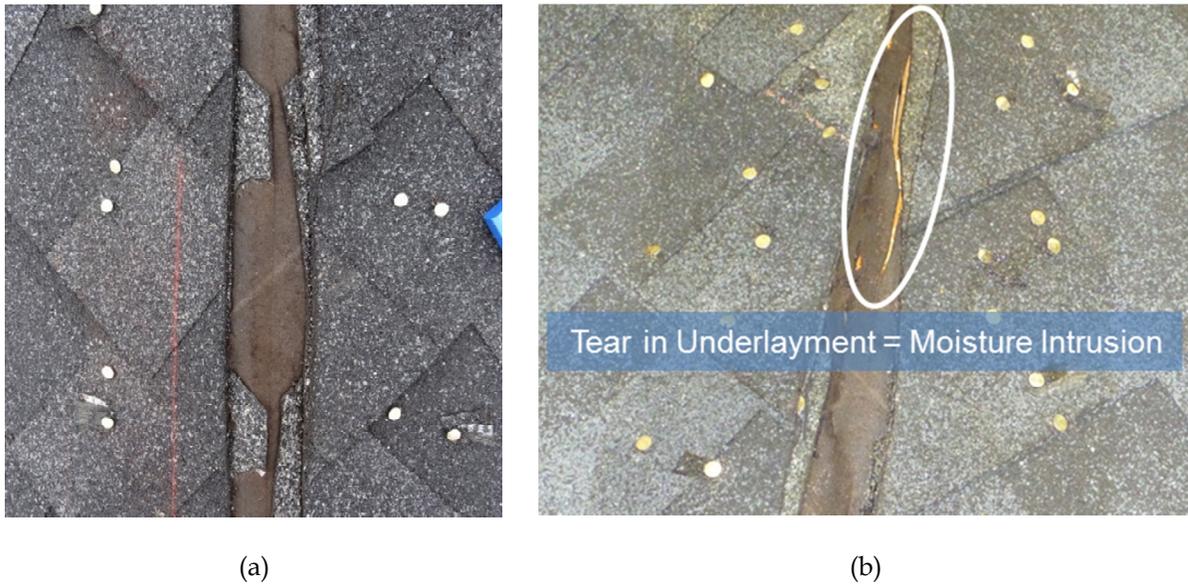
**Fig. 136. Underlayment wrapped over hip line: (a) likely water-resistant (LAM-201 – Roof 4) and (b) torn underlayment likely due to roof installers cutting field shingles at the hip line causing exposure of hip line to moisture intrusion (LAM-202 – Roof 6).**

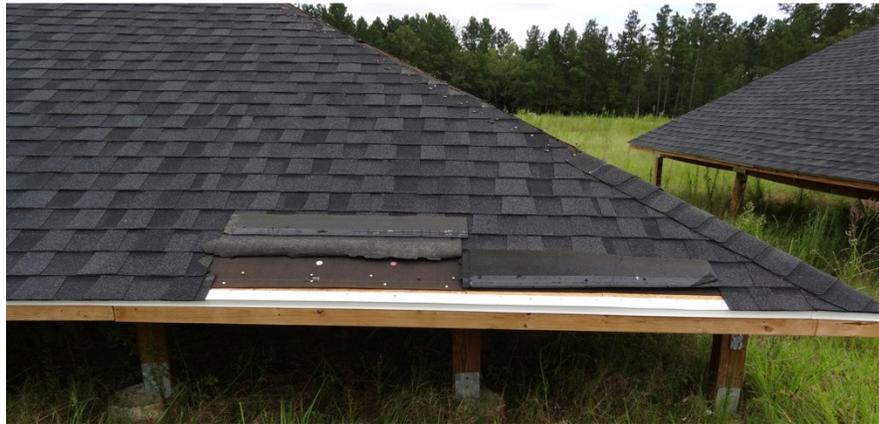
**Fig. 137. Pull-through eave starter strip shingles at fasteners causing cracking to the surface of first and second shingle courses (LAM-201 – Roof 6).**

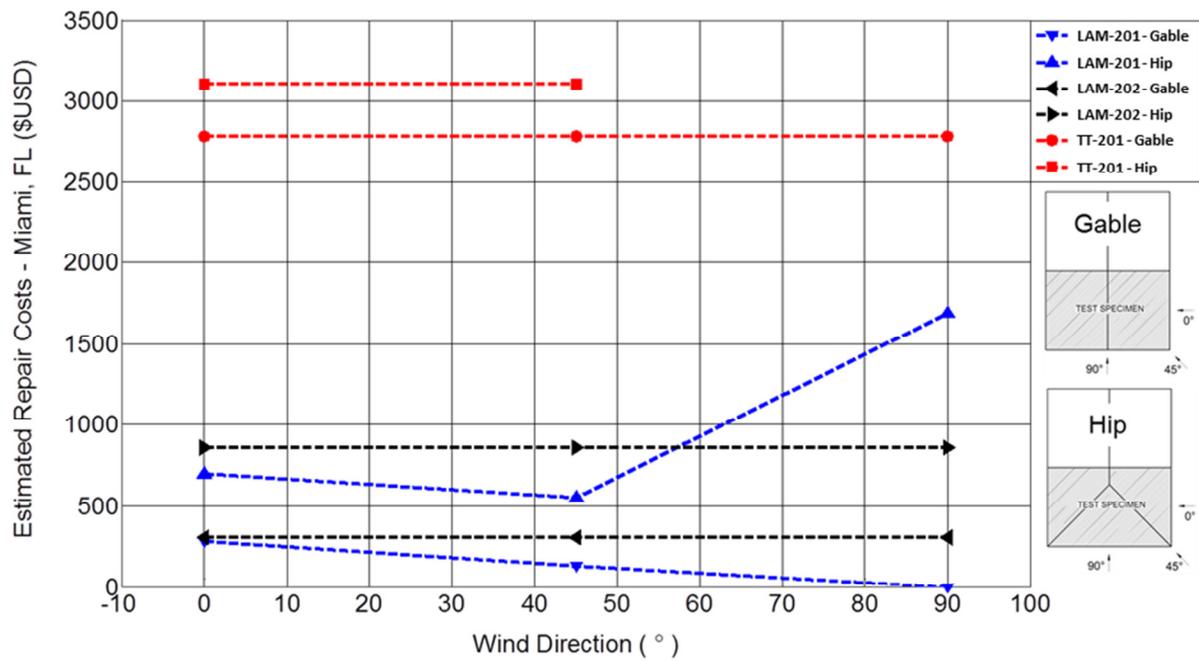
Fig. 138. Estimated cost of roof repairs in Miami, FL versus wind direction. (Costs estimated using Xactware 2012 software and October 2012 price list)

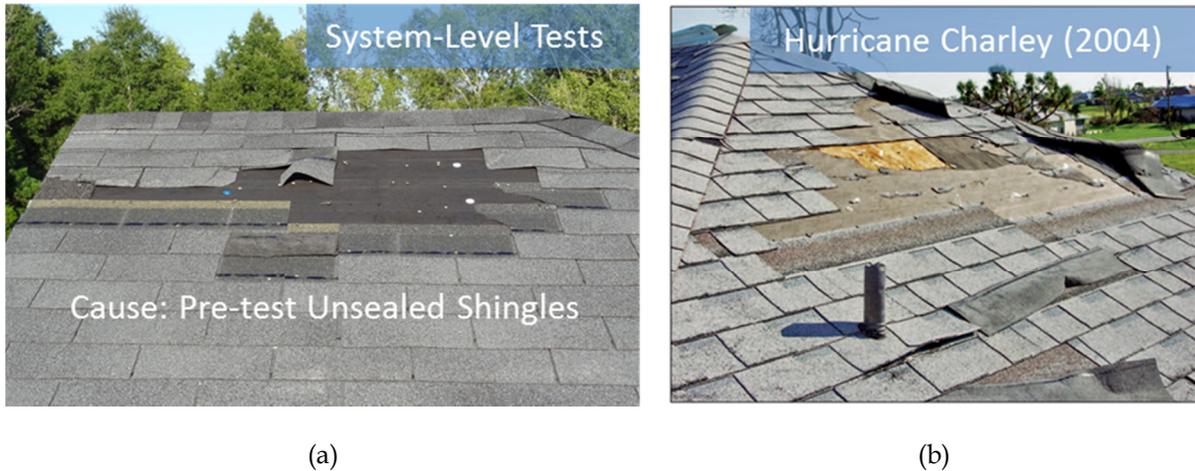
**Fig. 139. (a) Shingle blow off obtained from system-level performance test caused by pre-test non-bonded shingles and (b) blown off shingles observed by FEMA after Hurricane Charley [Photo from FEMA (2011)]**

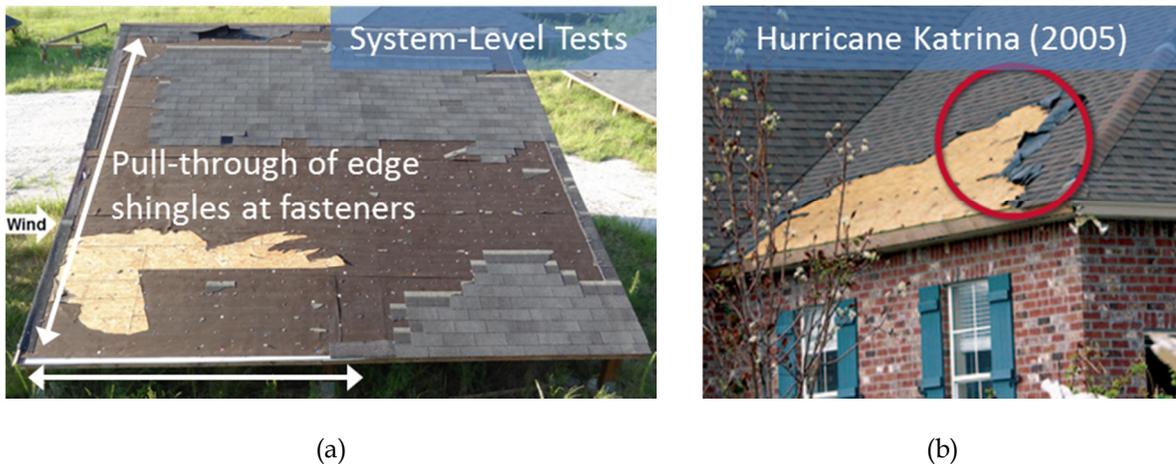
**Fig. 140. (a) Shingle blow off observed during System-Level wind tests caused by pull-through of edge details at their fasteners. (b) Roof from FEMA post-storm assessment teams after Hurricane Katrina [Photo from FEMA (2011)].**

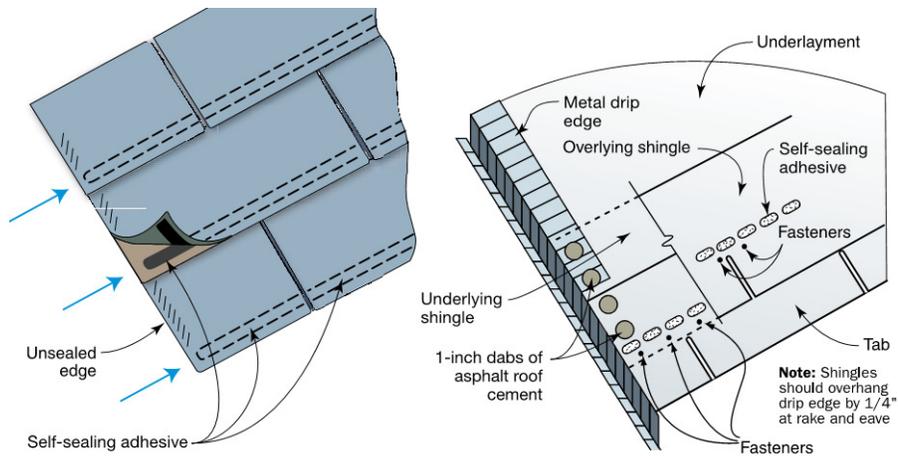
**Fig. 141. FEMA P-499 recommended installation method for rake details. Further work is necessary to define wind resistance of this method and to ensure long-term performance of asphalt roof cement. [Figure from FEMA (2012)]**

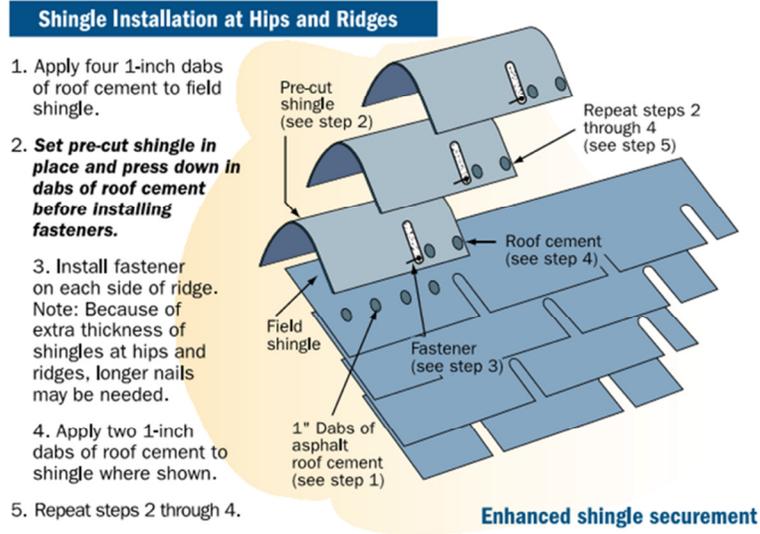
Fig. 142. FEMA P-499 Technical Fact Sheet 7.3 – new construction installation guideline for enhanced hip and ridge shingle wind resistance. Further work is necessary to define wind resistance of this method and to ensure long term performance of asphalt roof cement. [Figure from FEMA (2012)]
