# SELF-SEALING ASPHALT SHINGLES – TECHNICAL BULLETIN 1.0

## SEAL STRIP DESIGN, EXPECTATIONS, AND FAILURE ANALYSIS

J. Lyle Donan, P.E., C.F.E.I.  
President  
Donan Engineering Co., Inc.

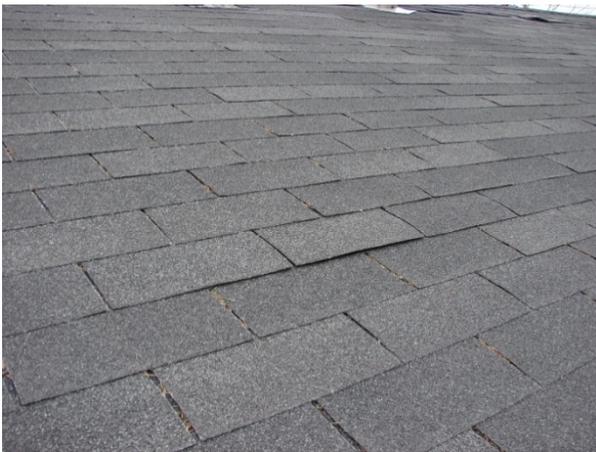
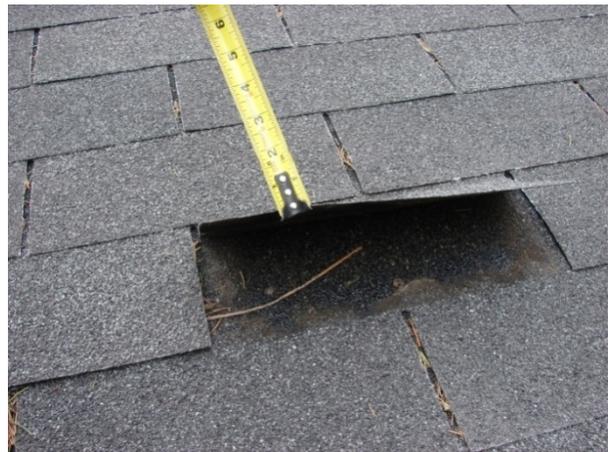
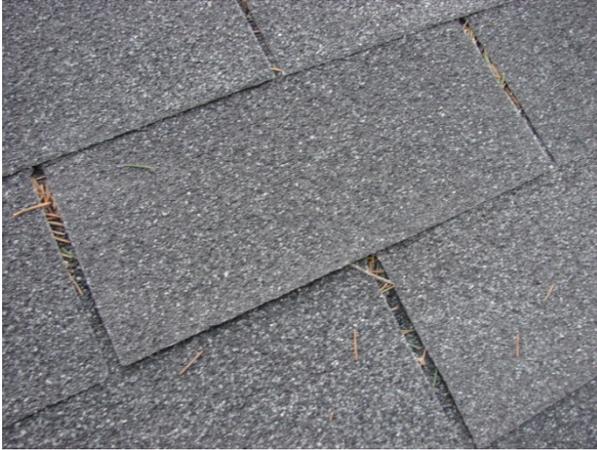
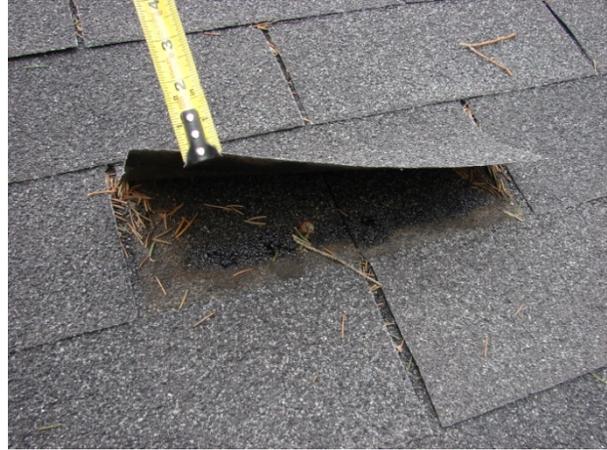
More bad news: While lying unsealed on the roof, the shingles were inherently prone to having dirt, leaves, seeds, twigs, or other common roof debris becoming lodged between the successive shingle courses. If this occurs, the shingles may not lay flat or may not make direct contact with the sealant strip; therefore, when warm temperatures do occur, they have no chance of adhesion, irrelevant of temperature. The following photographs illustrate this condition:

So how do you prevent this from occurring? It's simple. Only install a self-sealing asphalt shingle roof during a time of year when you are guaranteed abundant warm weather. However, since roofs are installed year round, there is only one recommended option to prevent this from occurring – hand sealing.

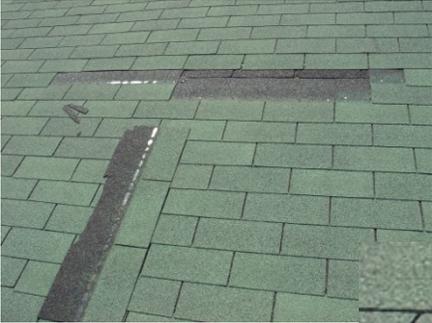
actually cause the shingles to physically delaminate. The following photographs illustrate both insufficient and sufficient adhesion of the asphalt sealant strip on a relatively new wind-damaged roof.

In these areas, the smooth and slick texture and reflective appearance indicates that the sealant strip failed to adhere as designed.

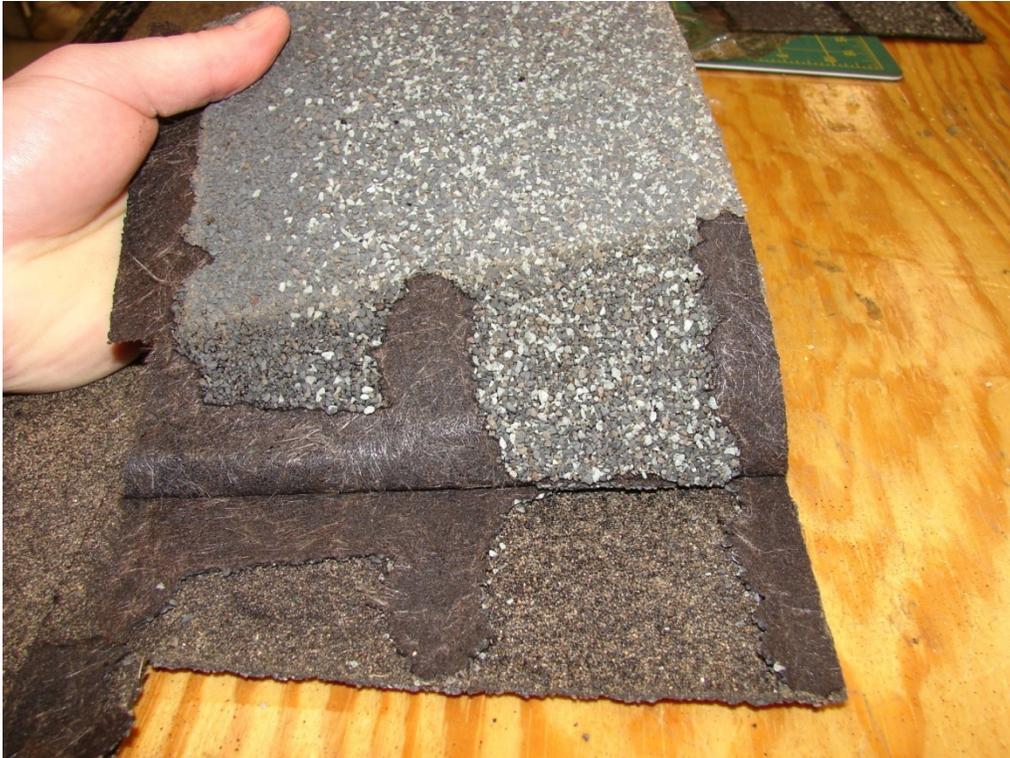
Another way to illustrate the amount of adhesion an asphalt seal strip is designed to achieve is to intentionally pull apart the top and bottom pieces of a dimensional shingle. As these two pieces are sealed together in the factory, the adhesion between them is a carefully controlled design quality. Pulling them apart delaminates the shingle as shown in the following photograph, where the delamination indicates that the material was suitably glued together by the asphalt adhesive. This exercise illustrates that not unlike two pieces of metal welded together, the weld is stronger than either piece individually.

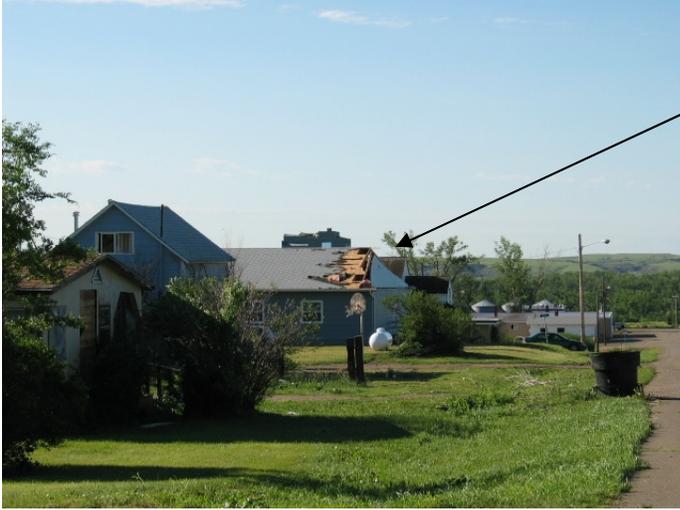
Winds passing over a roof create locally more intense forces of uplift at roof corners, eaves, rakes, hips, and ridges. Severe winds that were parallel to the ridge of this roof induced damage along the rake that extended into the field of the roof.

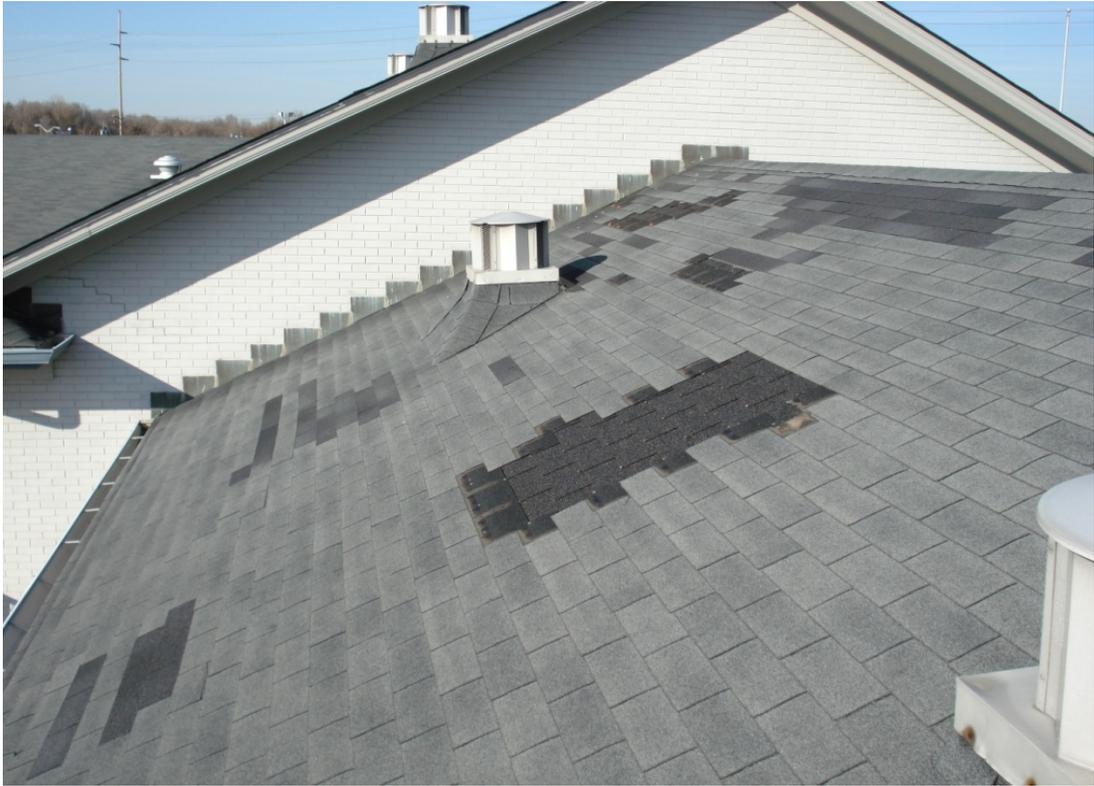
Severe winds passing over this roof caused widespread shingle loss, often in patches, because the shingles were well sealed – holding them together as they peeled and tore from the roof during the storm.

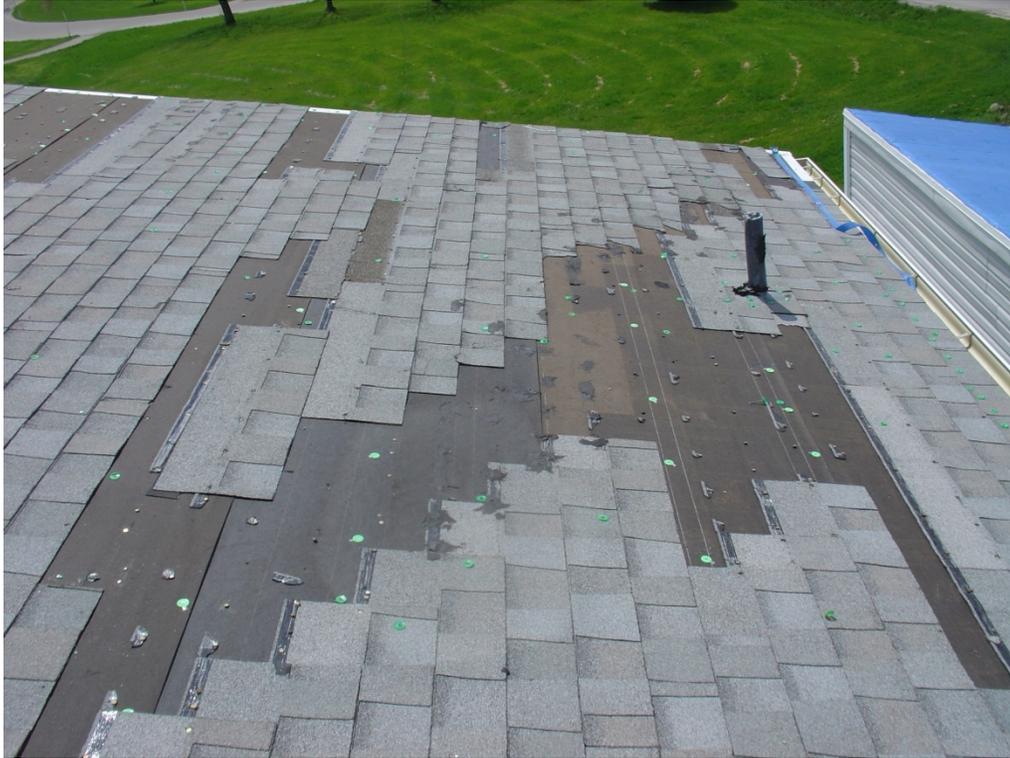
A poorly-sealed dimensional shingle roof that encountered strong, but not severe, wind.

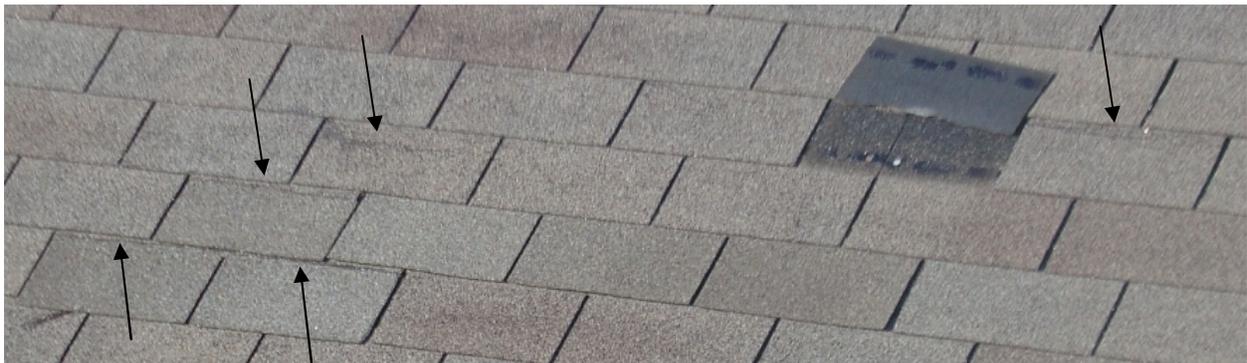
Numerous creased shingles (highlighted with arrows) indicate that they've flapped back and forth repetitively in the wind, probably over a long period of time. Eventually these shingles will tear and blow away, even under mild winds not associated with severe weather.

While shingle damages from wind justifiably warrant concern and diagnosis, the occasional missing or loose shingle, creased or not, does not necessarily mandate a roof replacement. In fact, because this is such a common condition, the industry considers the occasional loose or missing shingle a maintenance issue. We therefore should not be surprised to see such distresses over the lifespan of many asphalt shingle roofs.

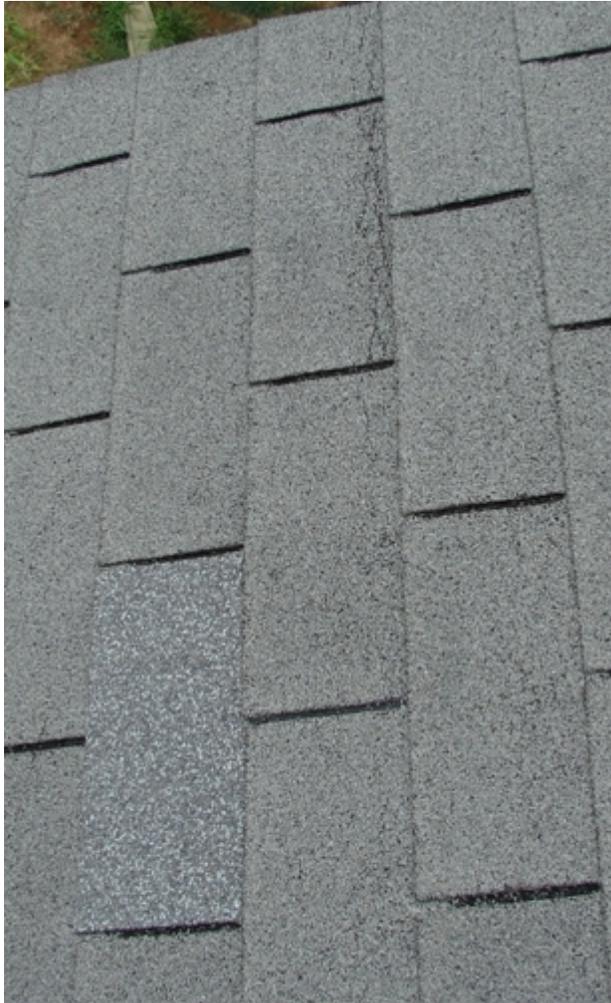
The creases illustrated in the above photographs are classic examples of unsealed shingles that have been repeatedly uplifted and stressed from wind. The repetitive bending creates linear creases that are parallel to the bottom edge of the shingles. As shown in these photographs, if the entire shingle is being lifted from wind, the cracks will occur close to the bottom edge of the overlying shingle. However, if only part of the shingle is unsealed or insufficiently sealed, the cracks are usually oblique to the shingle's corner, as shown in the following photograph:

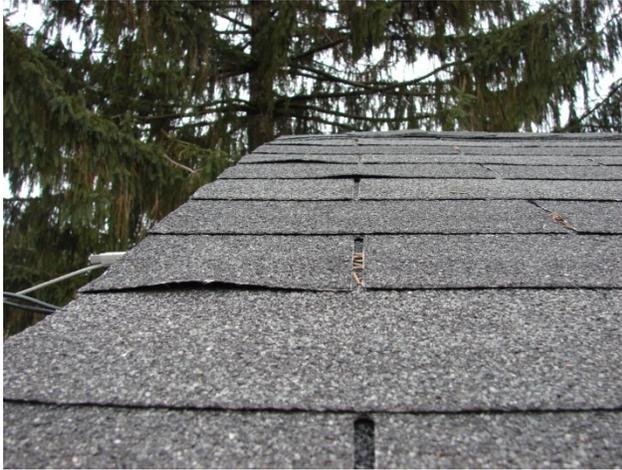
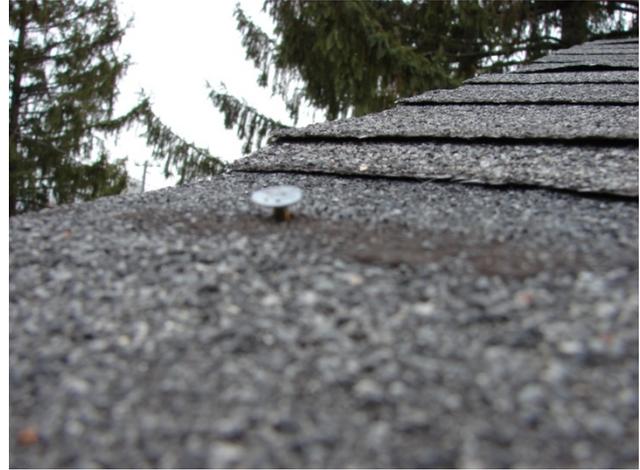
### Nail pops:

Regardless of seal strip performance, be wary of the roof that has many nail pops! While nail pops may occur for a variety of reasons, when they cause the overlying shingle to become raised, they may not only puncture the shingle or cause its seal strip to fail, but because they elevate the overlying shingle's profile, they also make a roof inherently more prone to wind damage.

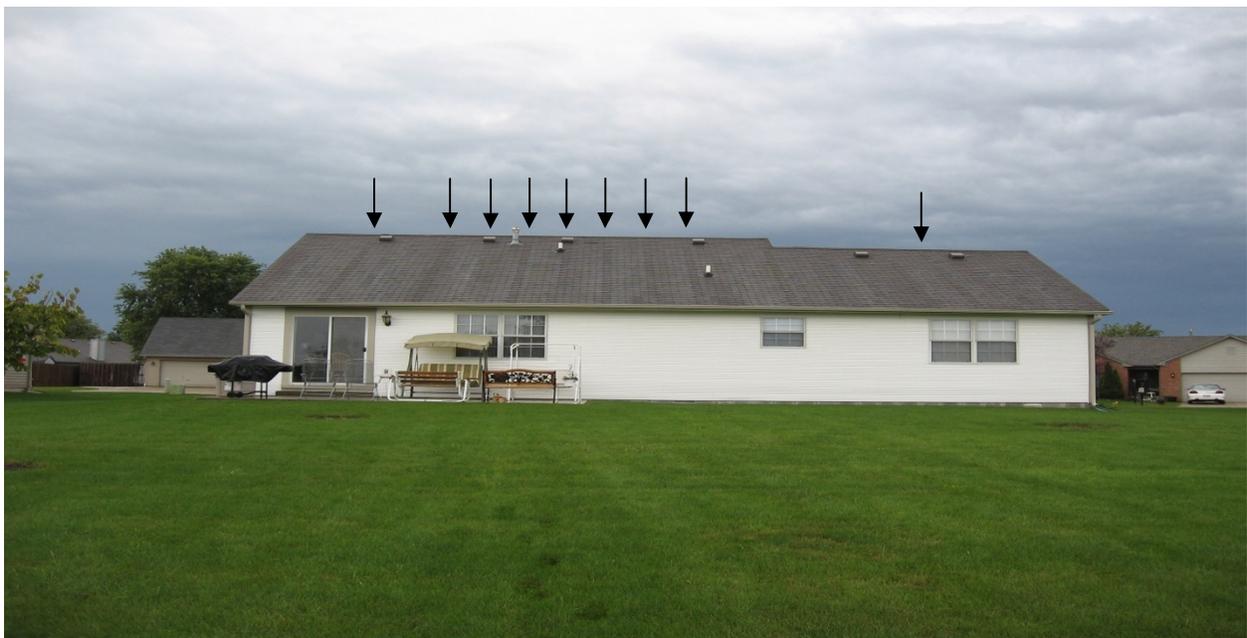
### Vertical Racking:

Regardless of seal strip performance, be concerned about a roof that contains recognizable parallel lines, usually spaced approximately three-feet apart, which correspond to rack lines from when the roof was being installed. As a rule of thumb, if you can see these lines in the roof, the shingles along these lines are loose. And if they're loose, they're inherently prone to wind damage – with or without “severe” winds.
